# CONEJOS RIVER

## DIVERSION INFRASTRUCTURE INVENTORY

**Structure Name:** NEW JB ROMERO D

**Date:** April 15, 2019

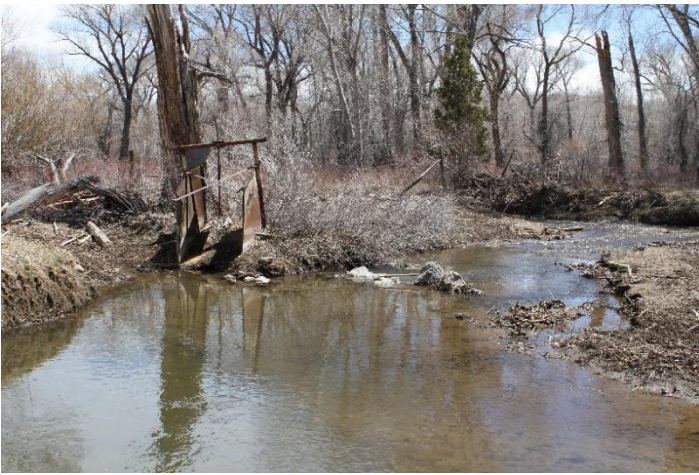
Headgate and diversion dam

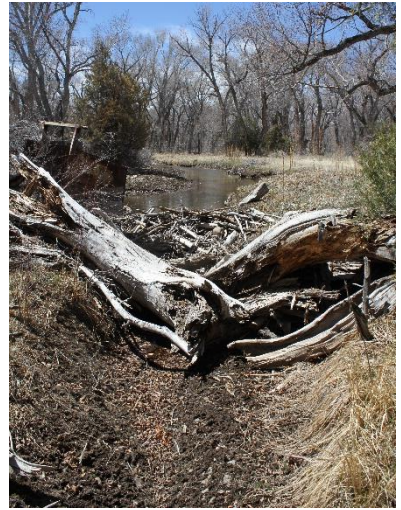
Headgate and feeder ditch looking upstream

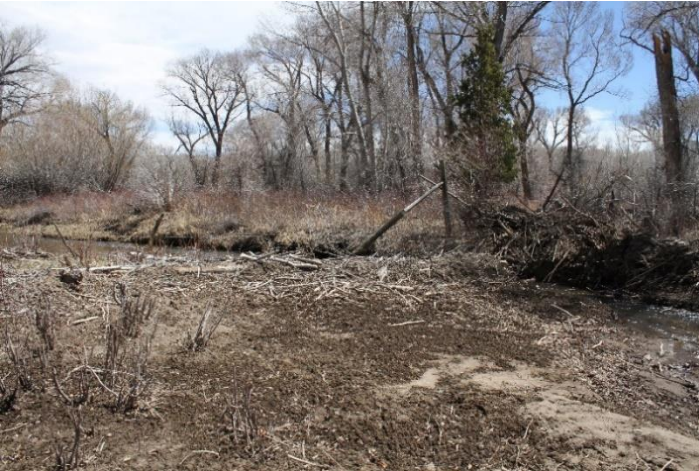
Debris diversion dam on feeder ditch

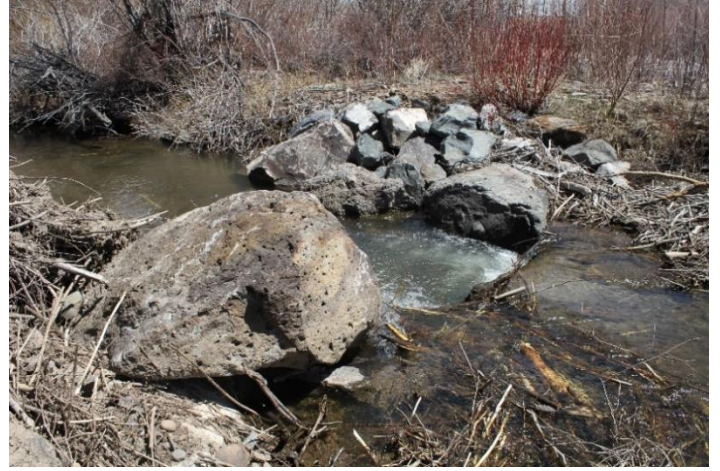
Rock control structure on feeder ditch

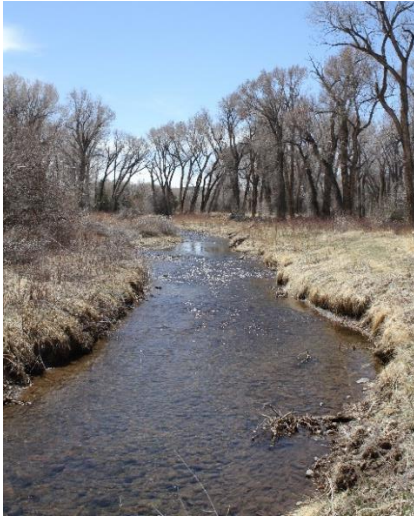
Feeder ditch looking upstream

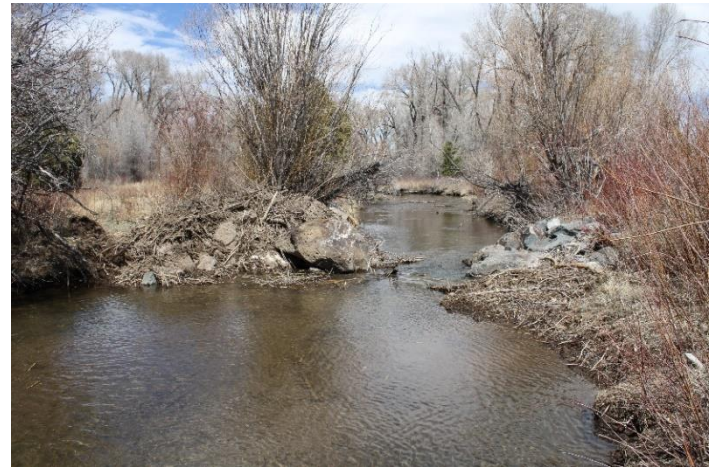
Feeder ditch and rock control structure looking stream

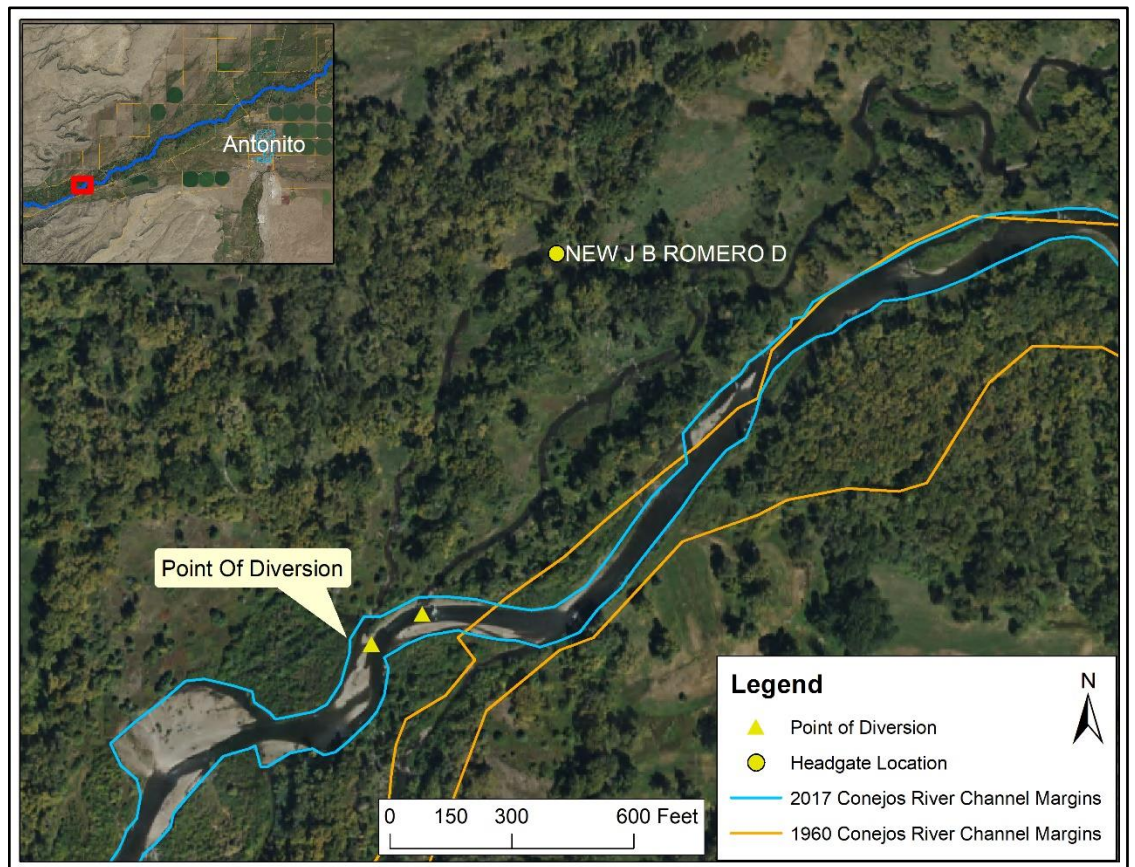
Point of diversion and headgate locations with 1998 and 2017 channel margins overlaid

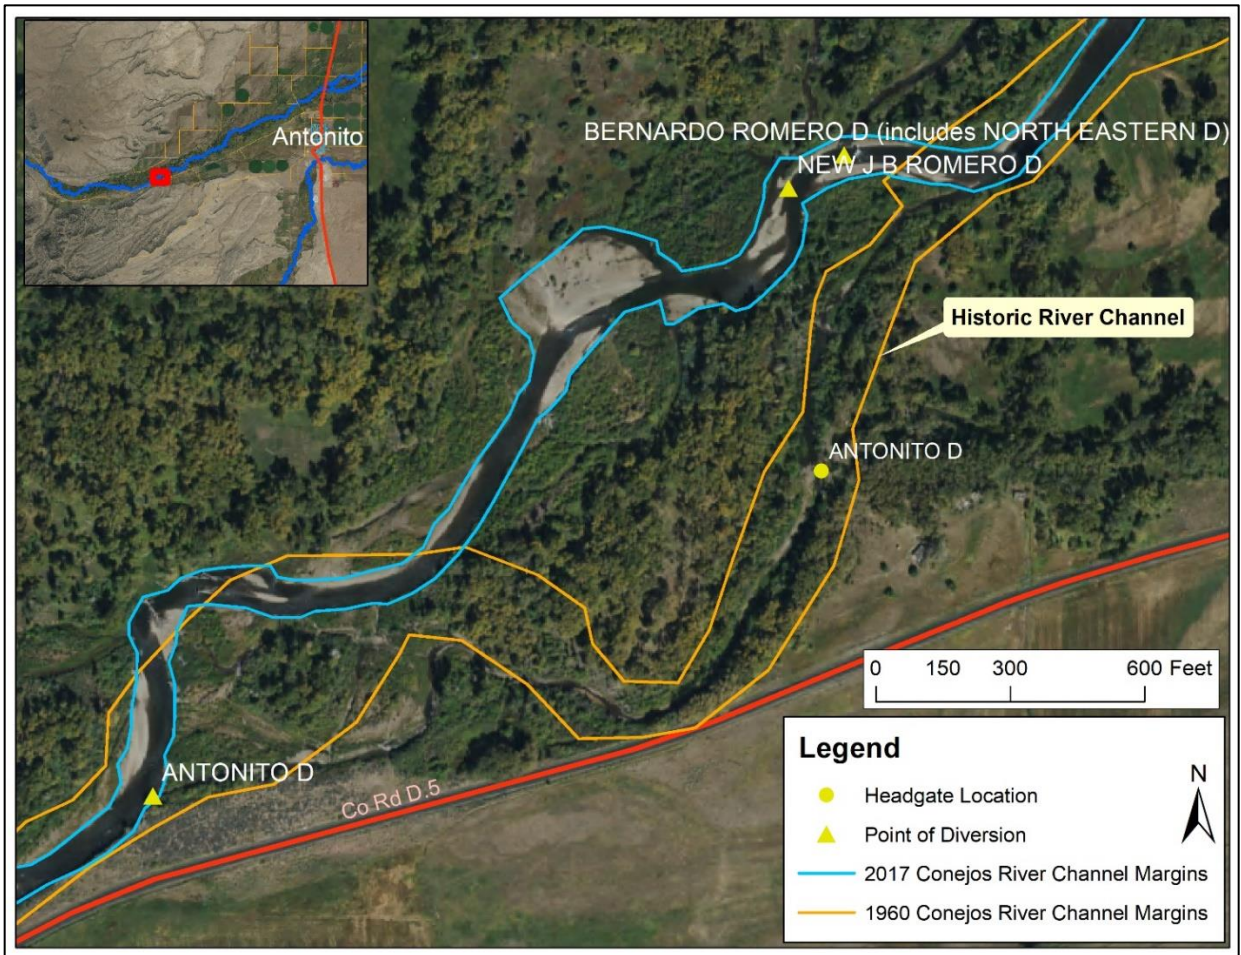
Point of diversion and headgate locations with 1975 and 2017 channel margins overlaid

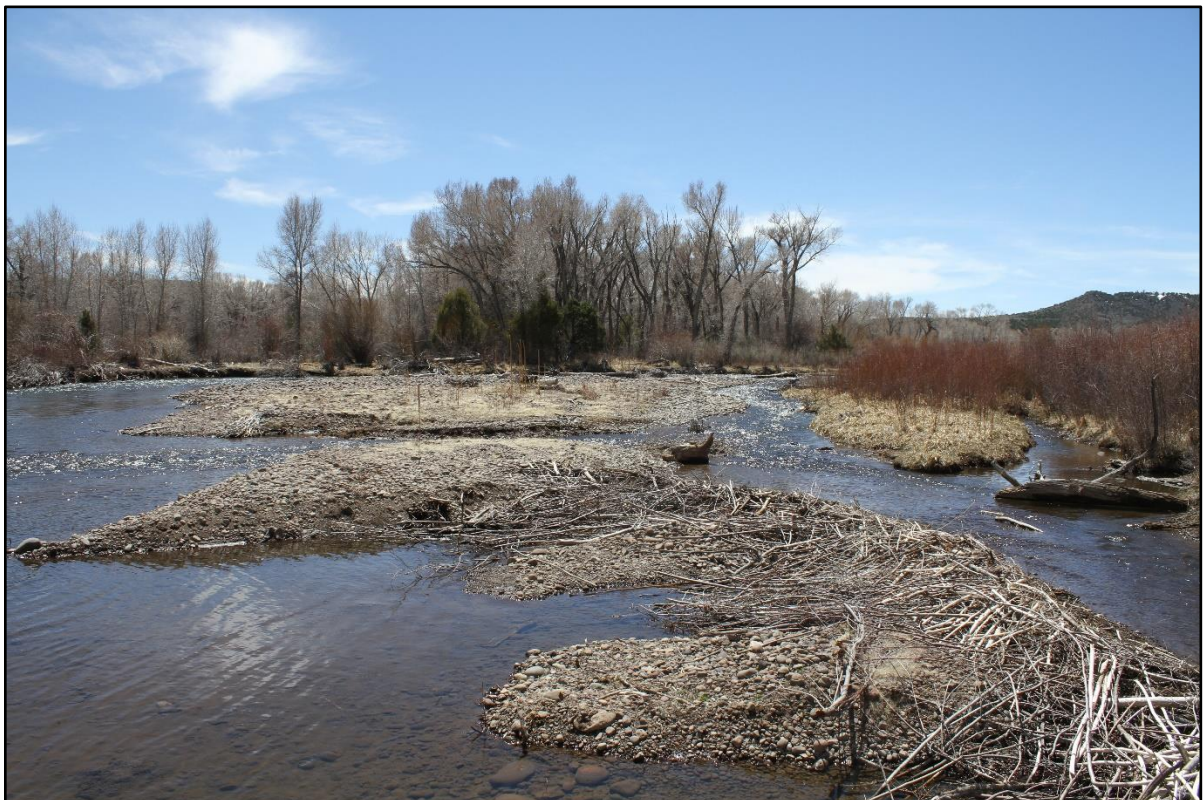
Historic river channel (1960), showing potential for river to migrate and bypass the point of diversion in the future
