# CONEJOS RIVER

## DIVERSION INFRASTRUCTURE INVENTORY

**Structure Name:** NORTH EASTERN D

**Date:** April 14, 2019

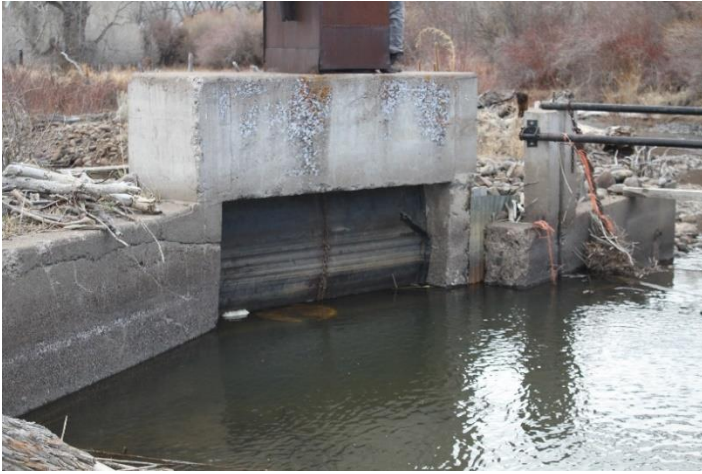
Headgate looking downstream

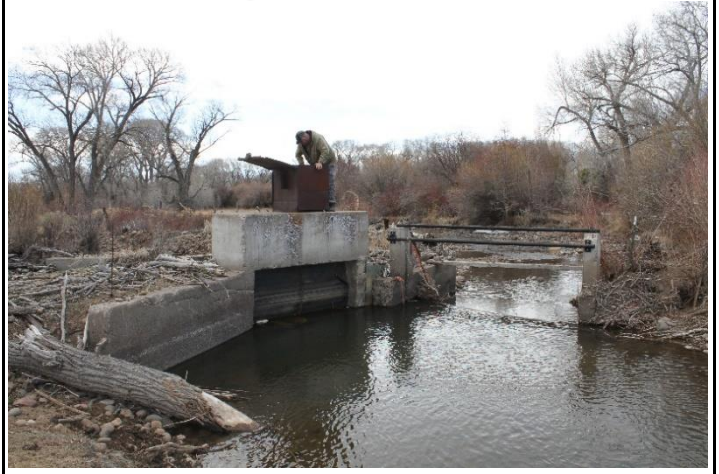
Headgate and diversion dam

**Repair(s) or Improvement(s) Currently Needed:** Given the issues identified at this structure, the SMP Technical Advisory Team (TAT) recommends replacing the river headgate and diversion dam as well as the main diversion and headgate on the feeder channel. The TAT further recommends headgate automation for the main headgate. New diversions and automated headgates would allow this structure to divert water at all flows and would increase efficiency and reduce maintenance. During high flows, the ditch's feeder channel acts as a secondary river channel, thereby dispersing flood flows and reducing downstream risk. The TAT recommends maintaining the feeder channel's overflow capability to mitigate flood risk. Additionally, the TAT recommends maintaining fish passage to preserve aquatic habitat connectivity in this reach. As noted under the New JB Romero description, an alternate solution to these issues is to combine the point of diversion and feeder channel with that of the New JB Romero Ditch to reduce maintenance and impacts to the river.

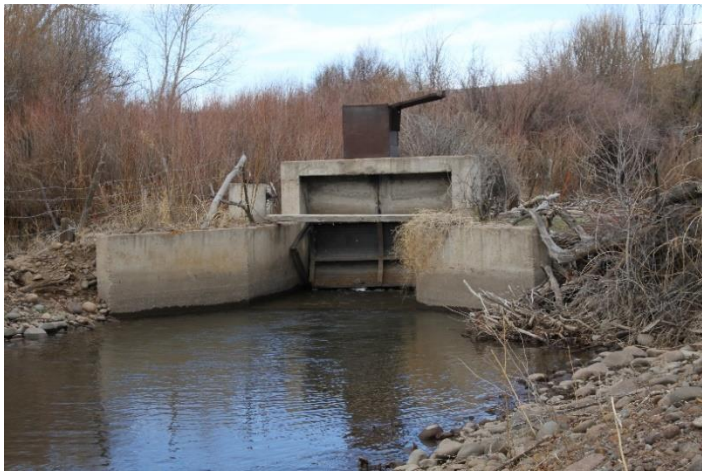
Headgate outlet

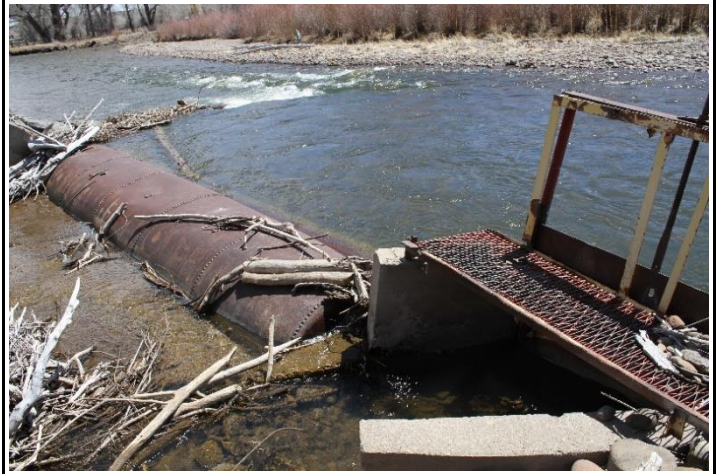
Point of diversion and river headgate

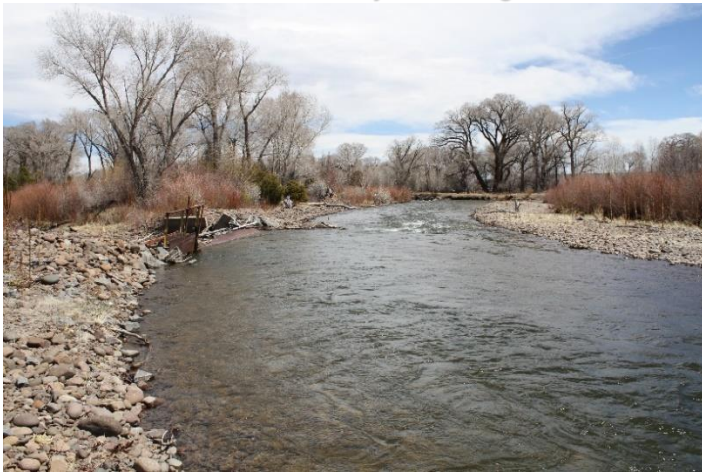
Point of diversion on Conejos looking downstream

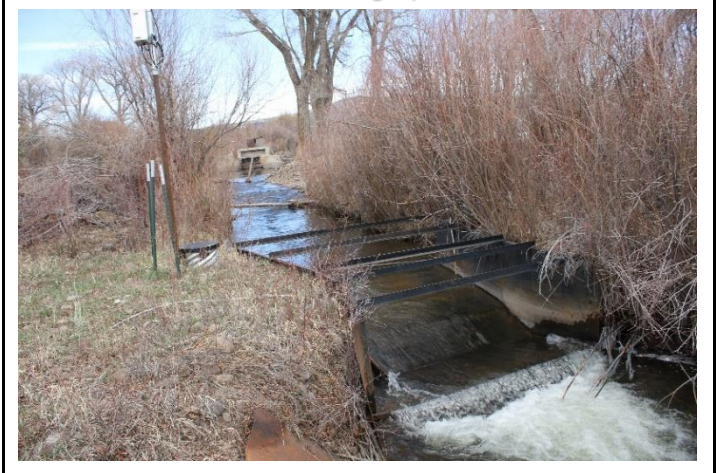
Flume looking upstream

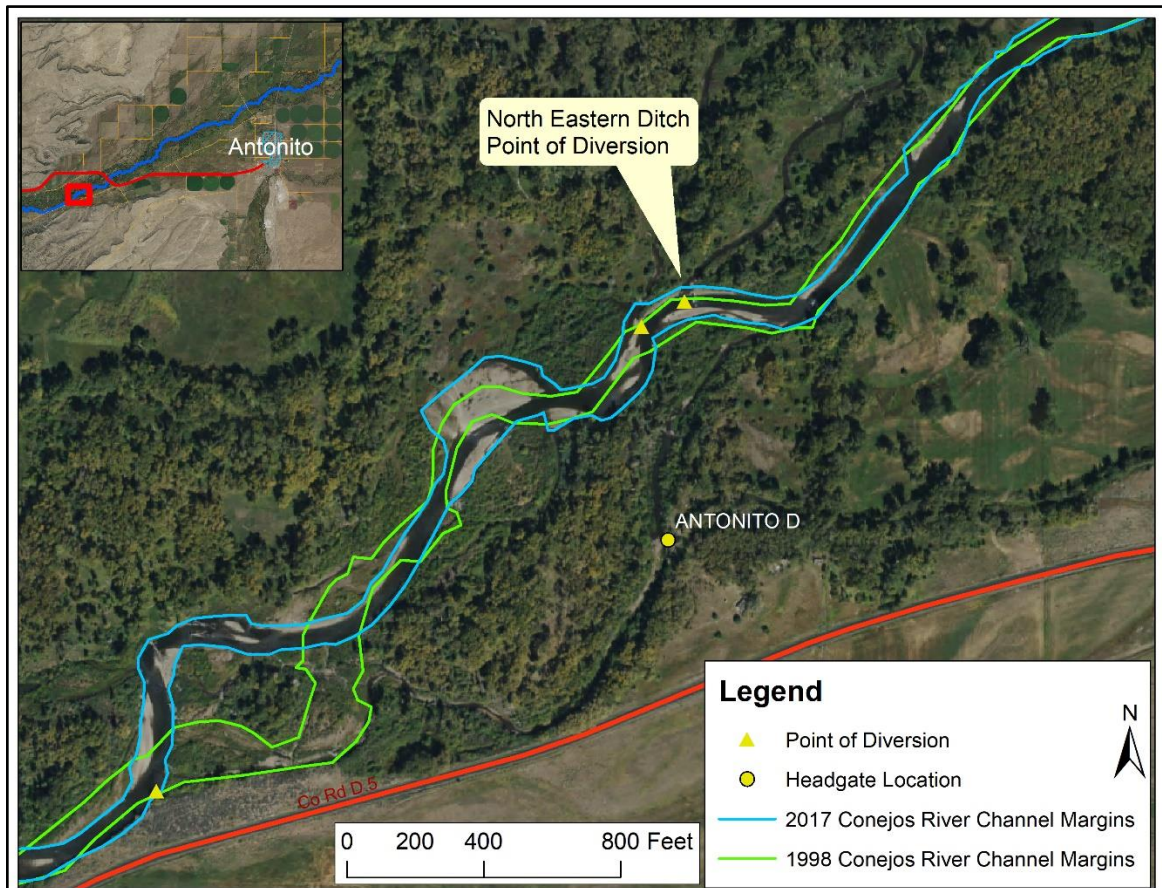
North Eastern Ditch point of diversion with 1998 and 2017 channel margins overlaid

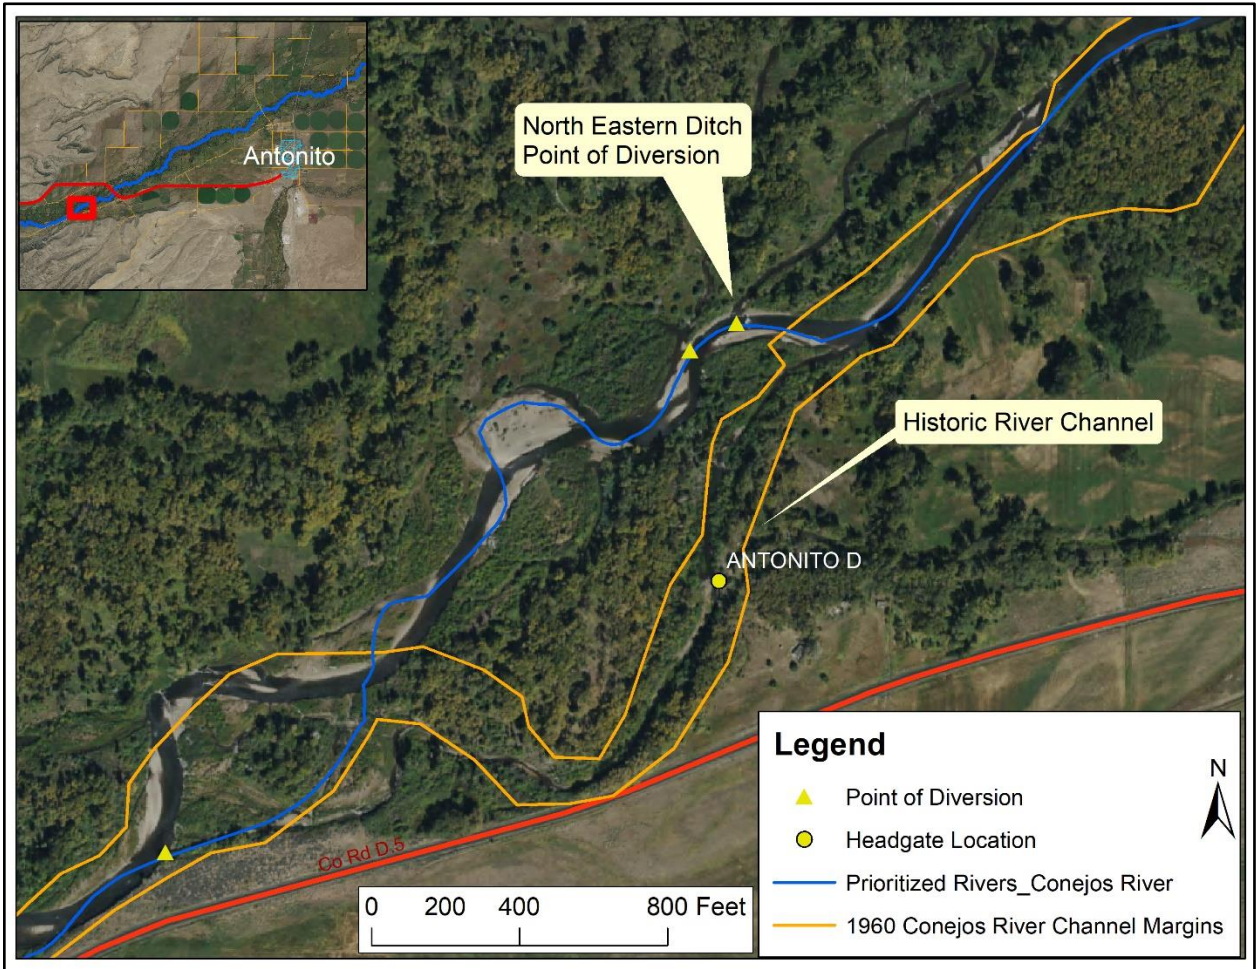
Map of historic river channel (1960), showing potential for river to migrate and bypass the point of diversion in the future

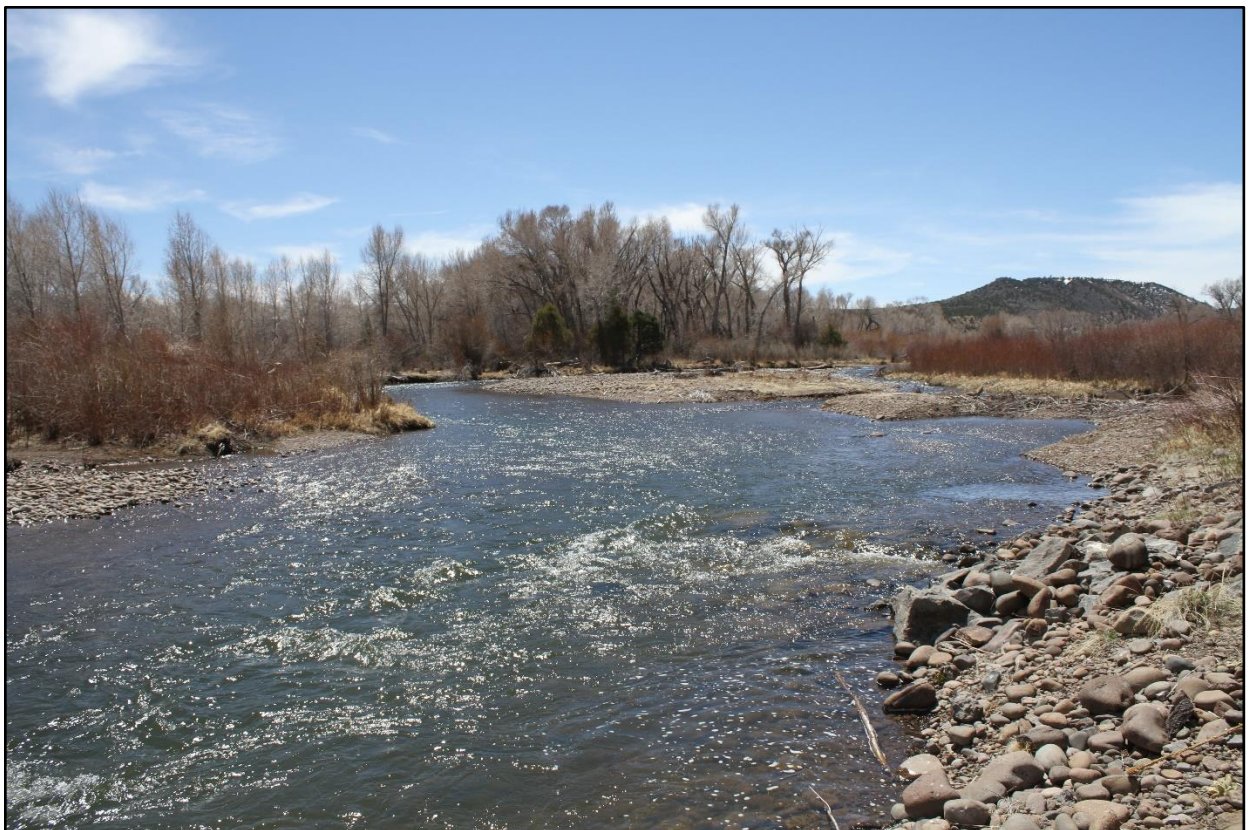
River channel upstream of diversion (looking upstream)
