CONEJOS RIVER

DIVERSION INFRASTRUCTURE INVENTORY

Structure Name: OVERFLOW D

Date: April 2, 2019

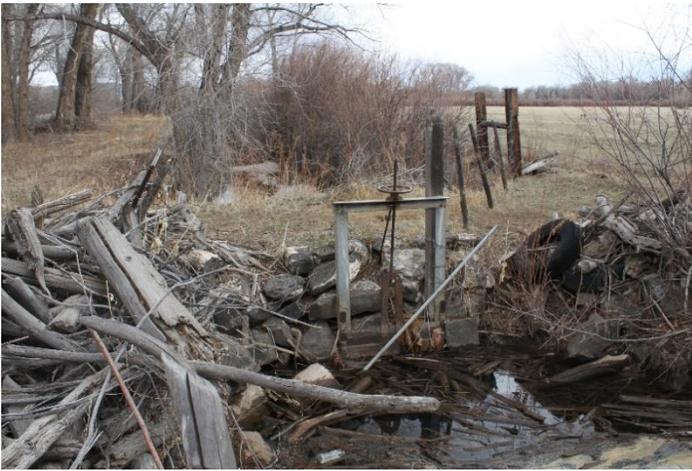
Headgate entrance

Structure Description: This structure's diversion dam is made up of a small stacked rock structure and a fence just downstream that collects debris and acts as a makeshift diversion. A short feeder channel delivers water to the headgate, which is on the east side of the river. Woody debris accumulates in front of the headgate. The headwall is constructed of rock and appears to be in fair condition overall.

Repair(s) or Improvement(s) Currently Needed: Given the issues identified at this structure, the SMP Technical Advisory Team (TAT) recommends installing a new diversion dam and trash rack to effectively divert water at all flows and to reduce maintenance. If any modifications are made to the diversion in the future, the TAT also recommends maintaining fish passage to maintain aquatic habitat connectivity in this reach.

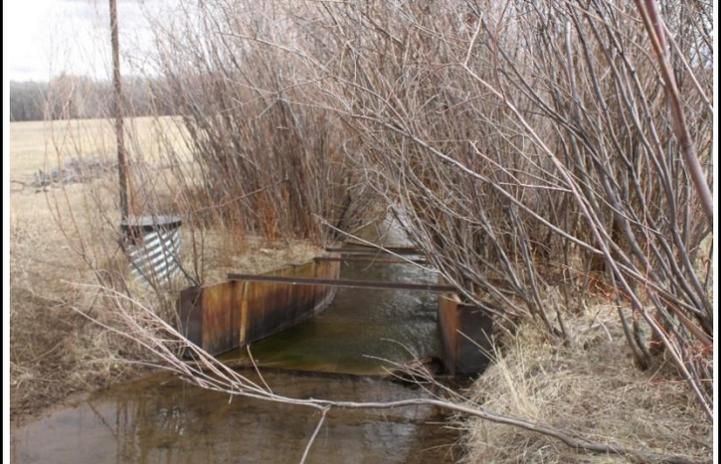
Flume looking downstream

Comments: The headwall is constructed of rock and overall appears to be in fair condition. From the piles of debris surrounding the structure, it was clear that a trash rack device would be beneficial. Flow is measured by a 4' Parshall flume. The Overflow Ditch is priority 20.

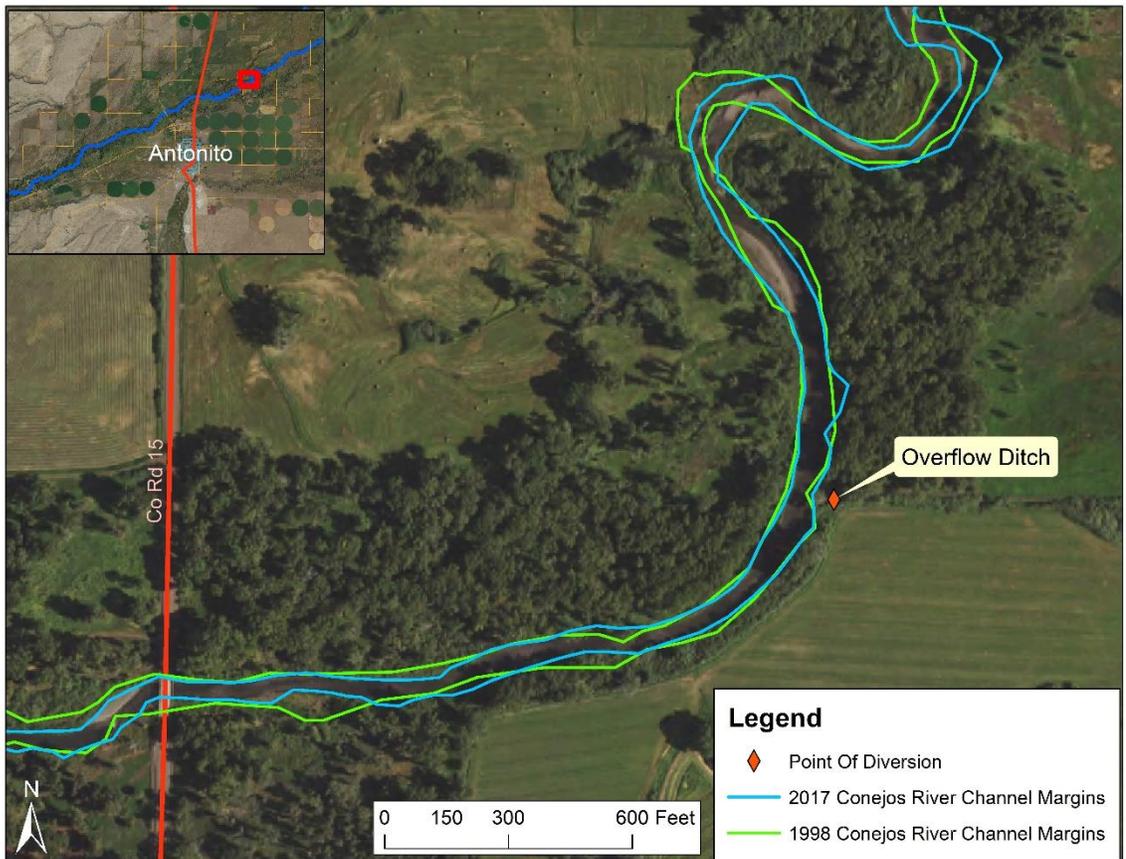
Overflow Ditch with 1998 and 2017 channel margins overlaid

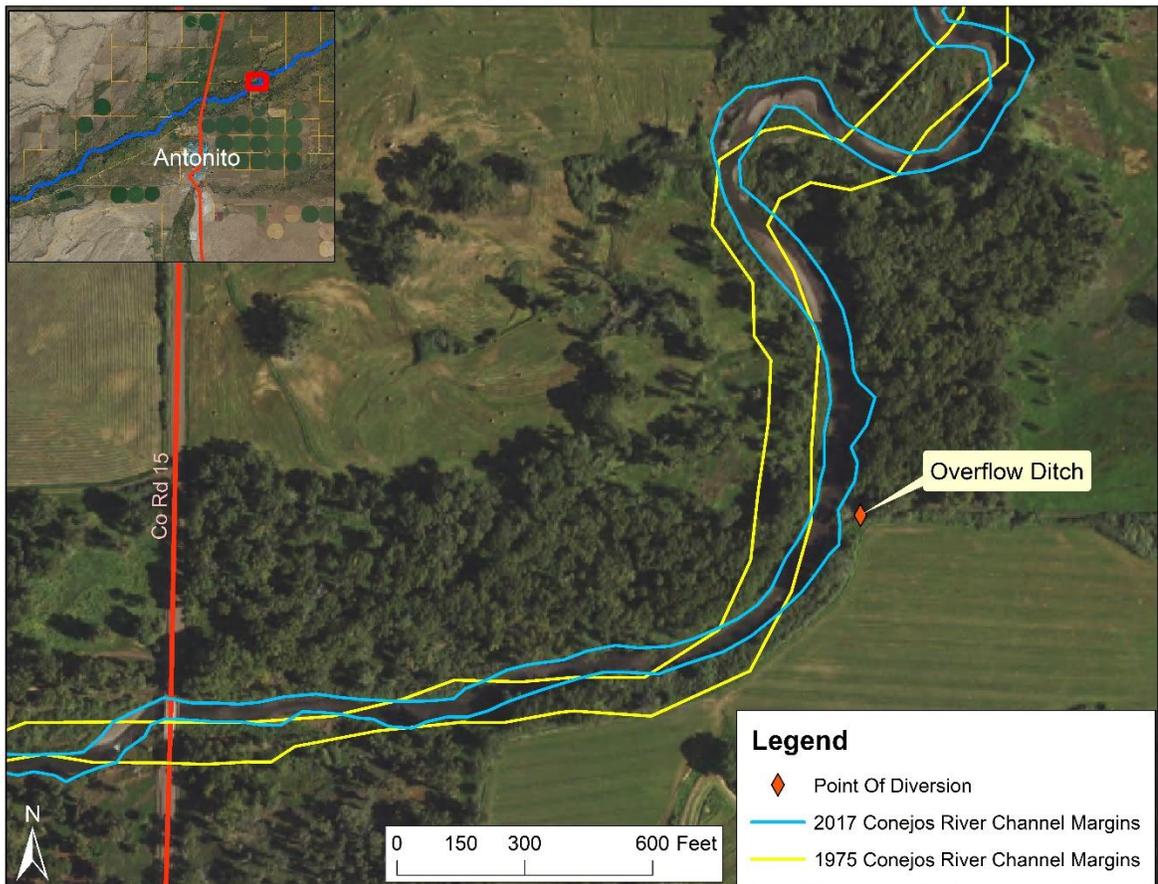
Overflow Ditch with 1975 and 2017 channel margins overlaid
