# CONEJOS RIVER DIVERSION INFRASTRUCTURE INVENTORY

**Structure Name:** RICHFIELD CANAL

**Date:** April 16, 2019

PHOTO LOG

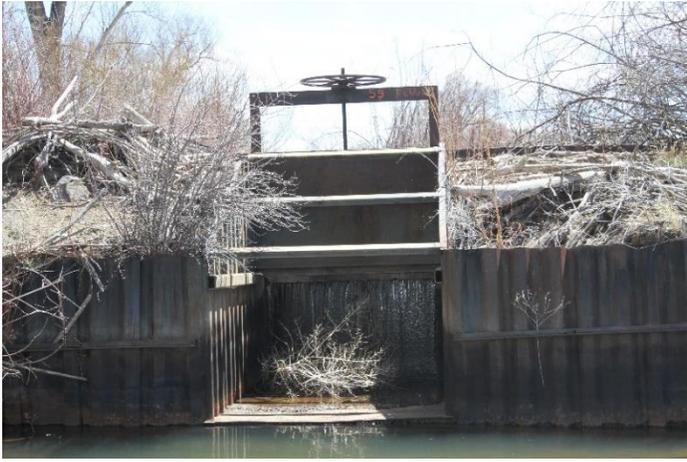
Headgate looking upstream

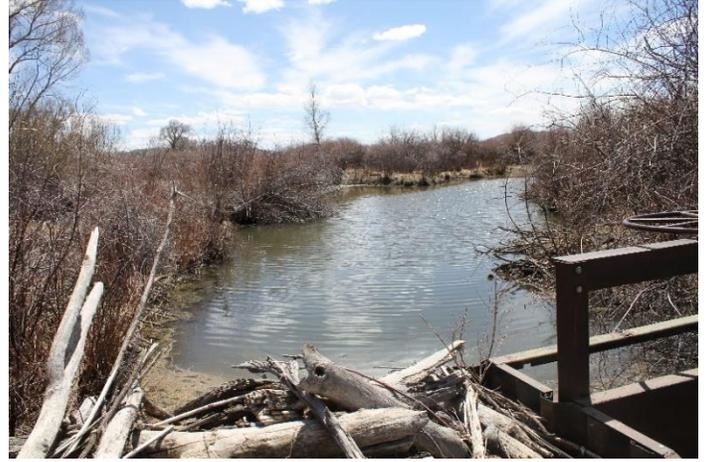
Ditch upstream of headgate

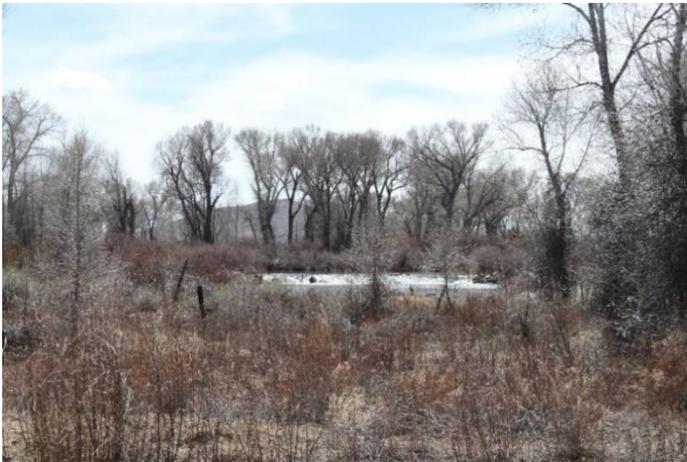
Diversion dam at confluence of Rio San Antonio and South Branch Coneos River

**Repair(s) or Improvement(s) Needed:** At the time of inspection, repairs were in progress, including carrier repairs and the installation of a new core, and headgate. No repair needs are anticipated after completion of these repairs.

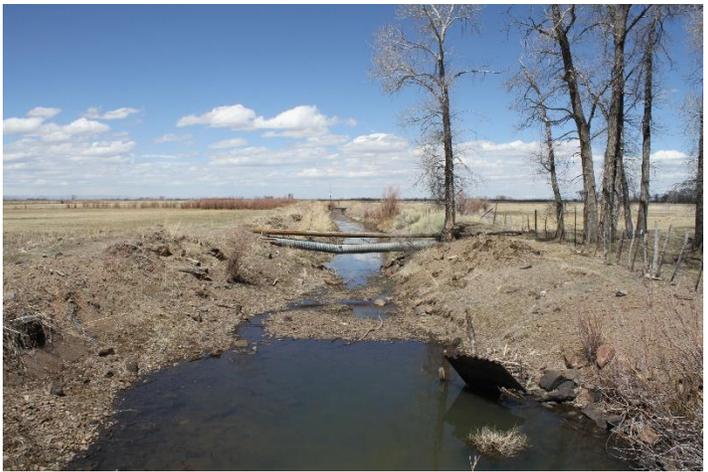
Ditch downstream of headgate

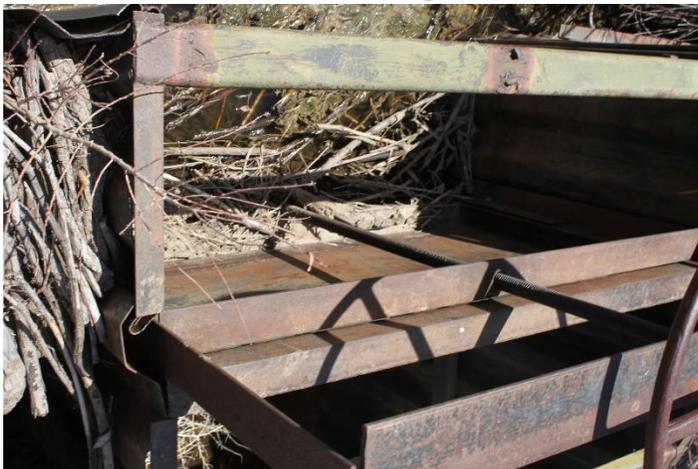
Debris at headgate

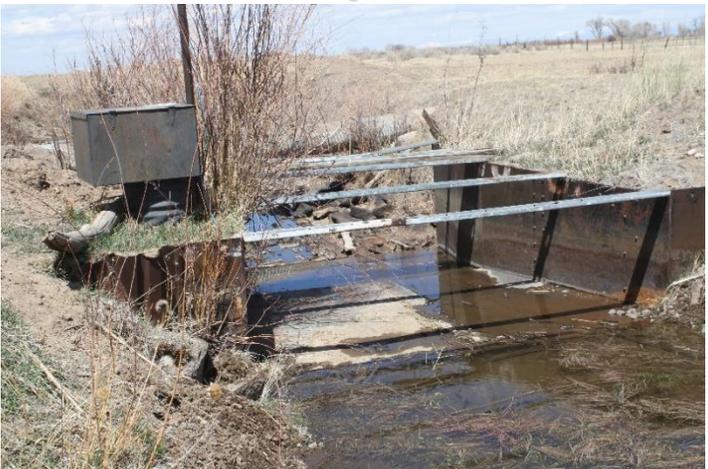
Flume looking downstream
