CONEJOS RIVER DIVERSION INFRASTRUCTURE INVENTORY

Structure Name: ROMERO D

Date: April 14, 2019

ROMERO DITCH

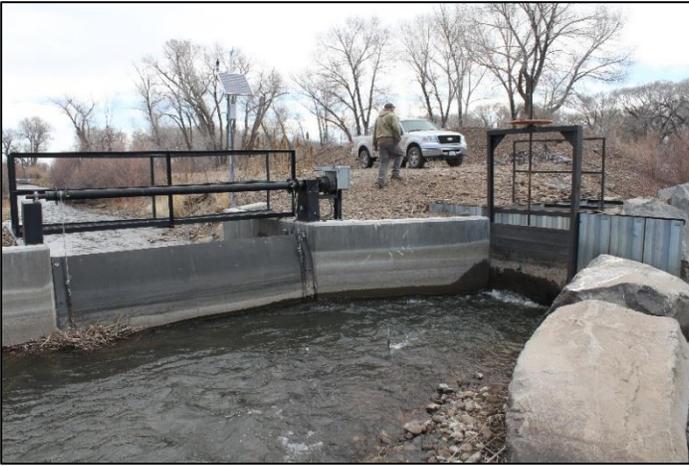
Headgate looking downstream

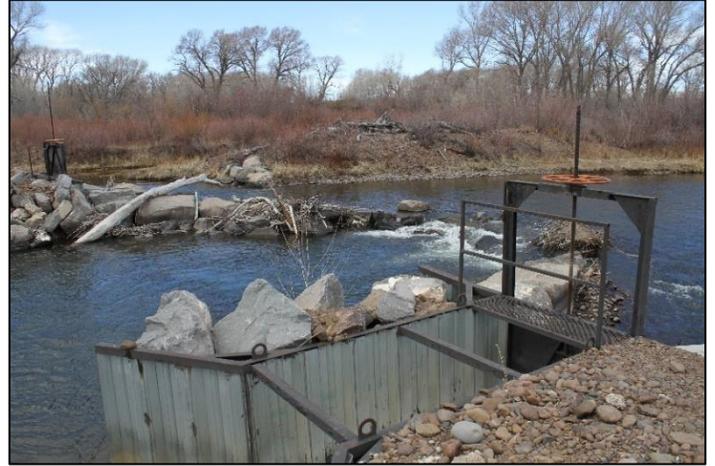
Diversion dam and sluice gate

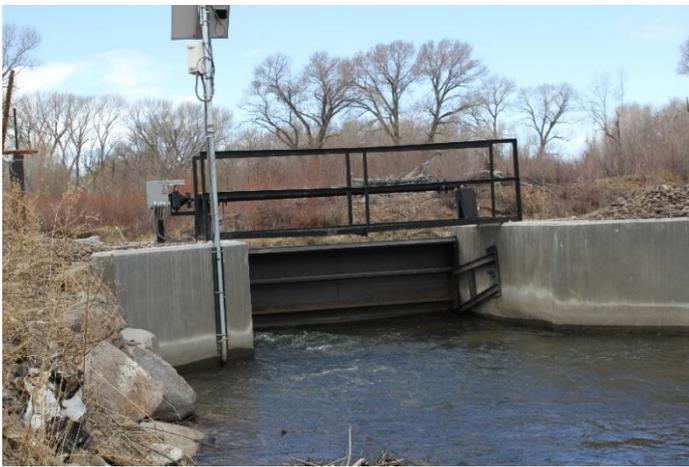
Headgate outlet

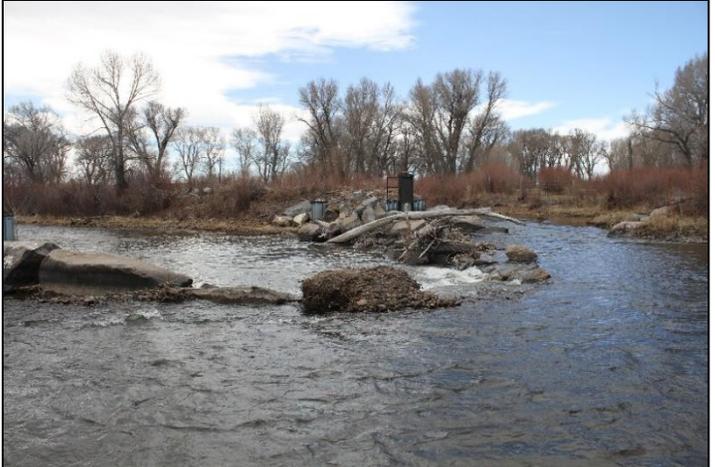
Diversion dam looking toward HEADS MILL & IRR D

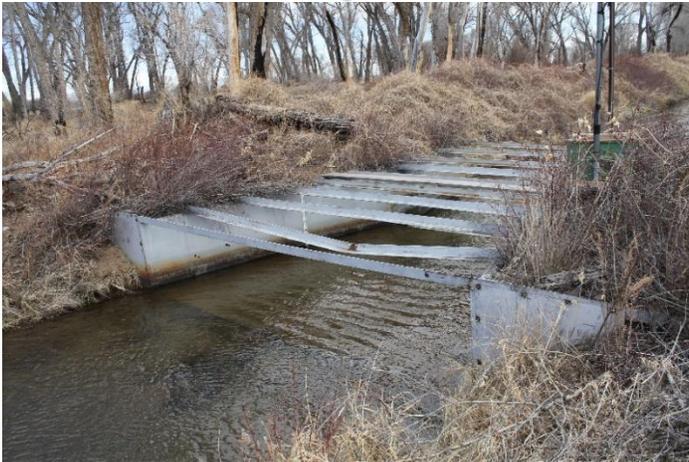
Flume looking downstream

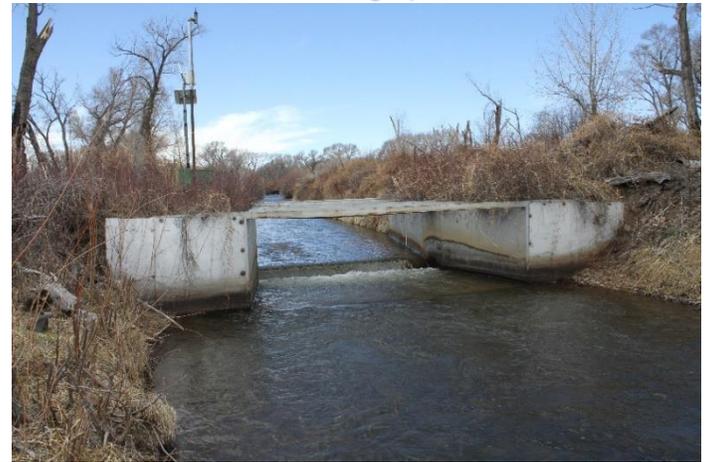
Flume looking upstream

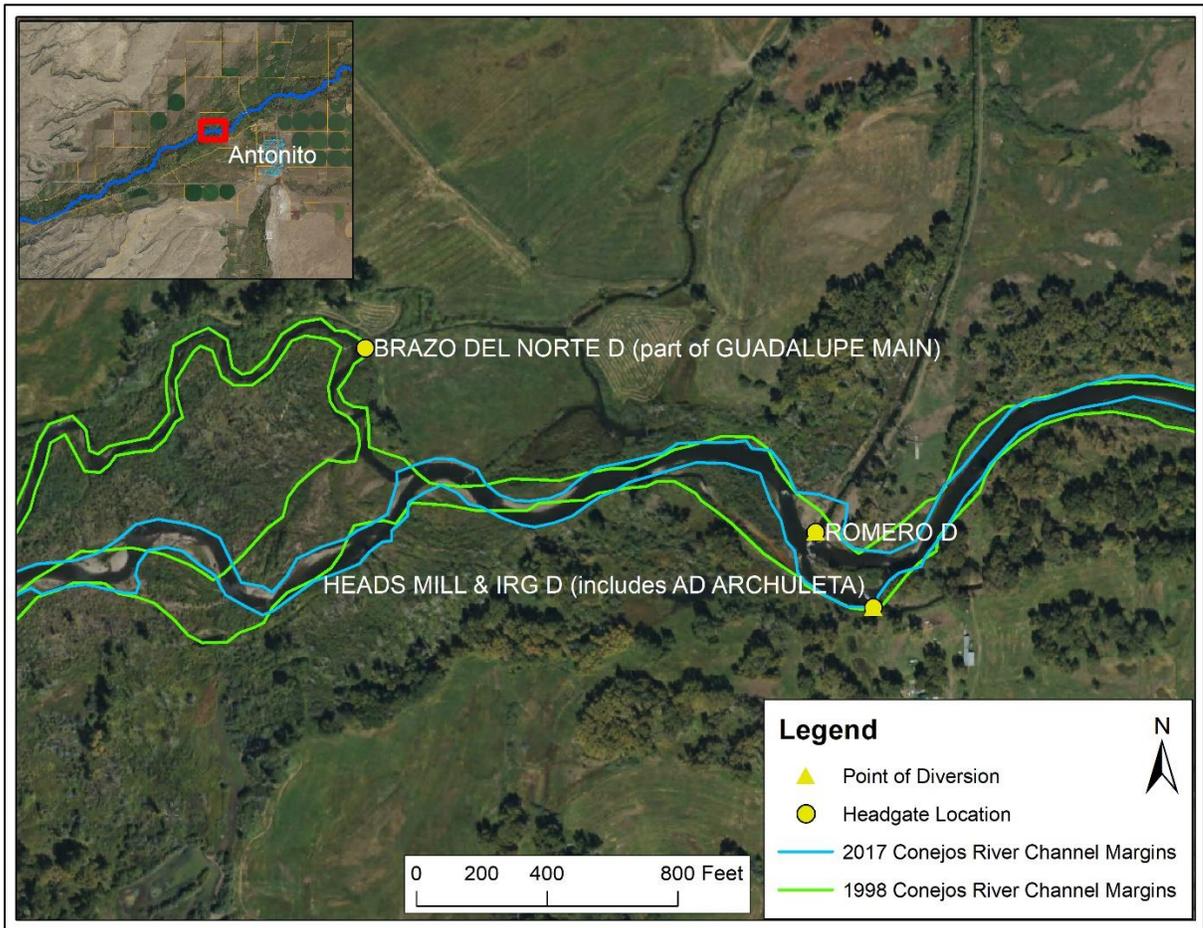
Repair(s) or Improvement(s) Currently Needed: The channel has migrated significantly in this area, especially upstream of the diversion dam. J-hooks were installed upstream to stabilize banks. If future channel migration occurs, other solutions may need to be considered, however no immediate repair needs were noted.

Headgate location with 1998 and 2017 channel margins overlaid
