CONEJOS RIVER

DIVERSION INFRASTRUCTURE INVENTORY

Structure Name: SABINE SCHOOL SECTION D

Date: April 15, 2019

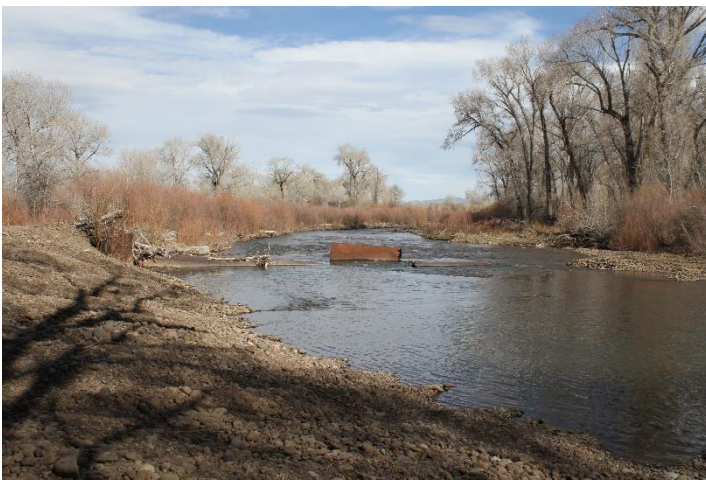
Headgate and diversion dam

Structure Description: The structure is located on the South Branch of the Conejos River at the apex of a meander. A repurposed molasses tank serves as the diversion dam and directs flow to the headgate, which is located on the north bank of the river. Some lateral migration of the meanders has occurred in this area, especially downstream of this structure. The streambank surrounding the headgate and diversion dam experiences erosion on an annual basis. If this erosion continues, it may wash out the headgate. The diversion dam is in disrepair. A segment of the tank forming the diversion dam has washed downstream and the channel surrounding the remaining dam has been scoured and may fail at high flows. Water users have difficulty diverting water at low flows. The diversion also appears to be a partial barrier to fish passage, especially at low flows.

Repair(s) or Improvement(s) Currently Needed: Given the issues identified at this structure, the SMP Technical Advisory Team (TAT) recommends replacing and/or potentially relocating the diversion and headgate, and implementing streambank stabilization and riparian revegetation upstream and downstream of the structure. A new diversion and headgate would create fish passage and connectivity, increase ditch efficiency and allow water users to divert water at all water levels, and reduce maintenance. Streambank stabilization would reduce erosion and help protect key diversion infrastructure.

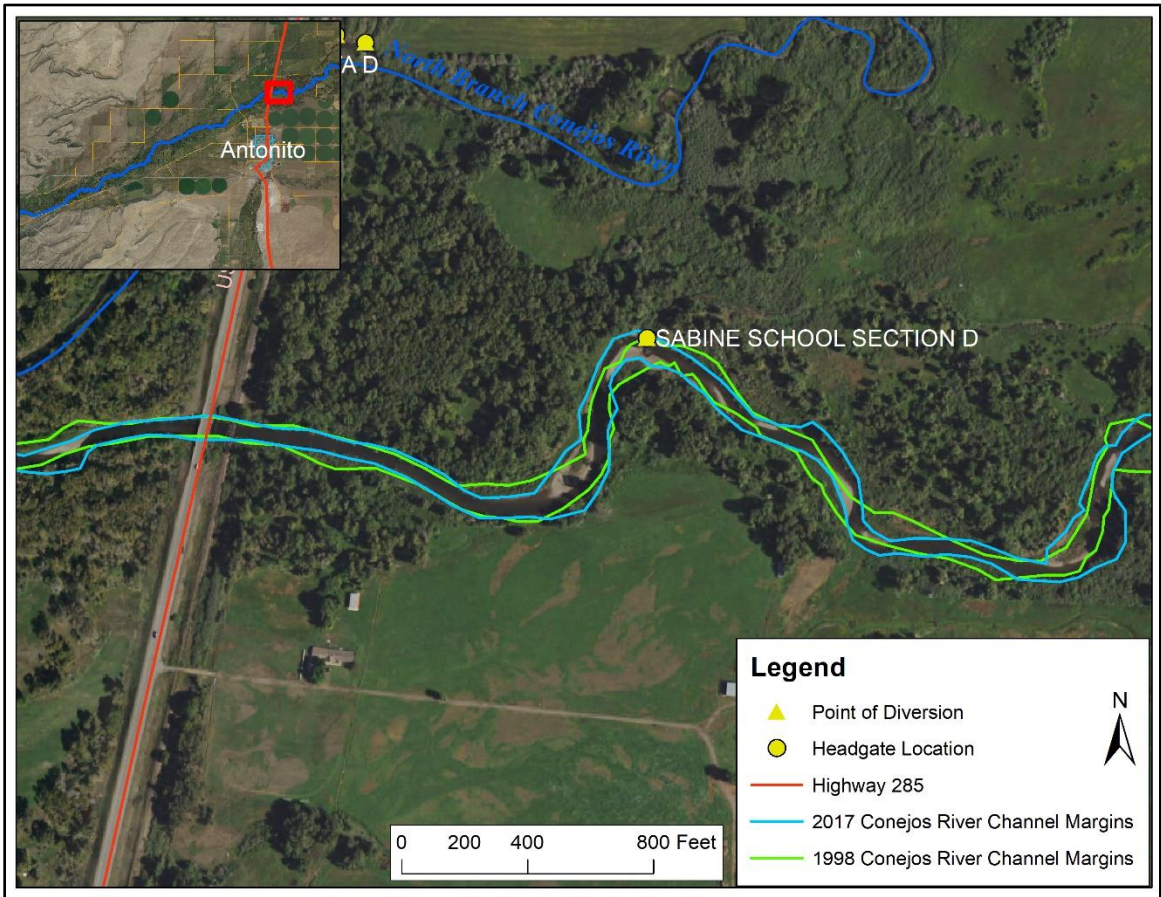
Headgate location with 1998 and 2017 channel margins overlaid.

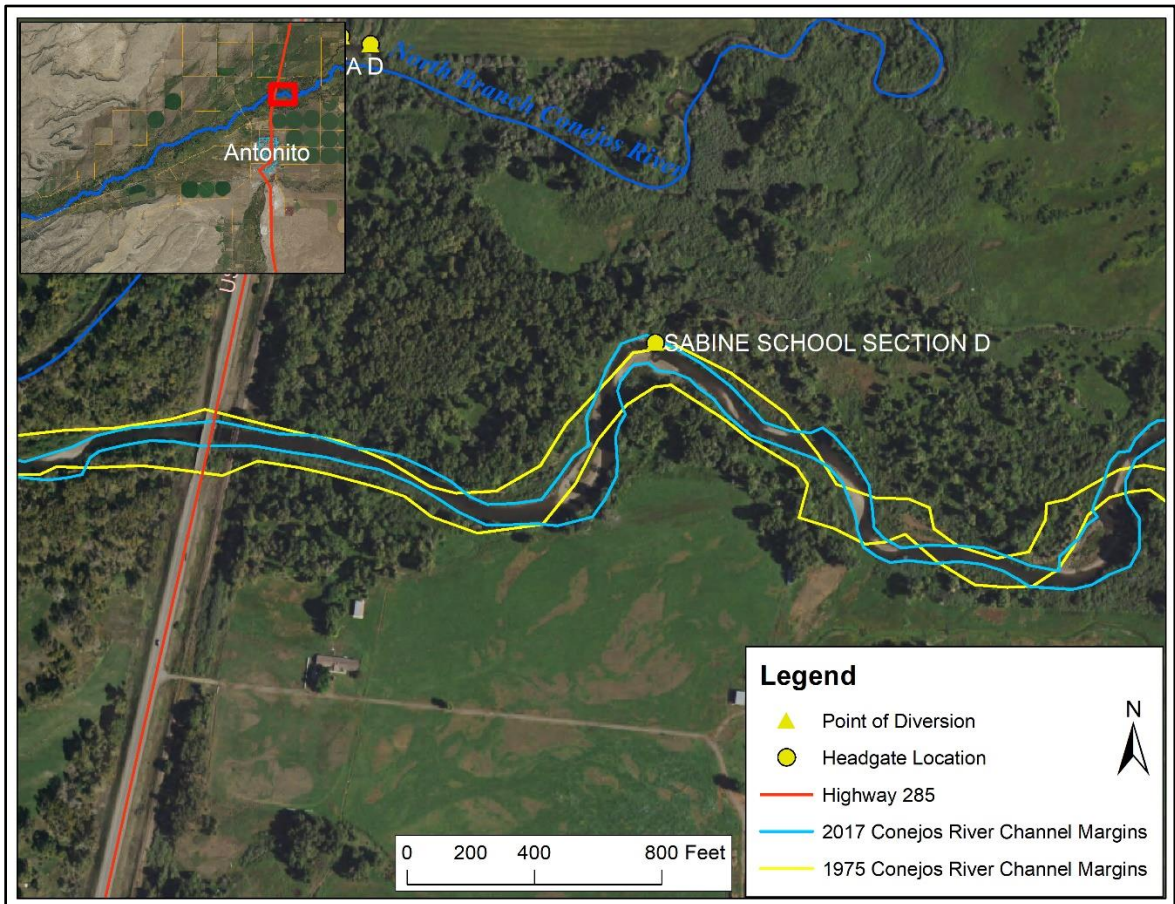
Headgate location with 1975 and 2017 channel margins overlaid.
