CONEJOS RIVER

DIVERSION INFRASTRUCTURE INVENTORY

Structure Name: SAN JUAN SAN RAFAEL D

Date: April 2, 2019

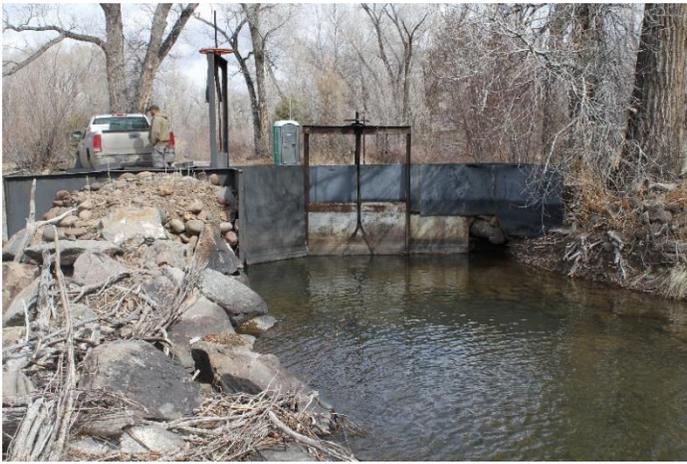
Structure Description: A feeder channel off the south bank of the Conejos River, approximately 1,500 ft long, directs water to the San Juan San Rafael headgate. The diversion dam is a boulder structure. The headgate sits across the feeder channel on the east bank. A return flow channel with a headgate directs unused water back to the river. The headgate does not seal completely.

Headgate looking downstream

Repair(s) or Improvement(s) Currently Needed: The SMP Technical Advisory Team (TAT) recommends headgate repair by installing a rubber mat or otherwise stopping the leak. Upstream of the diversion, the channel has migrated laterally but is not expected to affect the structure.

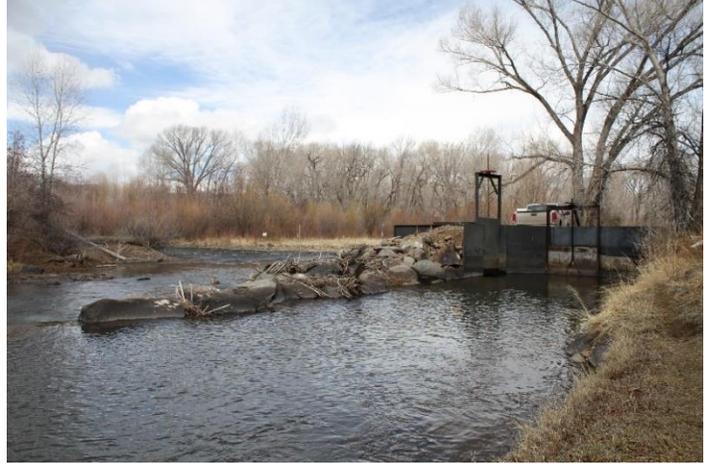
Headgate and diversion dam

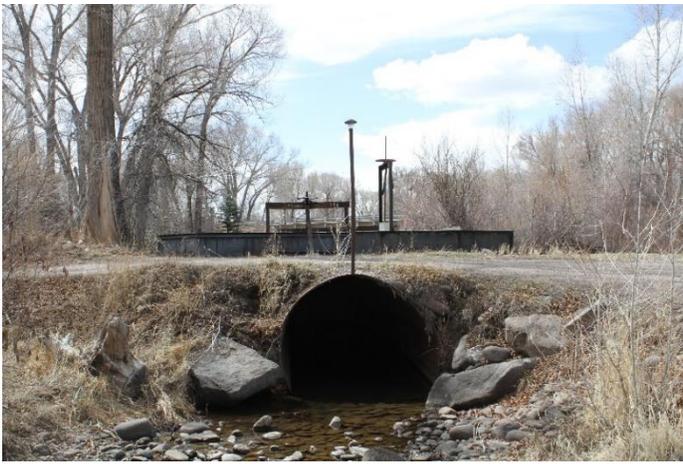
Headgate outlet

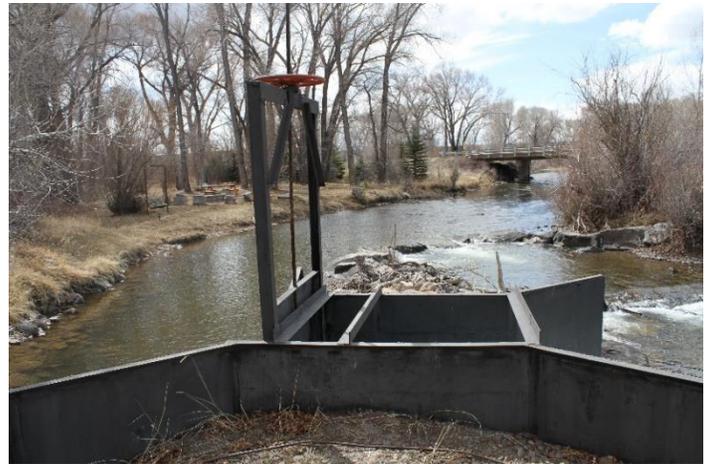
Feeder channel upstream of headgate

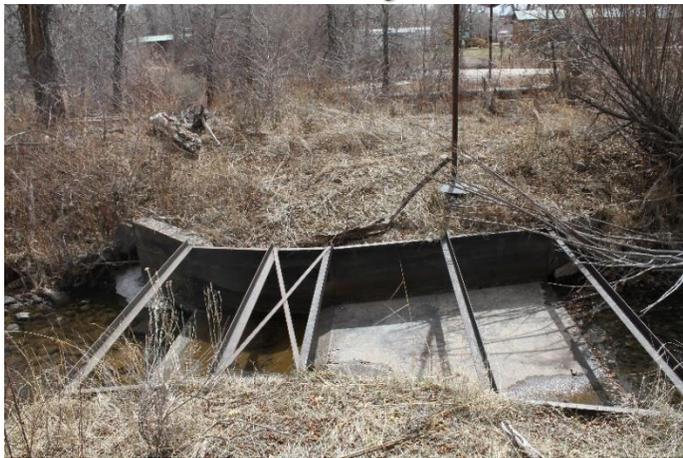
Flume looking south

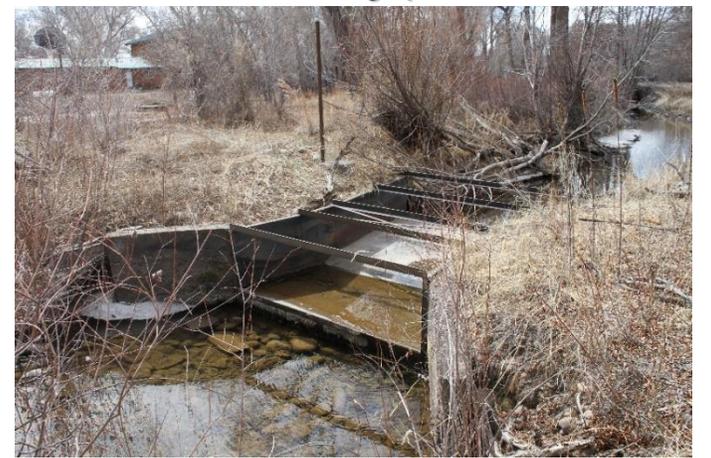
Flume looking upstream

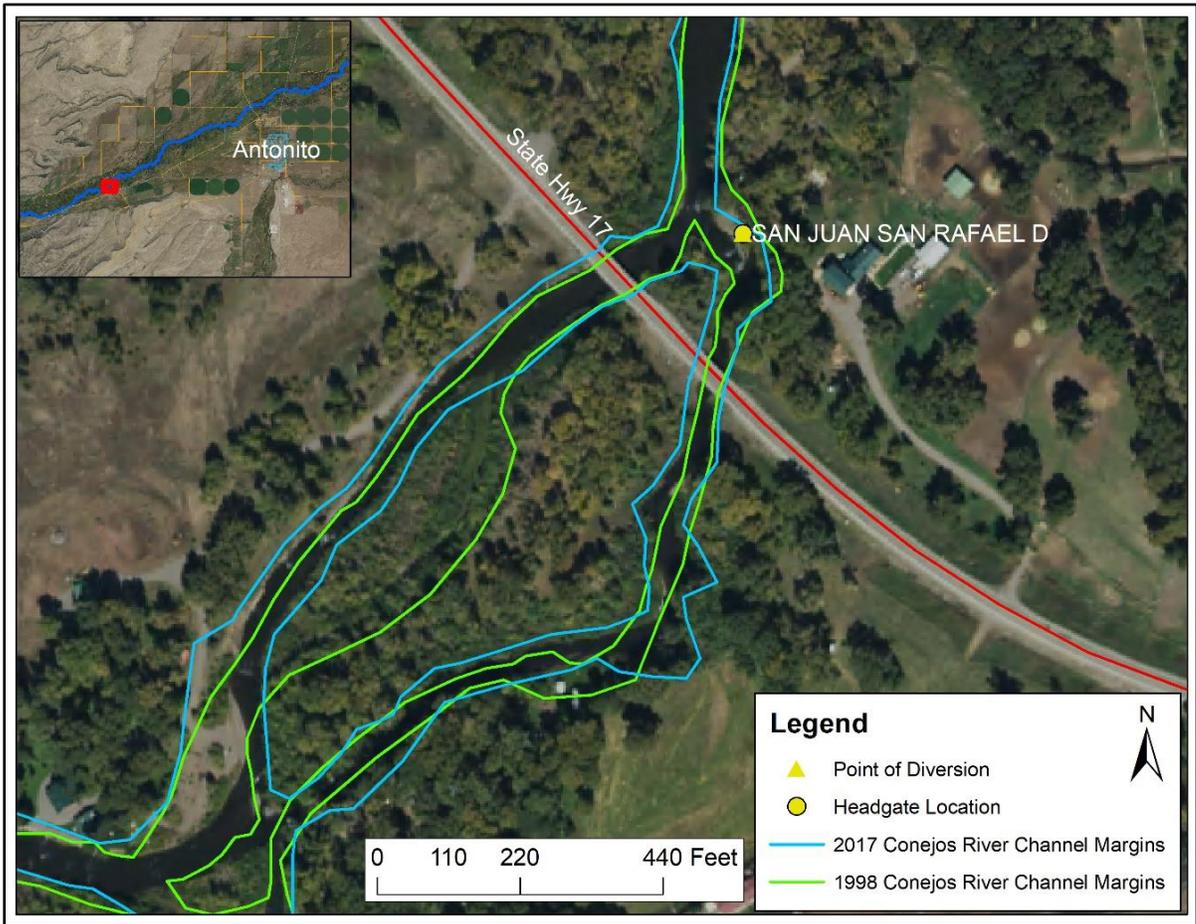
Point of diversion with channel margins from 1998 and 2017 overlaid

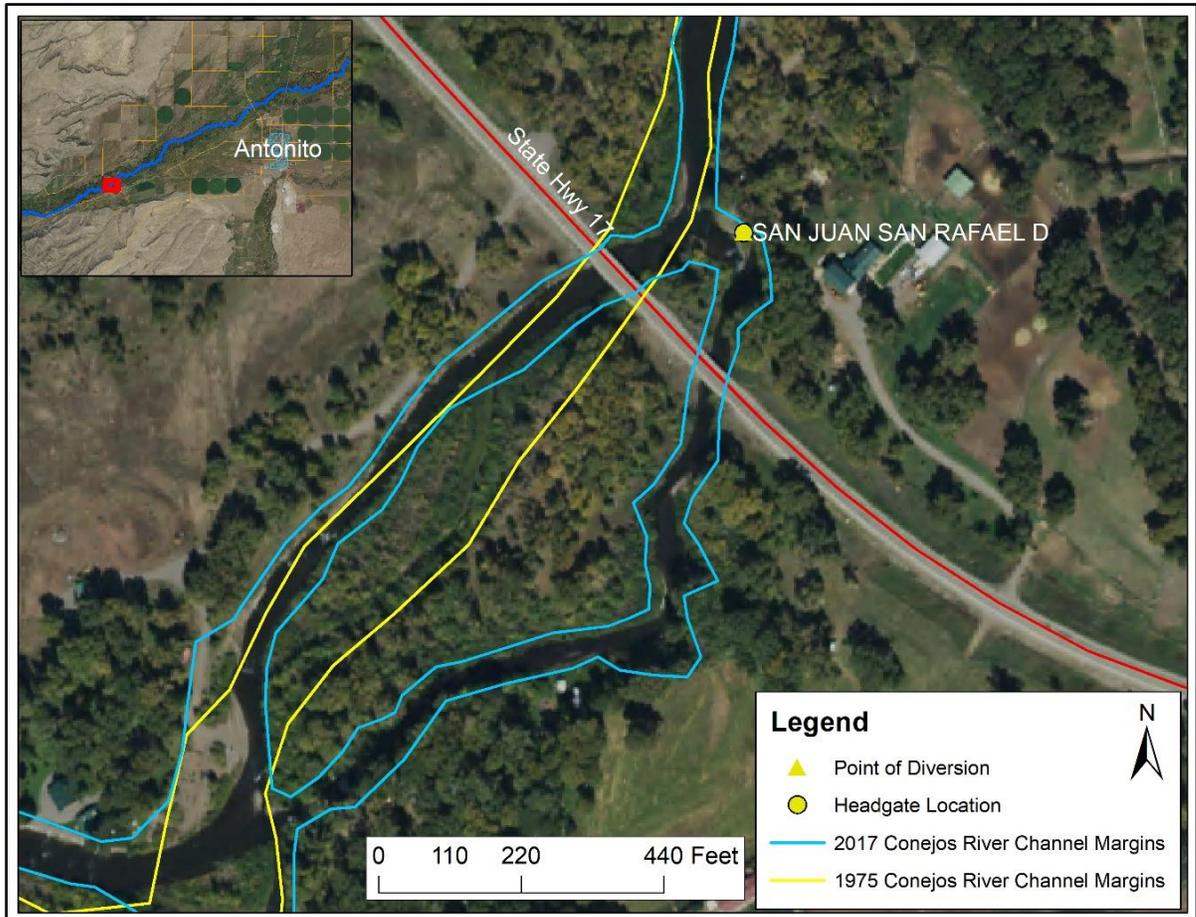
Point of diversion with channel margins from 1975 and 2017 overlaid
