CONEJOS RIVER DIVERSION INFRASTRUCTURE INVENTORY

Structure Name: SANCHES D

Date: April 15, 2019

SANCHES DITCH

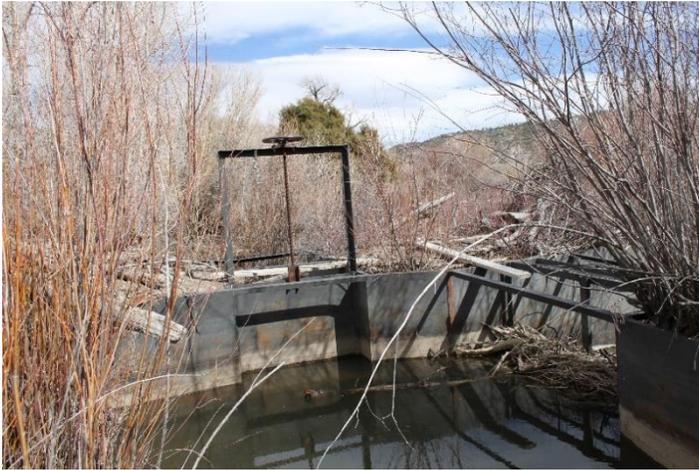
Headgate looking downstream

Repair(s) or Improvement(s) Currently Needed: Debris accumulation is an issue at the headgate and return flow structure (see photos below). The SMP Technical Advisory Team (TAT) recommends installing a trash rack above the headgate to minimize debris accumulation. As noted above, the TAT recommends an improved diversion dam that allows the ditch to divert water at all flows. For a description of recommended improvements to the diversion and feeder channel, see the Mecitos Ditch. Additionally, the TAT recommends repairing or resetting the Parshall flume.

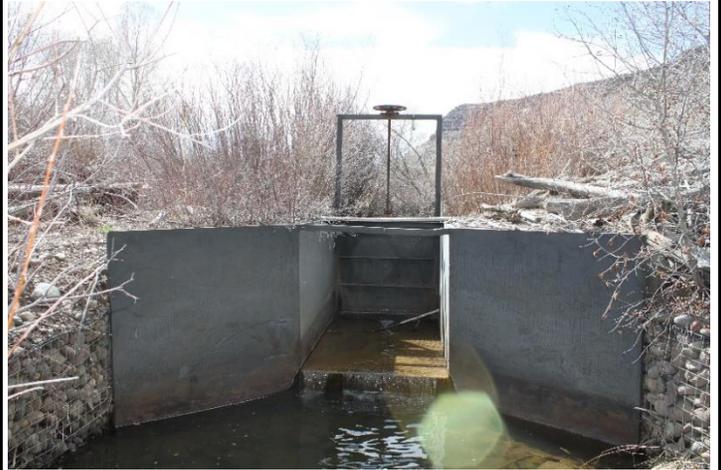
Headgate outlet

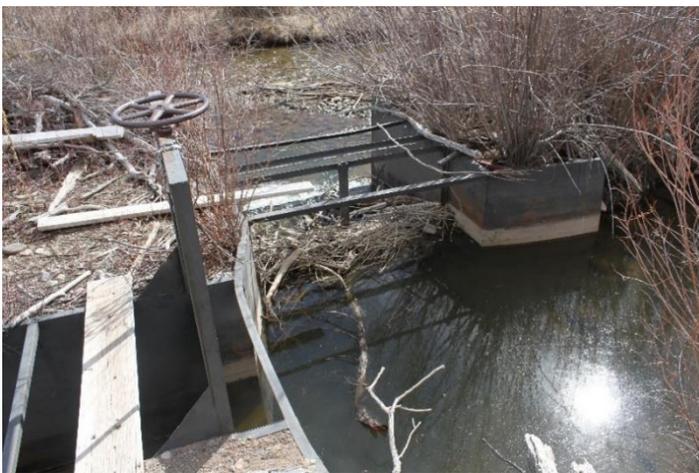
Return flow structure looking downstream

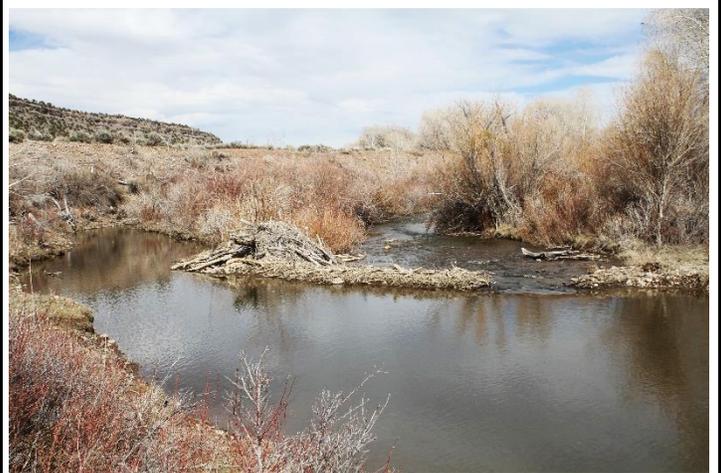
Diversion dam on feeder ditch looking downstream

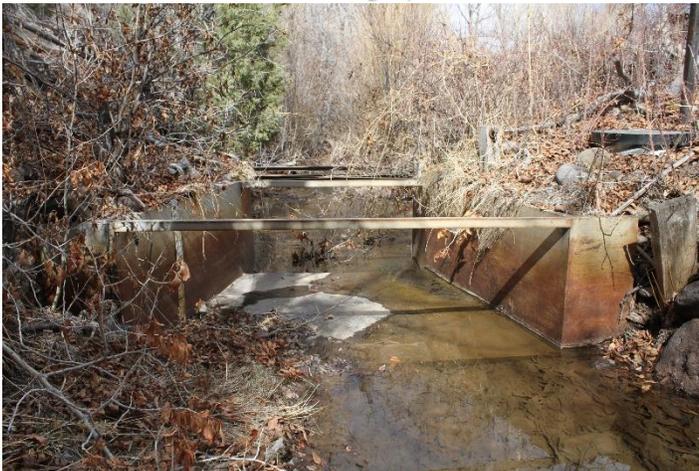
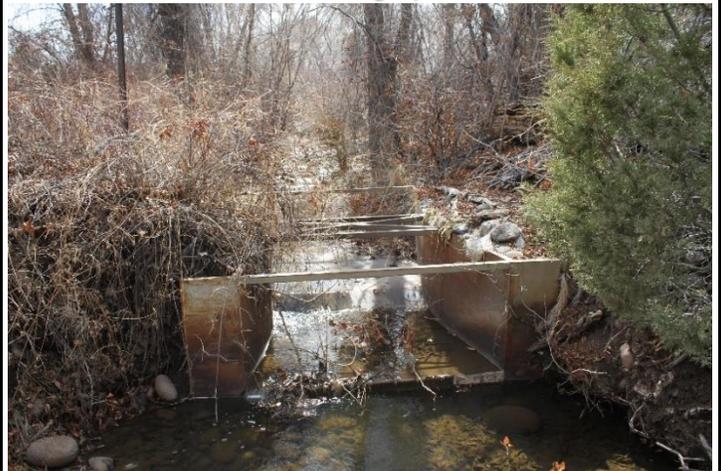
Flume looking upstream

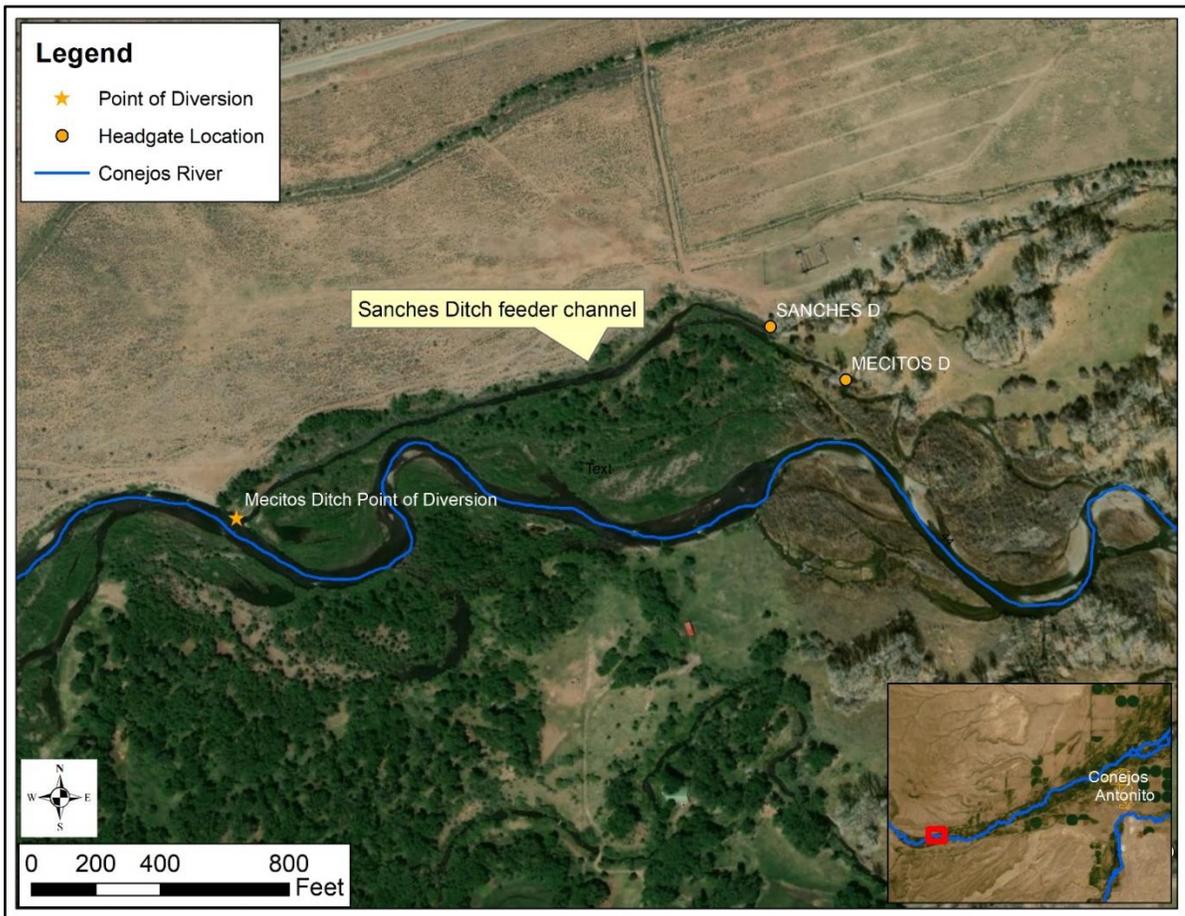
Sanches Ditch point of diversion and feeder channel

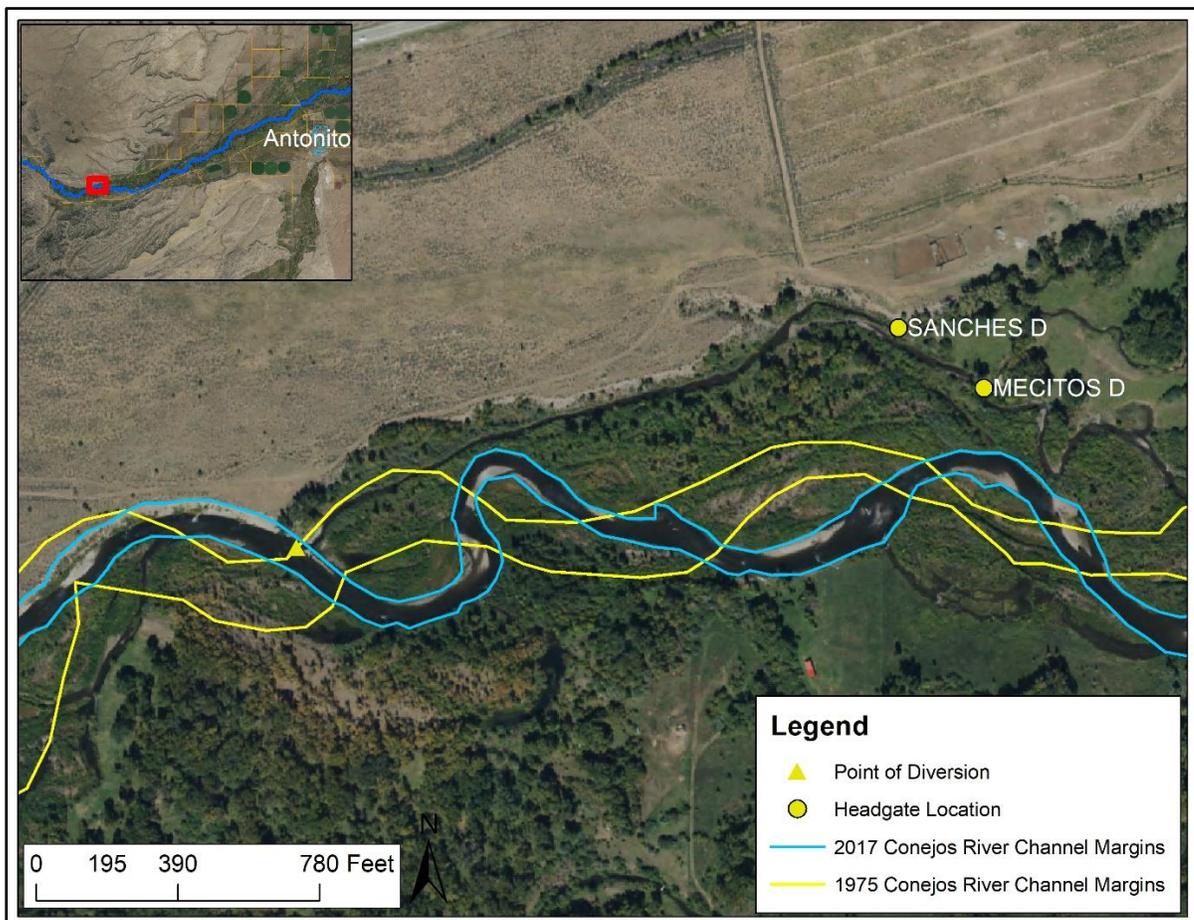
Headgate location with river channel margins from 1975 and 2017 overlaid
