CONEJOS RIVER

DIVERSION INFRASTRUCTURE INVENTORY

Structure Name: SANFORD D

Date: April 16, 2019

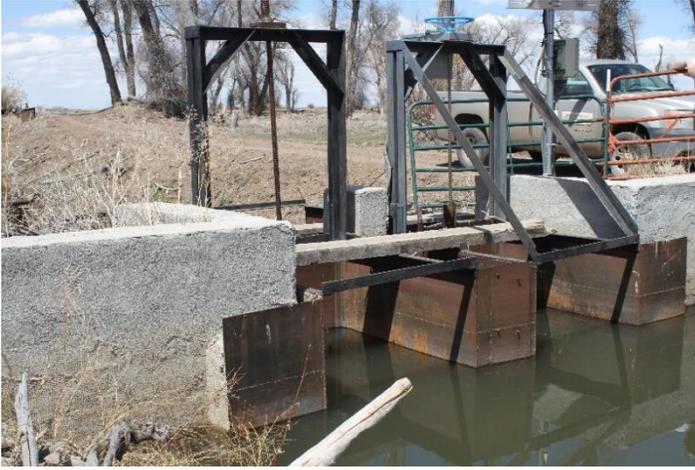
Headgate looking downstream (pre runoff)

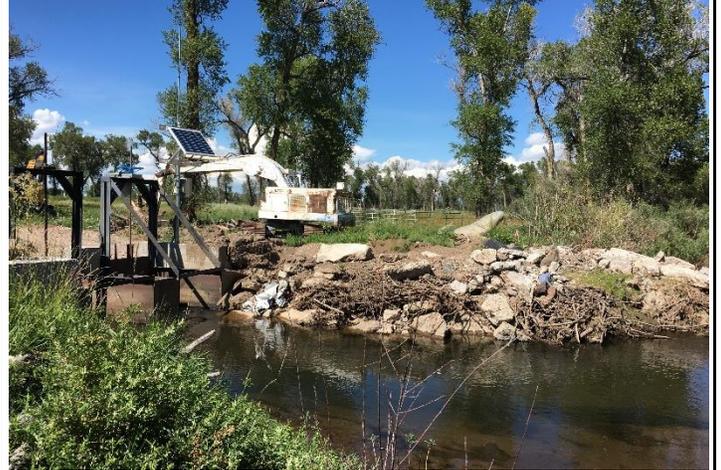
Headgate looking downstream (post-2019 runoff)

Repair(s) or Improvement(s) Currently Needed: Given the challenges the ditch company faces, the SMP Technical Advisory Team (TAT) recommends stabilizing the headgate and repairing the return flow structure and flume. Bank stabilization would prevent flood flows from damaging this structure in the future, a repaired return flow structure would be capable of passing flood flows, and a repaired flume improve measurement accuracy.

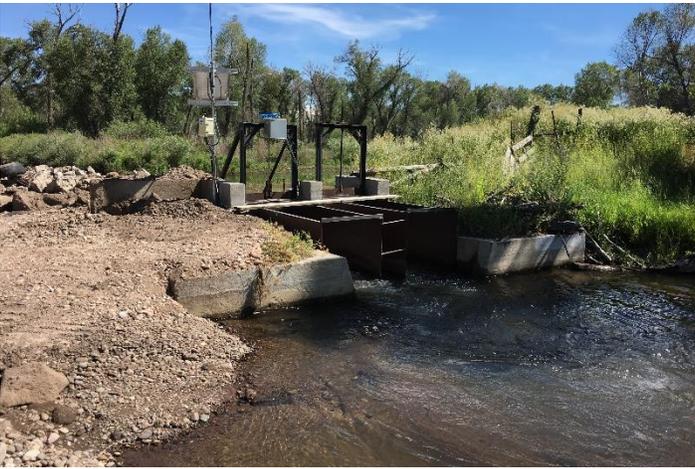
Headgate looking upstream (post-2019 runoff)

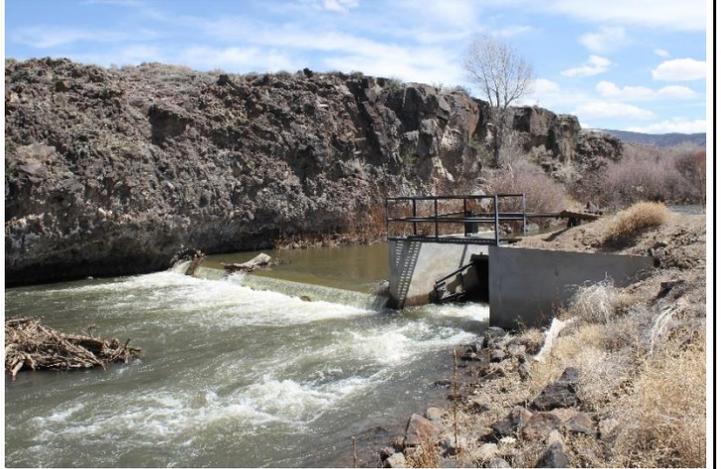
Comments: This ditch includes priorities 104 and 172. Although the diversion dam on the mainstem Conejos River is in decent condition, the overflow structure and flume are in poor condition, leading to an overall diversion and other condition rating of "D."

Diversion dam looking upstream

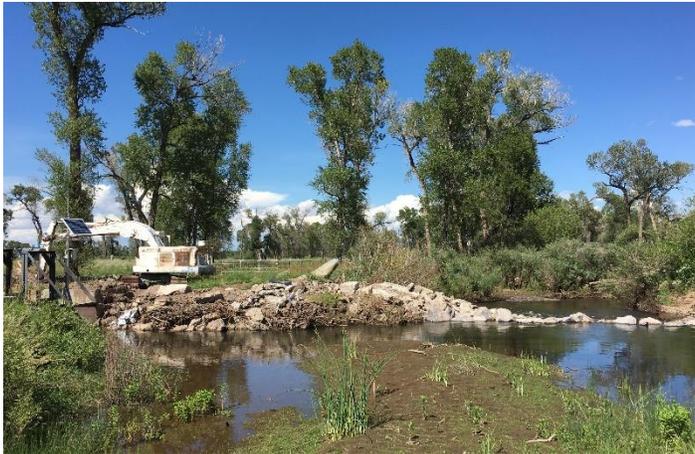
Repair(s) or Improvement(s) Completed Since 2006: New automated headgates installed with a new concrete headwall. A new overflow/return flow structure was also installed, but washed out in spring 2019 (see photos below).

Headgate and overflow structure (post-2019 runoff)

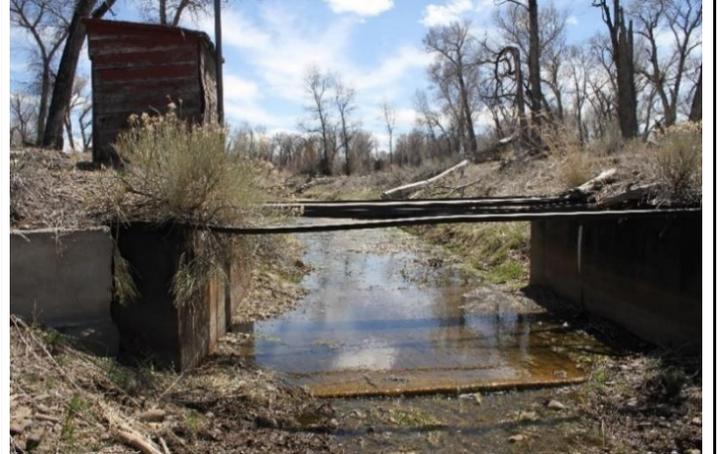
Flume looking upstream

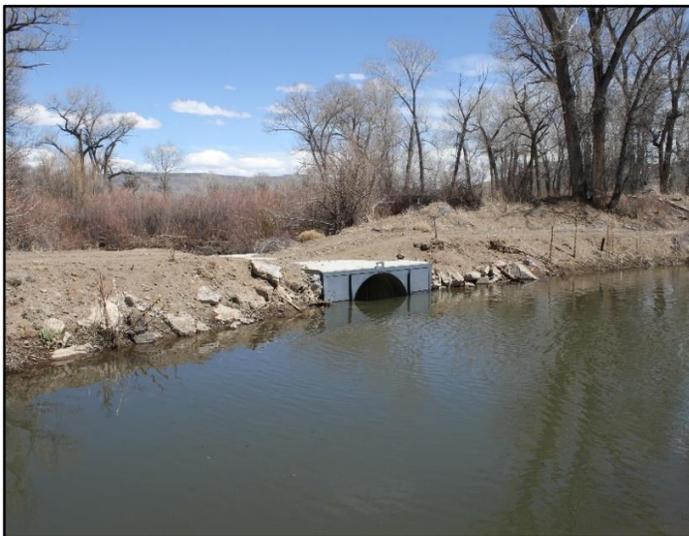
Overflow culvert (pre-2019 runoff)

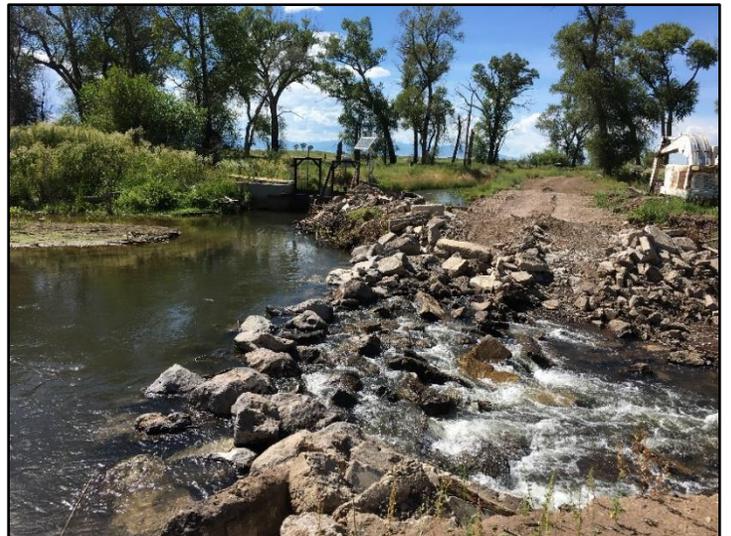
Overflow culvert (post-2019 runoff)

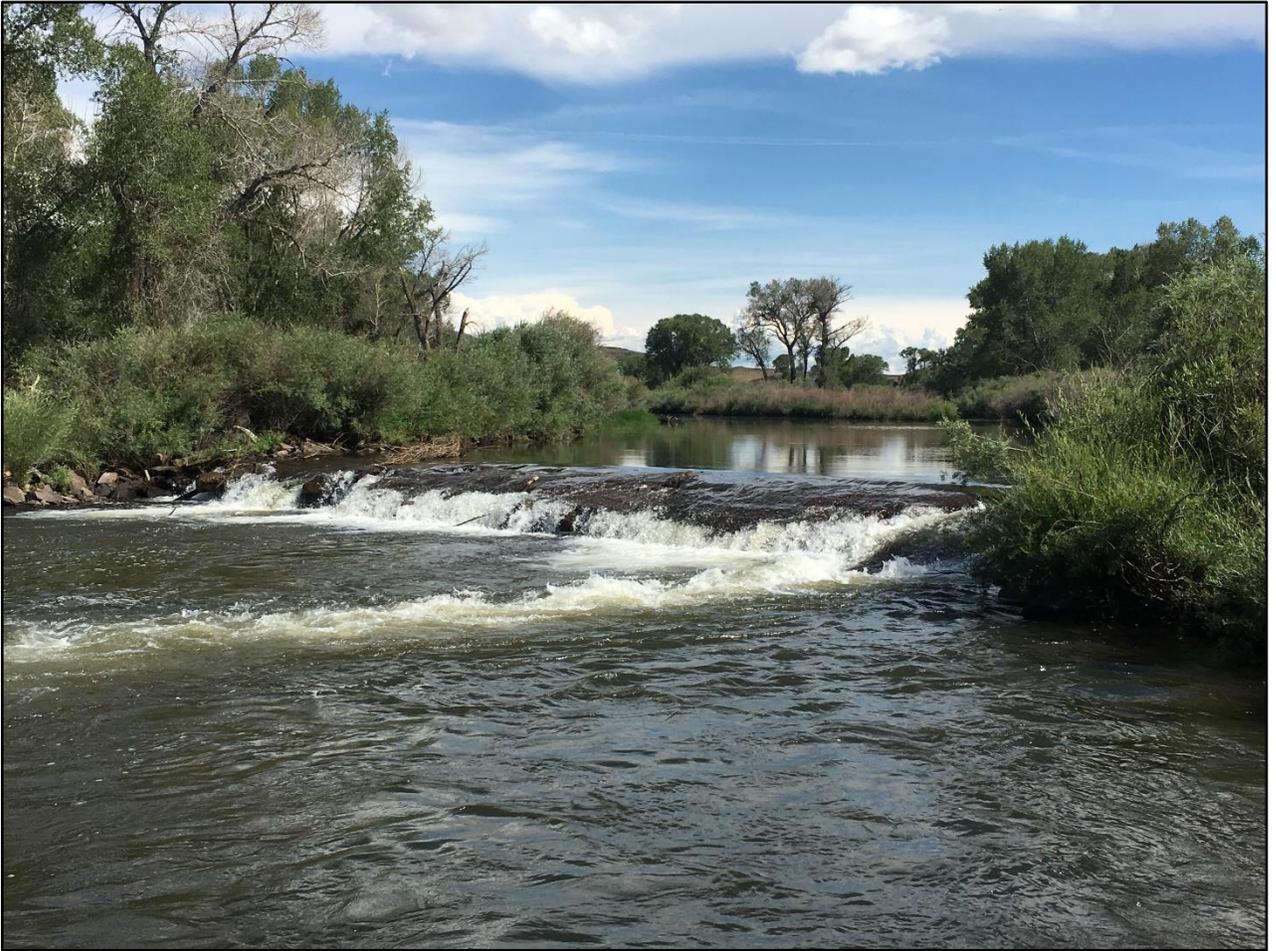
Diversion dam at Rio San Antonio Confluence
