CONEJOS RIVER DIVERSION INFRASTRUCTURE INVENTORY

Structure Name: SANTIAGO D

Date: April 15, 2019

Conejos River Stream
Management Plan

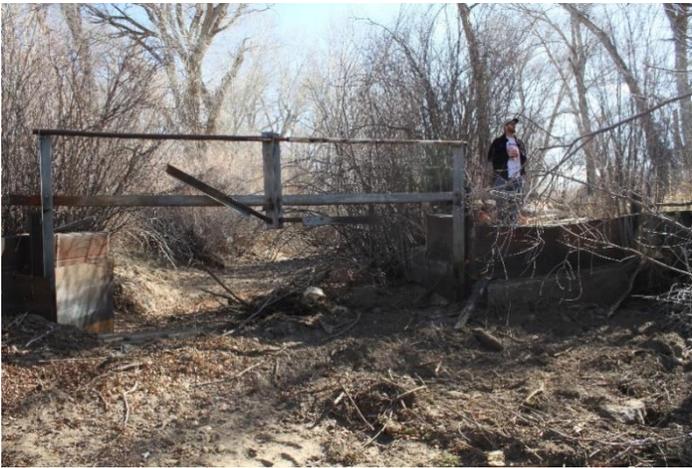
Diversion dam looking downstream

Structure Description: A check board diversion with steel wingwalls directs water to the headgate, which is located on the south bank of the river. There is a log trash boom in front of the headgate. The diversion is difficult to maintain and sediment deposition is a significant issue at this structure.

Repair(s) or Improvement(s) Currently Needed: Given these issues, the SMP Technical Advisory Team (TAT) recommends repairing or replacing the diversion. A new diversion would control flows more effectively, allow for sediment transport, and reduce maintenance.
