# CONEJOS RIVER

## DIVERSION INFRASTRUCTURE INVENTORY

**Structure Name:** SELEDONIA VALDEZ IRR D (includes San Jose Ditch and William Sabine No 1, and Vega Grande Ditch)

**Date:** April 2, 2019

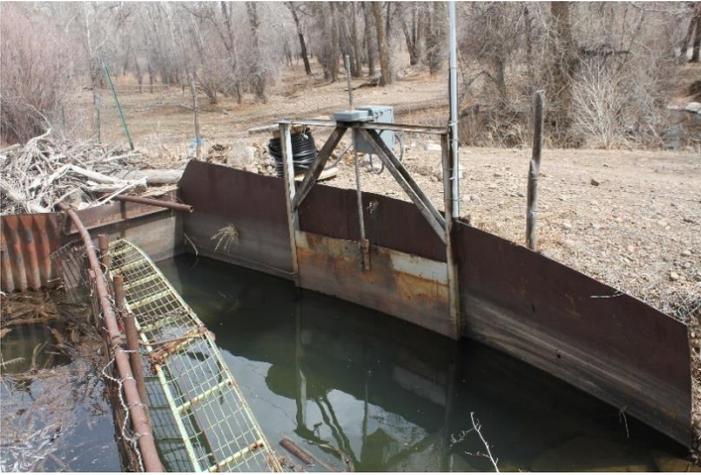
Headgate looking downstream

**Structure Description:** A diversion dam, constructed of boulders, directs water to the headgate, which sits along the south bank of the river. A steel grate trash rack protects the headgate. Boulders and concrete chunks have been placed on the west bank upstream of structure to prevent erosion, however the bank upstream of the diversion continues to erode. The river channel in this location is unstable. The meander on which the headgate is situated is tightening and could be cut off during high flows.
