CONEJOS RIVER DIVERSION INFRASTRUCTURE INVENTORY

Structure Name: SERVIETTA D

Date: April 14, 2019

SERVIETTA DITCH

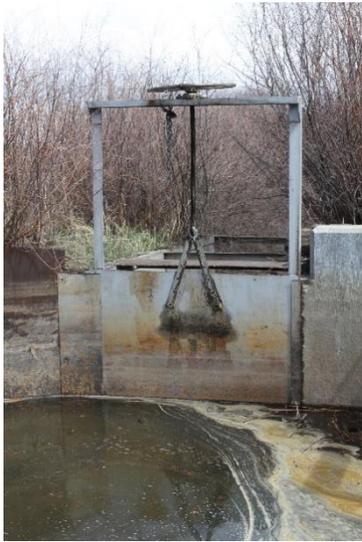
Headgate looking downstream

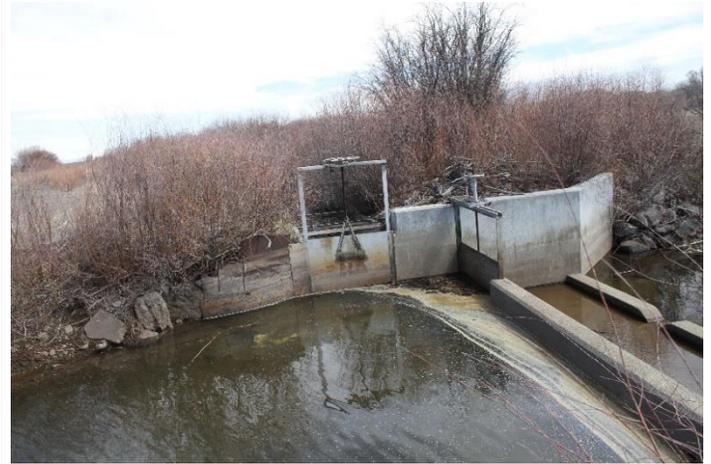
Headgate and diversion dam

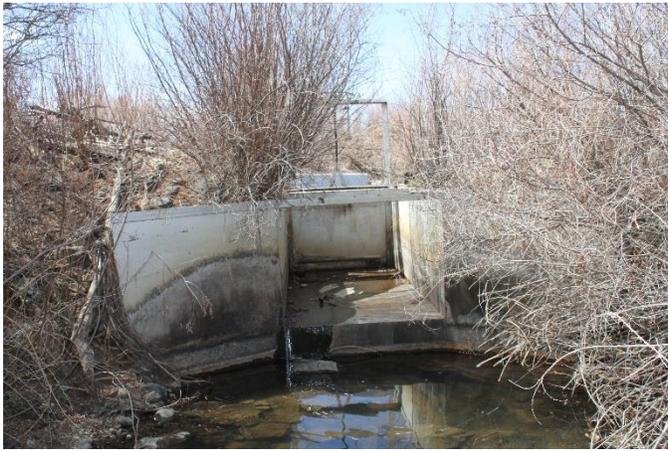
Headgate outlet

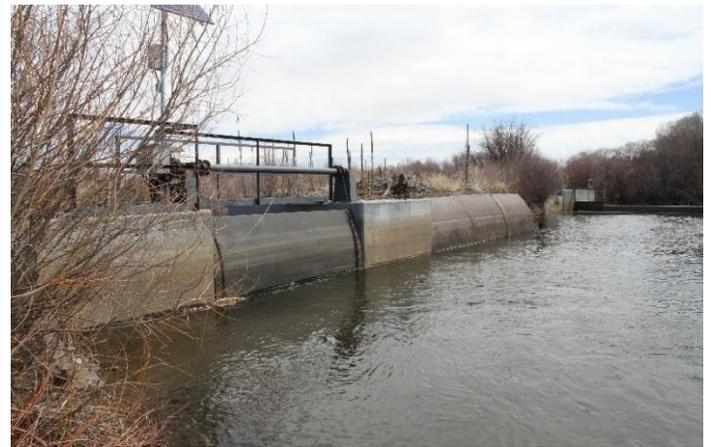
Diversion Dam

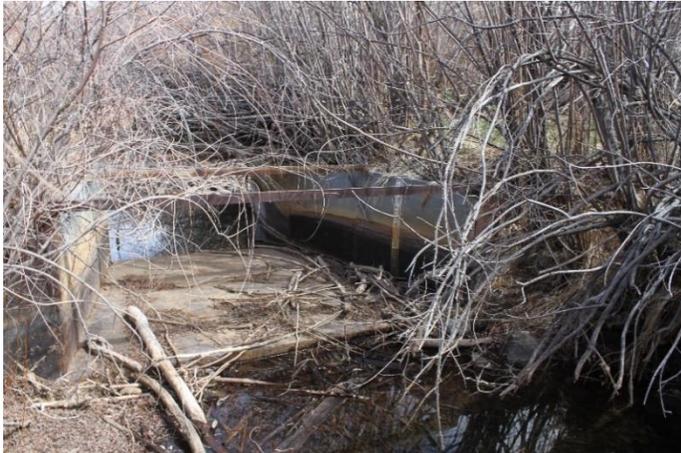
Flume looking downstream

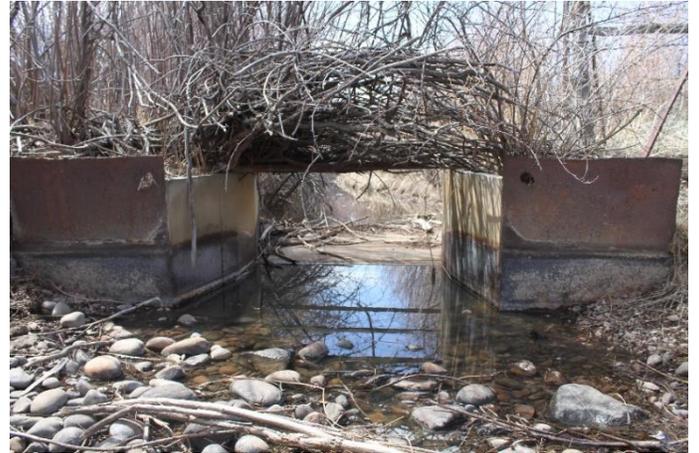
Flume looking upstream
