# CONEJOS RIVER

## DIVERSION INFRASTRUCTURE INVENTORY

**Structure Name:** SMITH BROS D

**Date:** April 16, 2019

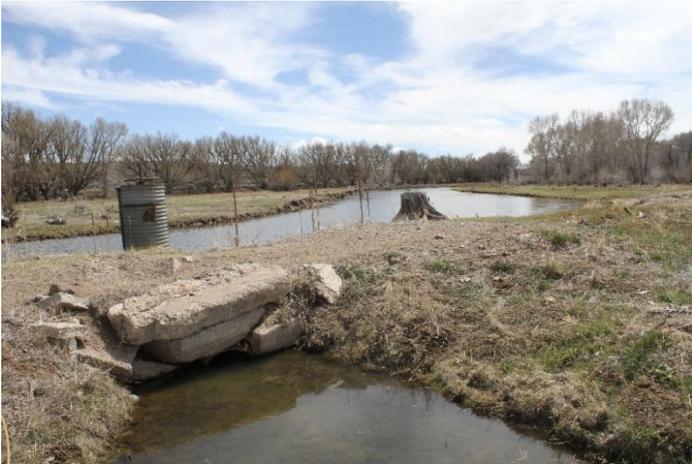
Headgate outlet looking upstream

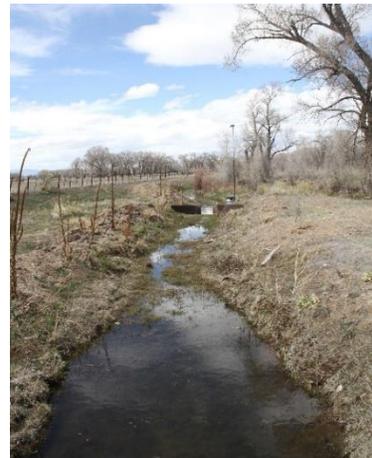
Ditch downstream of headgate

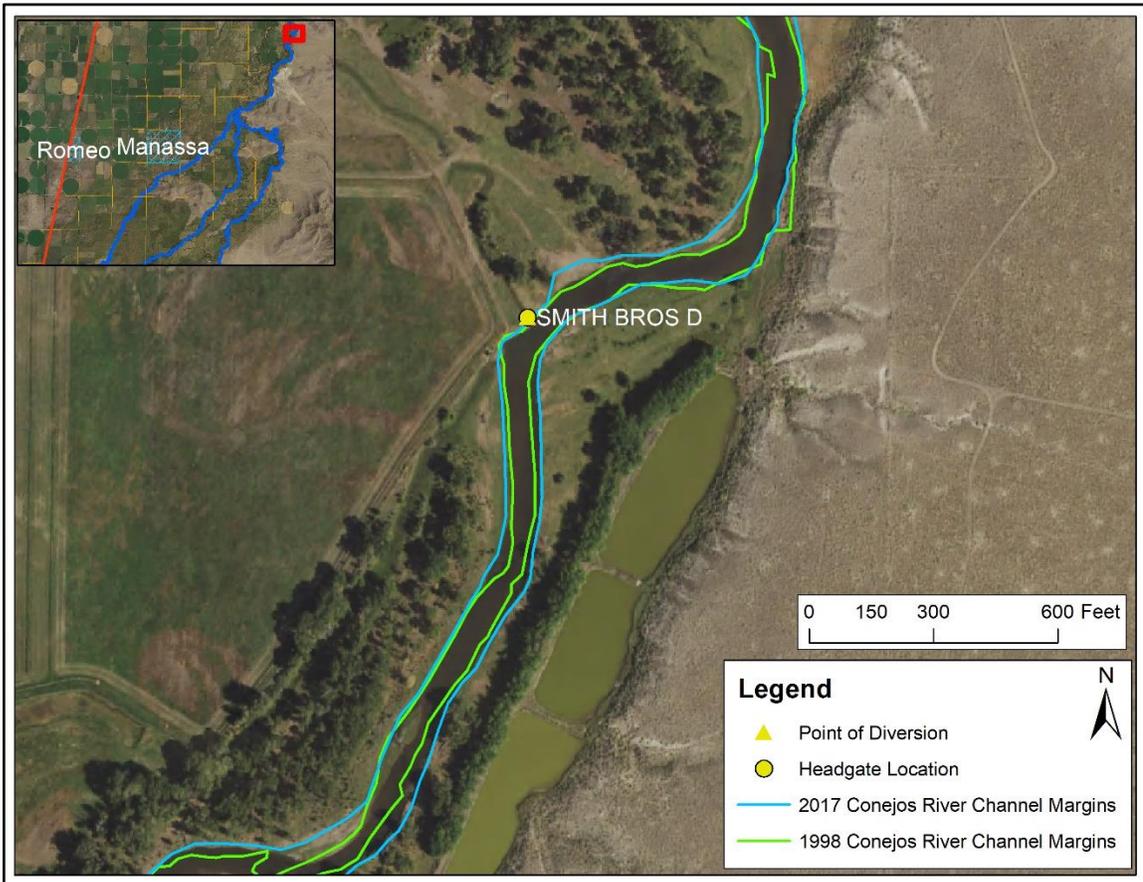
Headgate location with 1998 and 2015 channel margins overlaid.

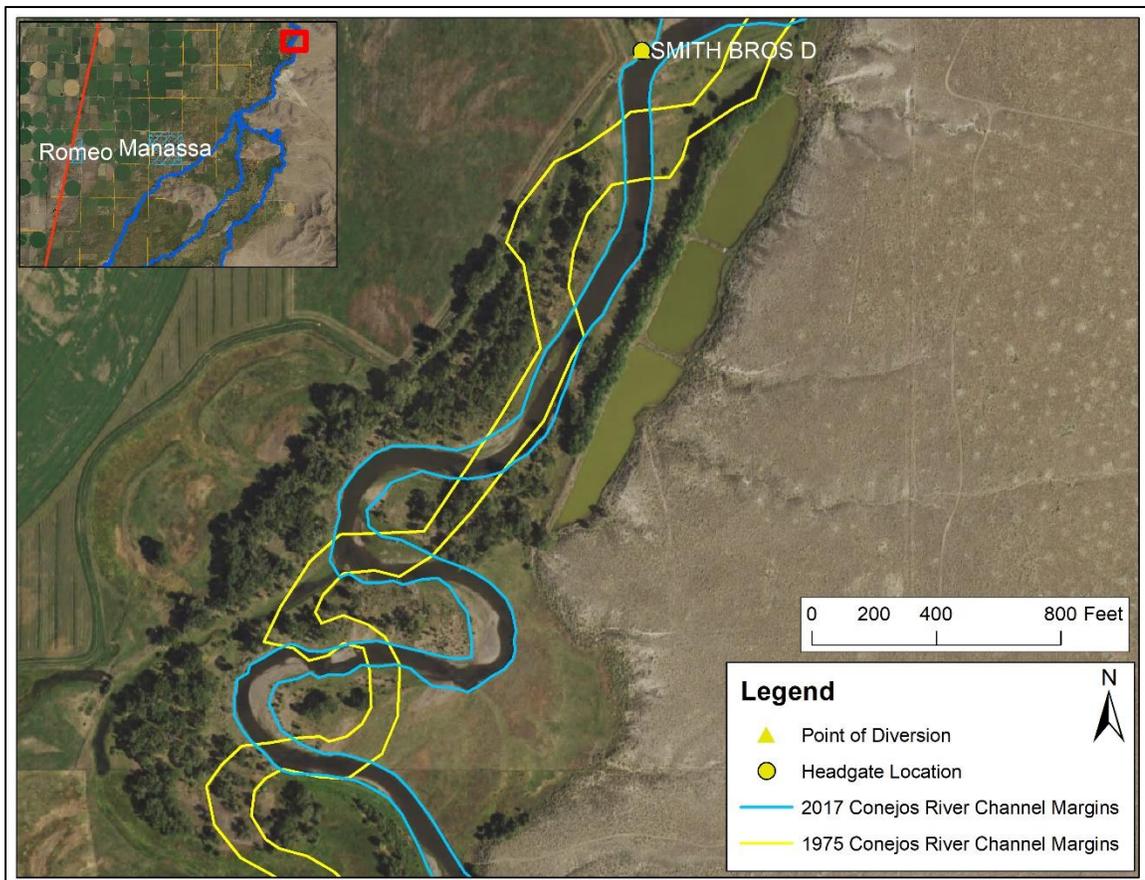
**Structure Description:** Channel avulsion has occurred upstream of this structure's diversion, but the river migrated very little in the last 20 years. Cutbanks and accelerated bank erosion is an issue near the diversion, however. There is no diversion dam at this structure. The headgate is located on the outside of a meander that is stabilized with concrete blocks. Despite stabilization, the headgate is tilted. The flume is also tilted.

1975 and 2015 channel margins, illustrating channel avulsion upstream of diversion.
