# CONEJOS RIVER DIVERSION INFRASTRUCTURE INVENTORY

**Structure Name:** STOVER D

CONEJOS RIVER DIVERSION INFRASTRUCTURE INVENTORY

Conejos River Stream  
Management Plan

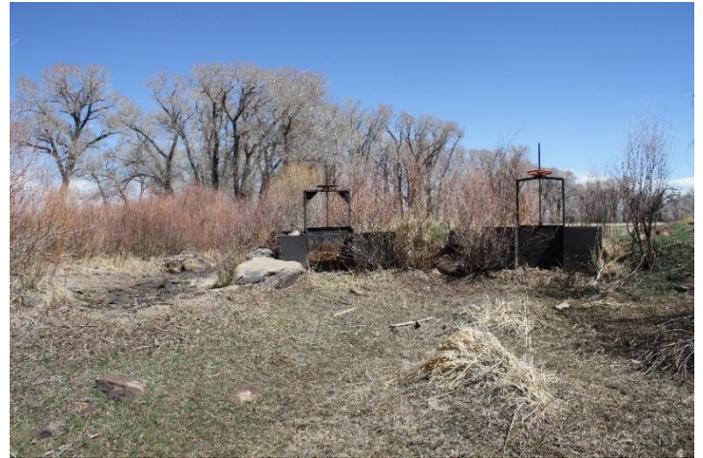
Headgate, diversion dam, and return gate

**Structure Description:** This structure is located just upstream of County Rd 17.5. The channel in this area is relatively stable, partially due to bedrock controls. A U-shaped rock weir diversion dam directs water to the headgate, located on the east bank of the river. A new Parshall flume was installed approximately 5 years ago.

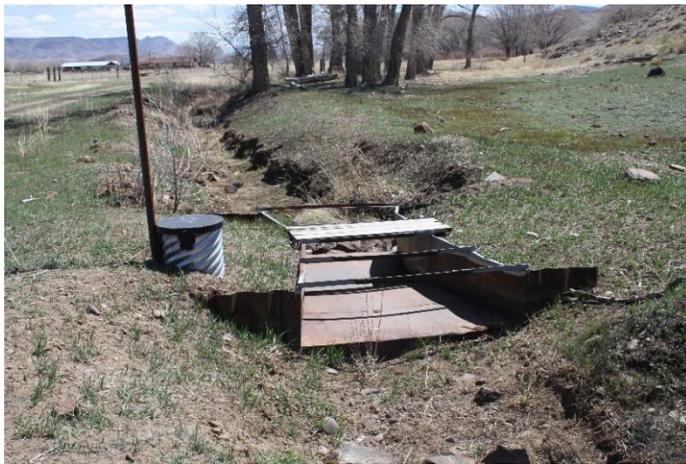
Parshall flume looking downstream

**Repair(s) or Improvement(s) Since 2006:** New Parshall flume installed ~5 years ago.
