CONEJOS RIVER

DIVERSION INFRASTRUCTURE INVENTORY

Structure Name: TROGILLIO D

Date: April 15, 2019

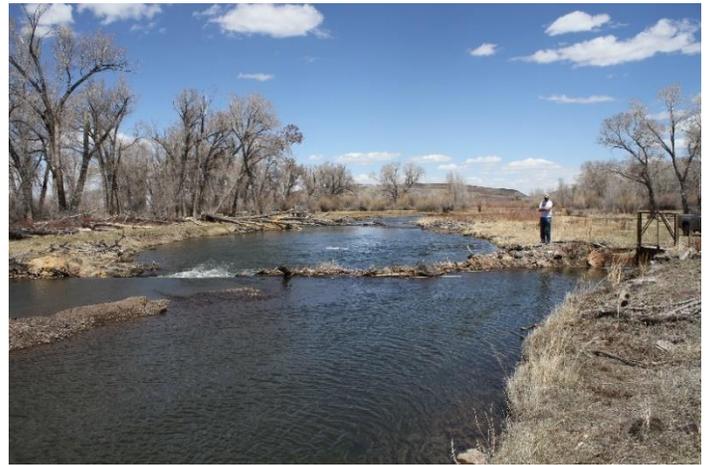
Structure Description: The river is relatively stable upstream and at the diversion, however significant lateral migration has occurred in the last 20 years downstream of the diversion. Additionally, channel avulsion could occur during a high flow event. A diversion dam made of large boulders, debris, and a repurposed molasses tank directs water to the headgate, which is located on the east bank of the river. The diversion can form a barrier to fish passage at some flow levels. Sediment and debris accumulate at the diversion and headgate.

Headgate and diversion dam

Repair(s) or Improvement(s) Currently Needed: Given the issues identified at this structure, the SMP Technical Advisory Team (TAT) recommends installing a new diversion dam and adjacent sluice gate and implementing bank stabilization and riparian revegetation. The TAT also recommends creating fish passage at the diversion. A new diversion and sluice gate would create fish passage, allow for sediment and debris transport, and reduce maintenance. Bank stabilization and riparian revegetation would reduce erosion and improve river health and function.

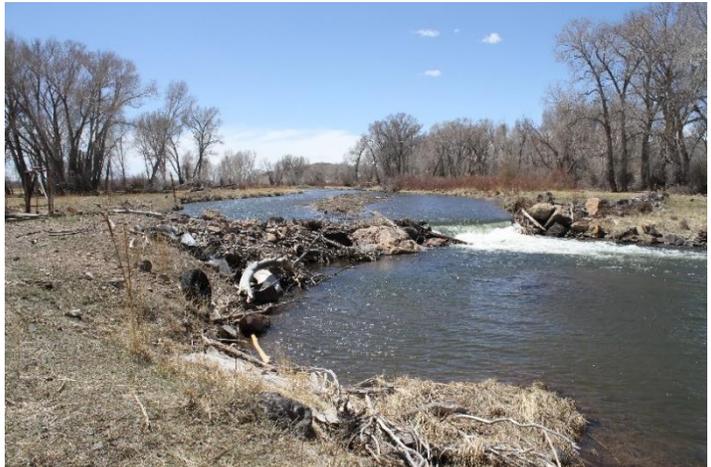
Diversion dam looking upstream

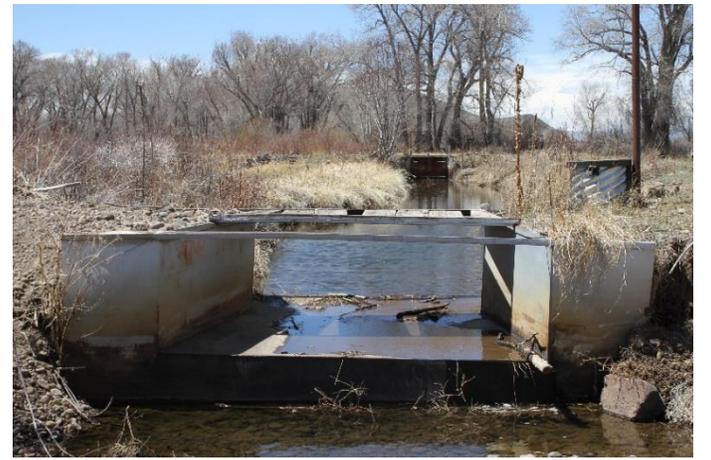
Flume looking upstream

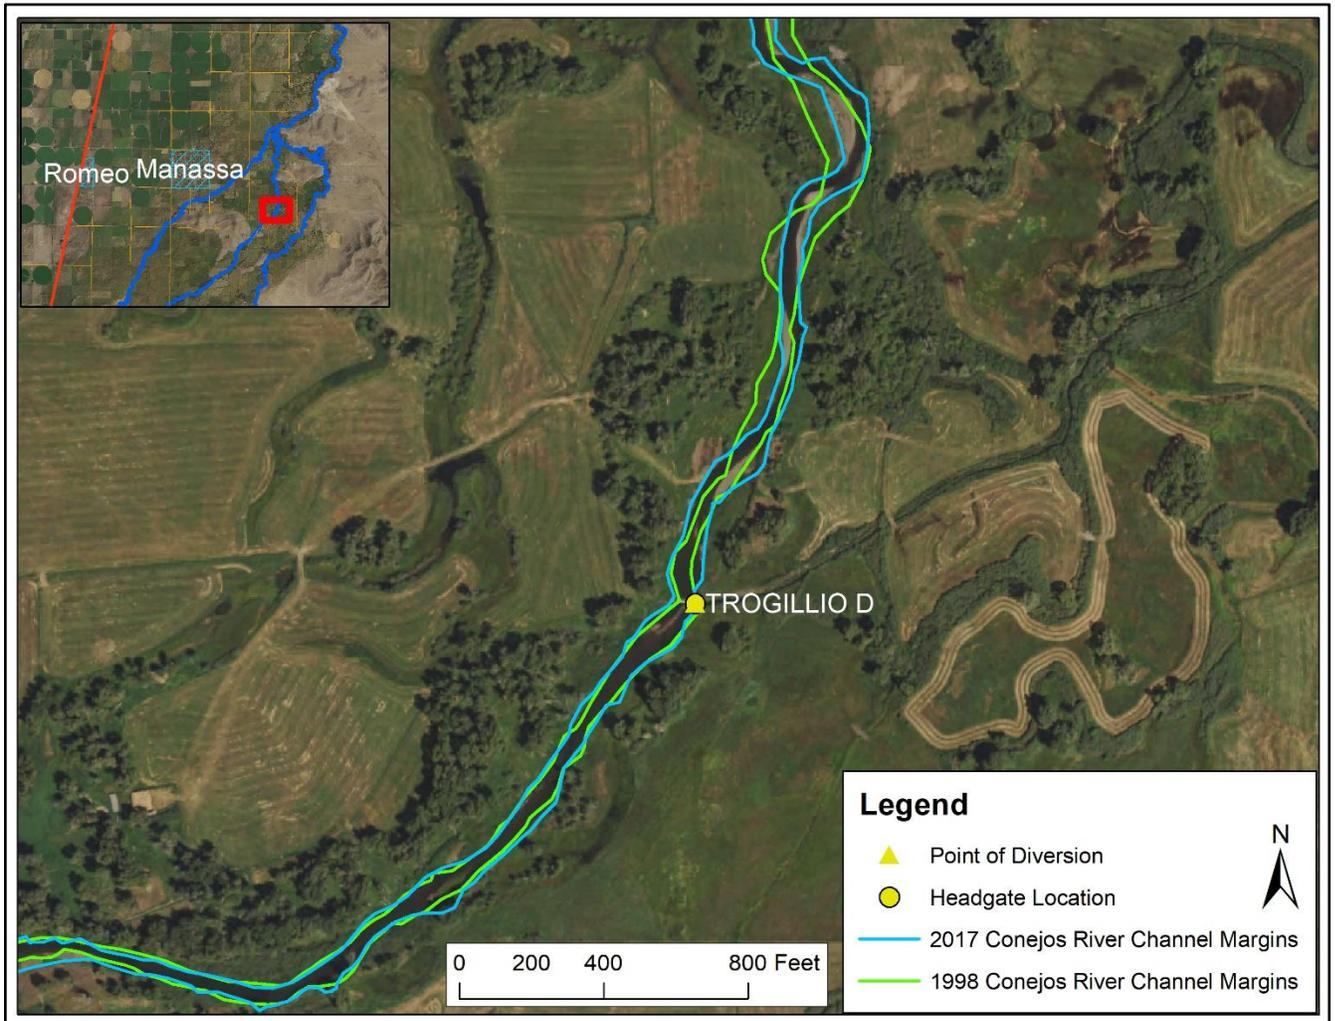
Headgate location with 1998 and 2015 channel margins overlaid
