CONEJOS RIVER DIVERSION INFRASTRUCTURE INVENTORY

Structure Name: VEGA D

VEGA DITCH

Conejos River Stream
Management Plan

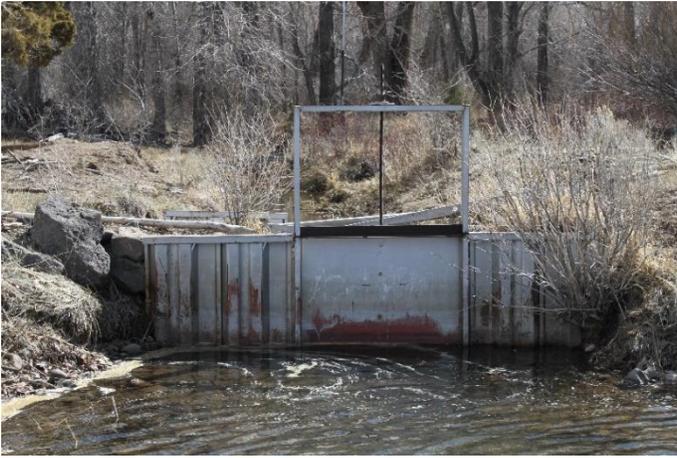
Headgate looking downstream

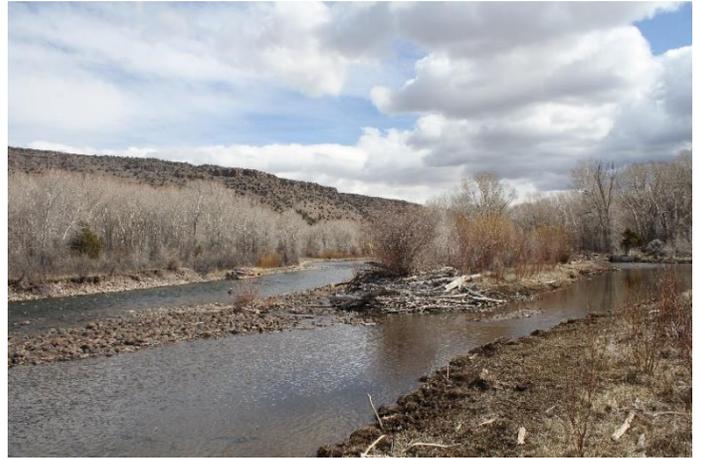
Structure Description: There is a short feeder channel, located on the south bank of the Conejos River, that leads to the headgate. A rock boulder diversion, at the head of the return flow channel and adjacent to the structure, directs water to the headgate. Water can seep through this diversion.

Diversion dam with headgate in background

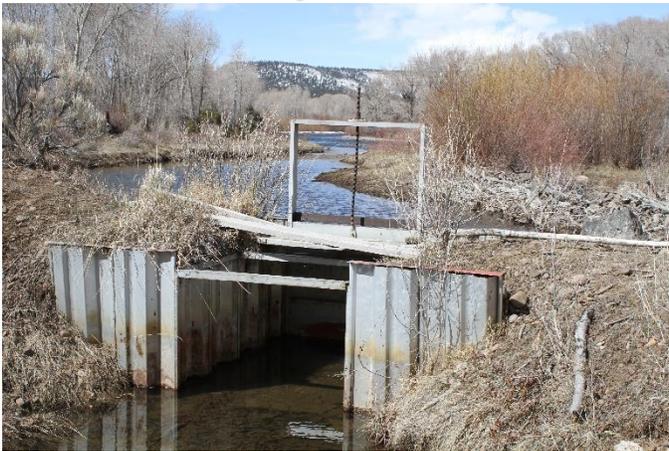
Headgate outlet

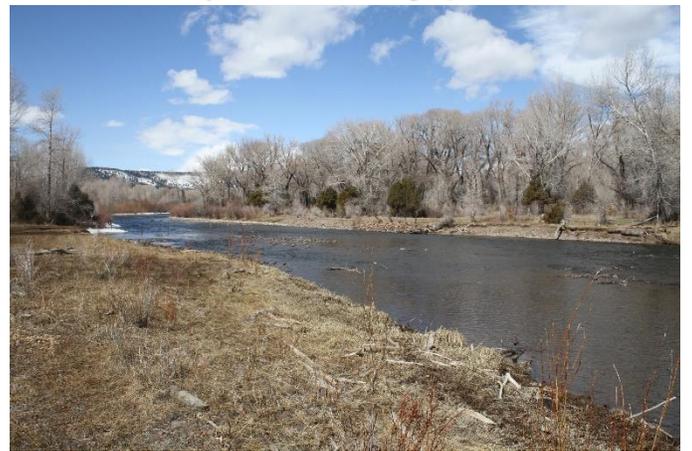
Conejos River looking upstream

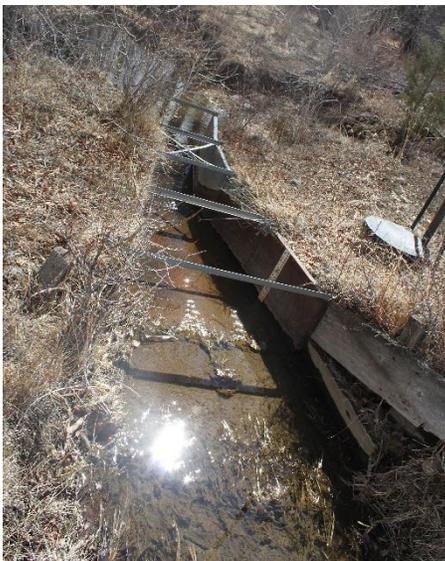
Parshall Flume

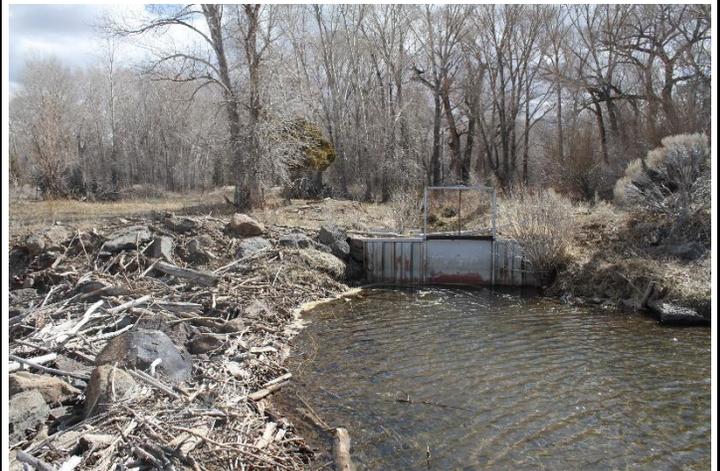
Headgate and diversion at head of return channel

Repair(s) or Improvement(s) Currently Needed: No immediate repair needs were noted at this structure. However, to minimize maintenance and reduce impacts to the river, this diversion could be combined with that of the Canon Irrigating Ditch.

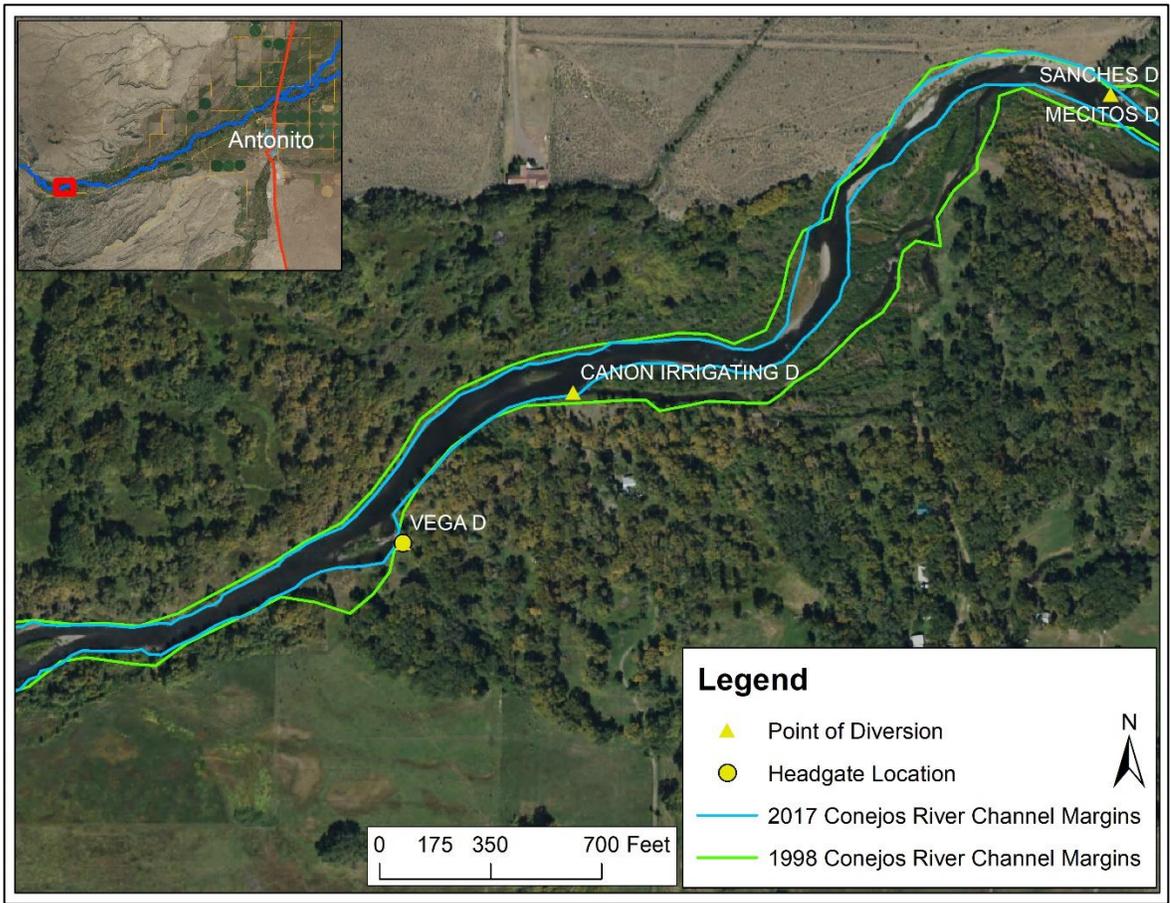
Headgate location with 1998 and 2017 channel margins overlaid

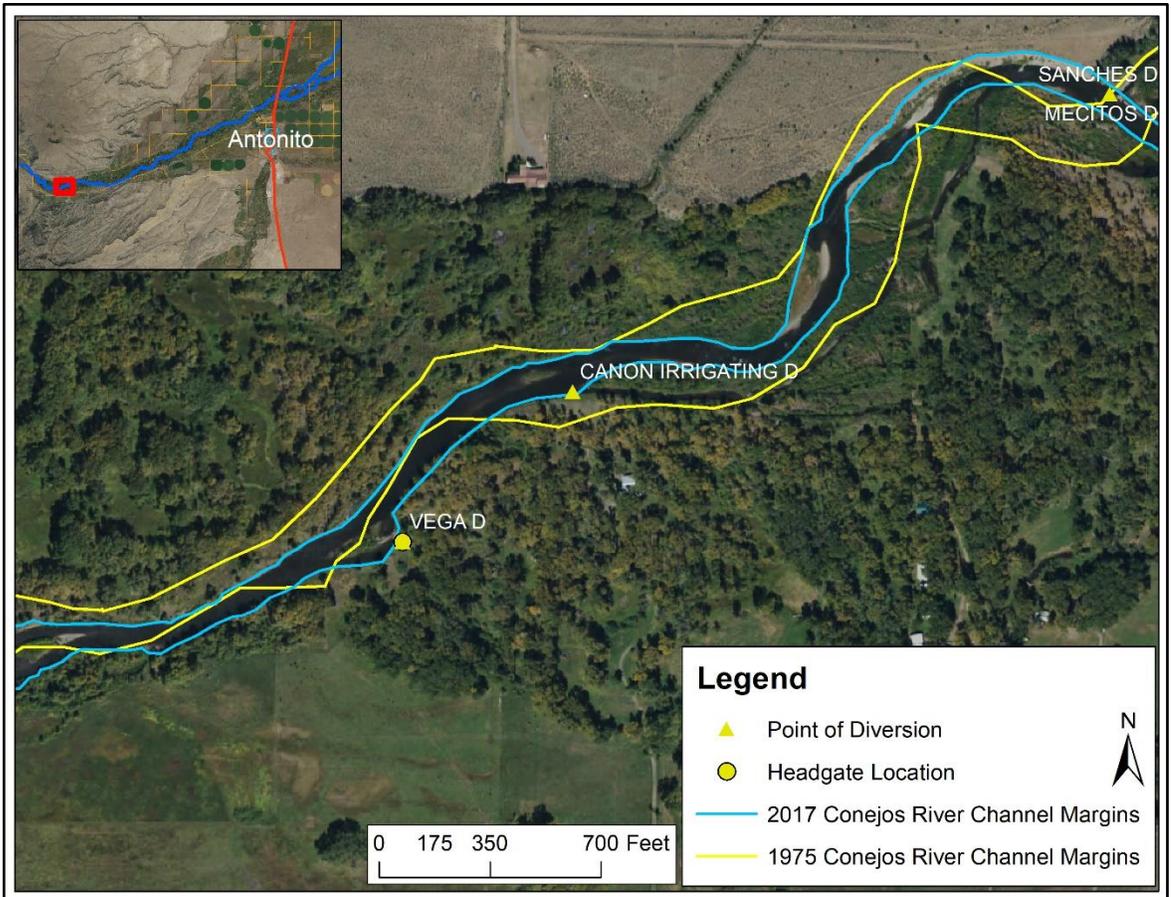
Headgate location with 1975 and 2017 channel margins overlaid
