CONEJOS RIVER

DIVERSION INFRASTRUCTURE INVENTORY

Structure Name: WILLIAM STEWART COMPANY IRRIGATION D

Date: April 16, 2019

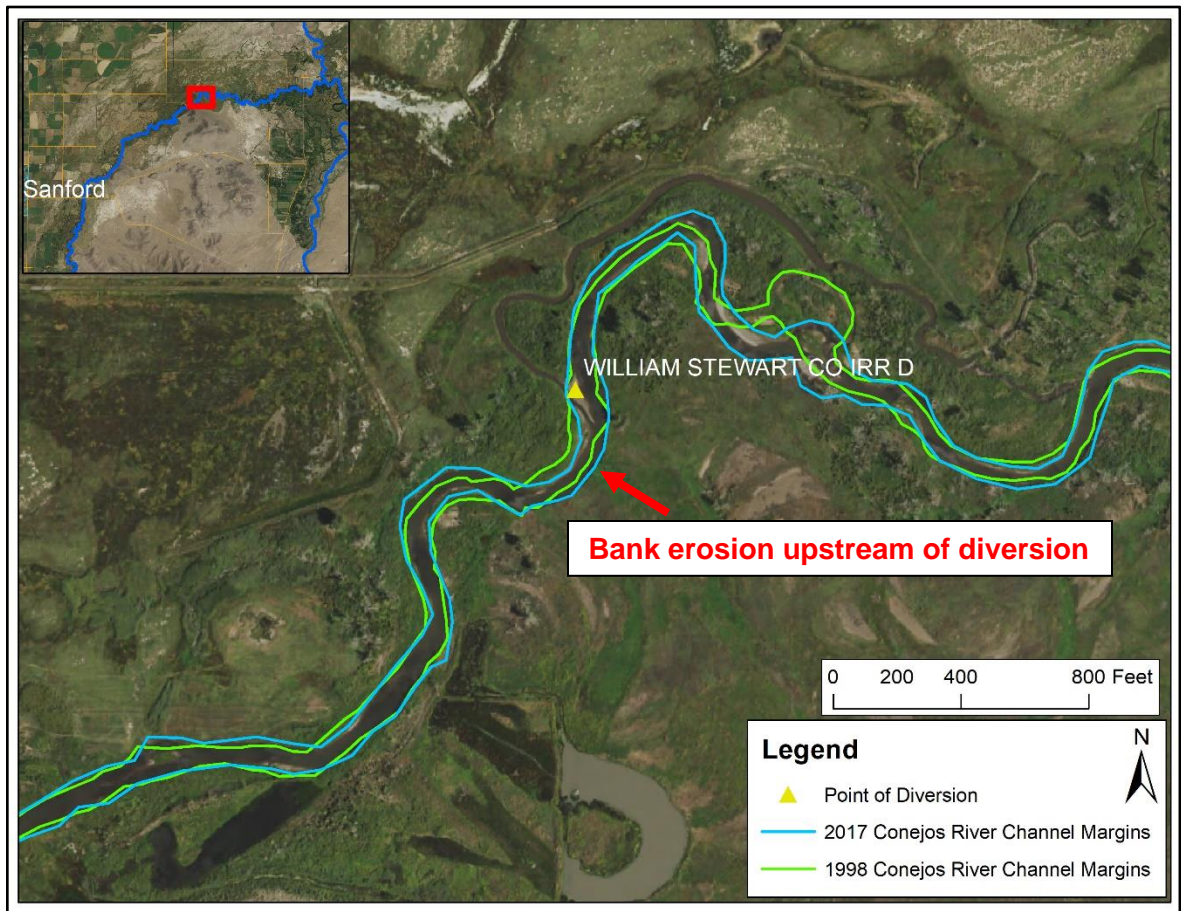
Headgate location with 1998 and 2015 channel margins overlaid.

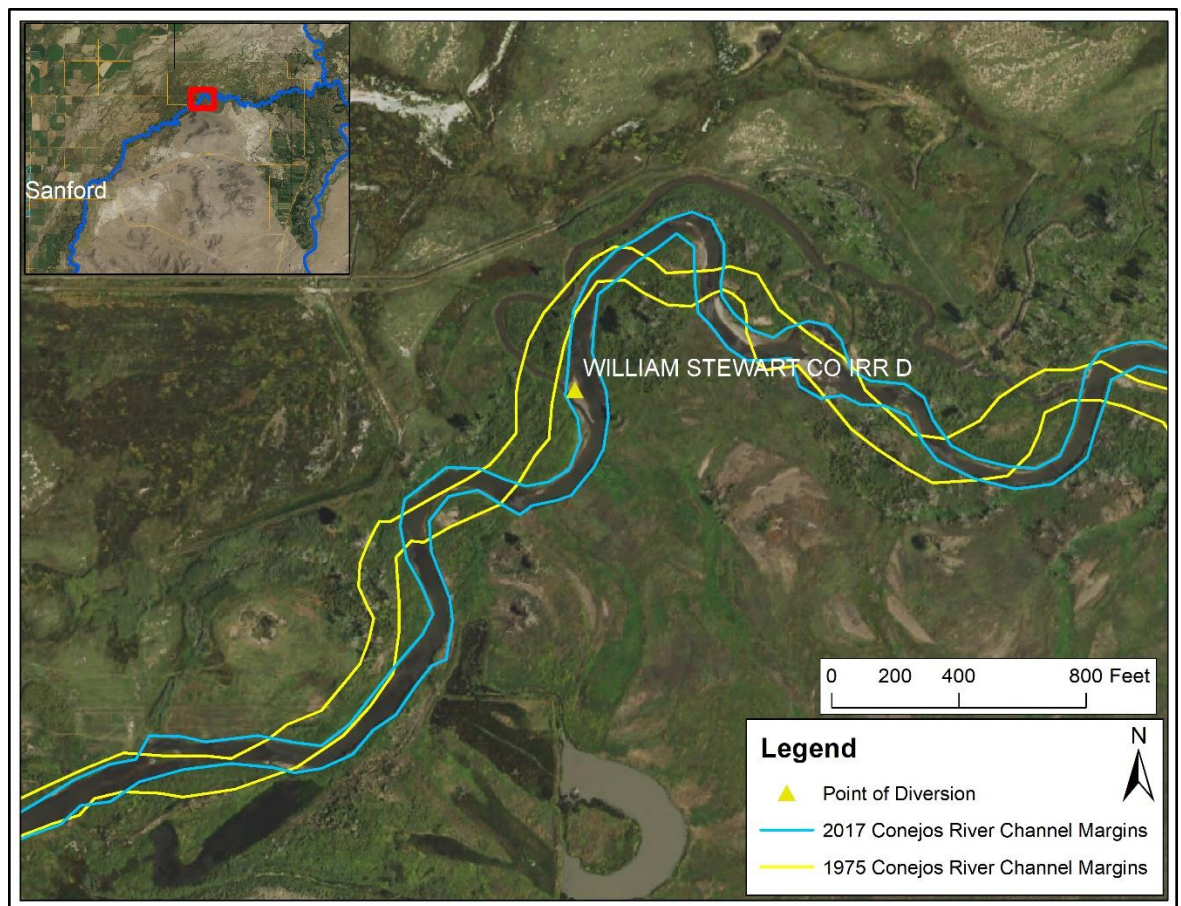
Headgate location with 1975 and 2015 channel margins overlaid.
