CONEJOS RIVER

DIVERSION INFRASTRUCTURE INVENTORY

Structure Name: EAST BEND D

Conejos River Stream Management Plan

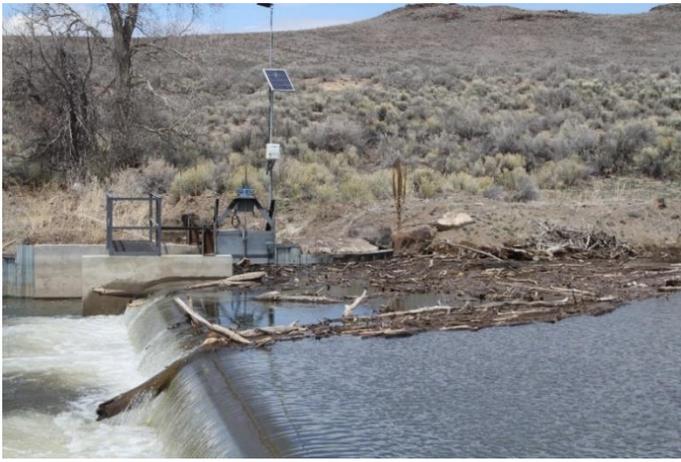
Headgate and diversion dam

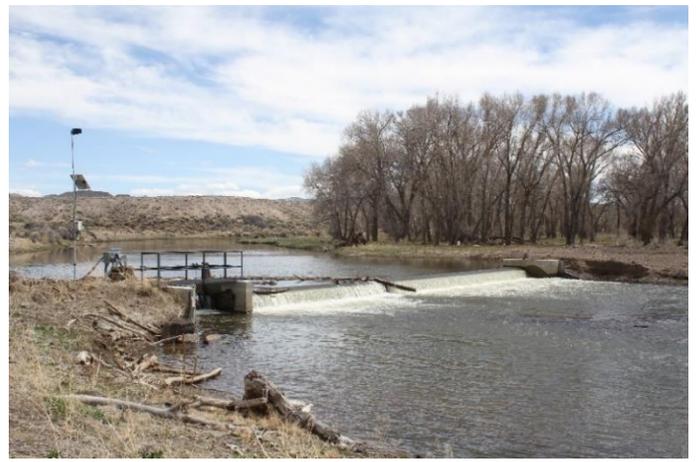
Diversion dam looking upstream

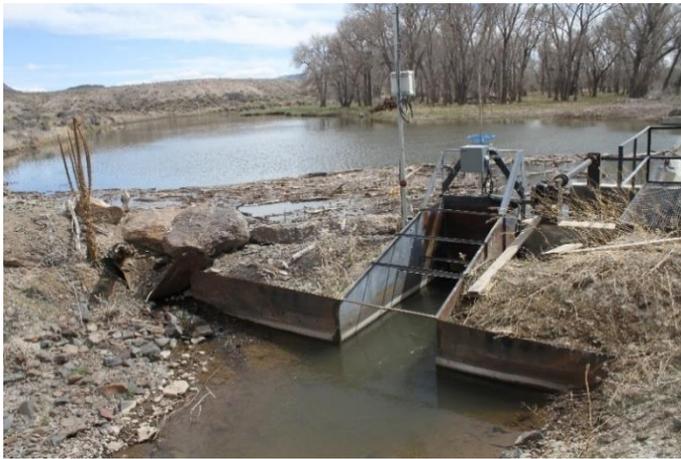
Headgate outlet

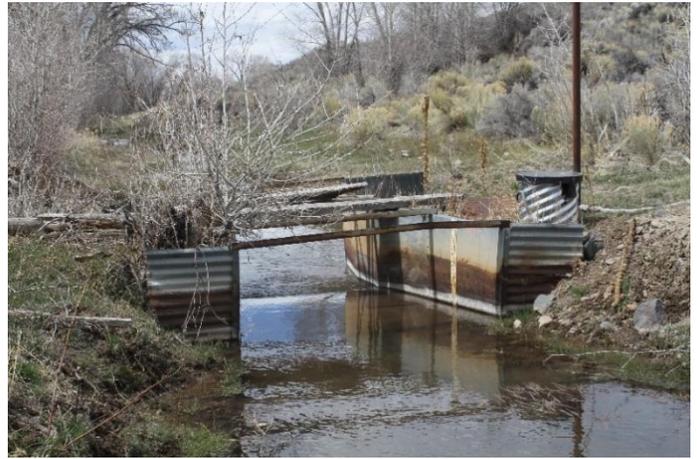
Flume looking downstream

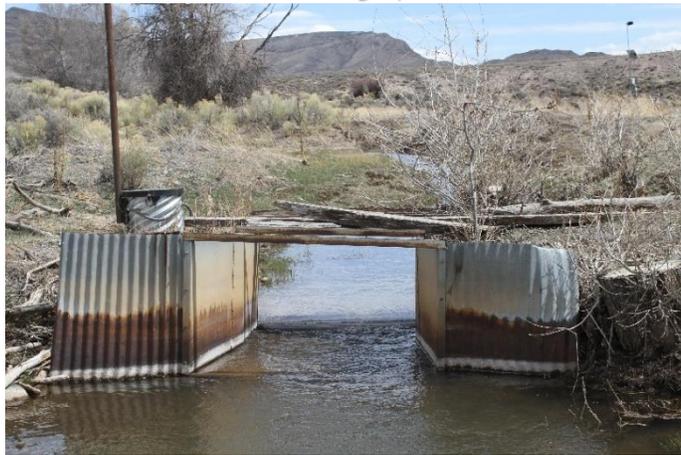
Flume looking upstream

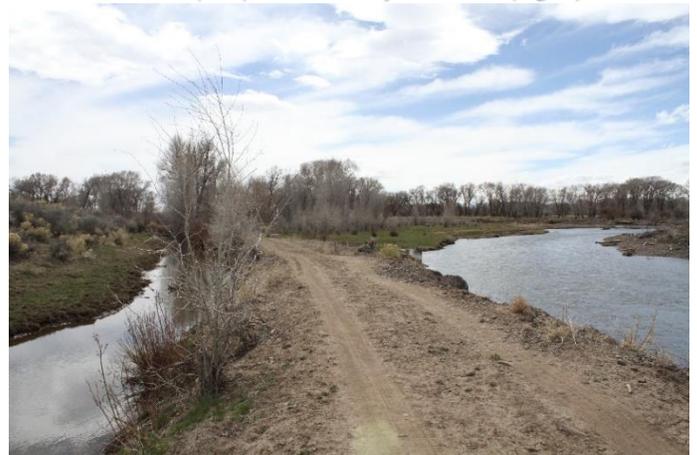
Ditch (left) and Conejos River (right)

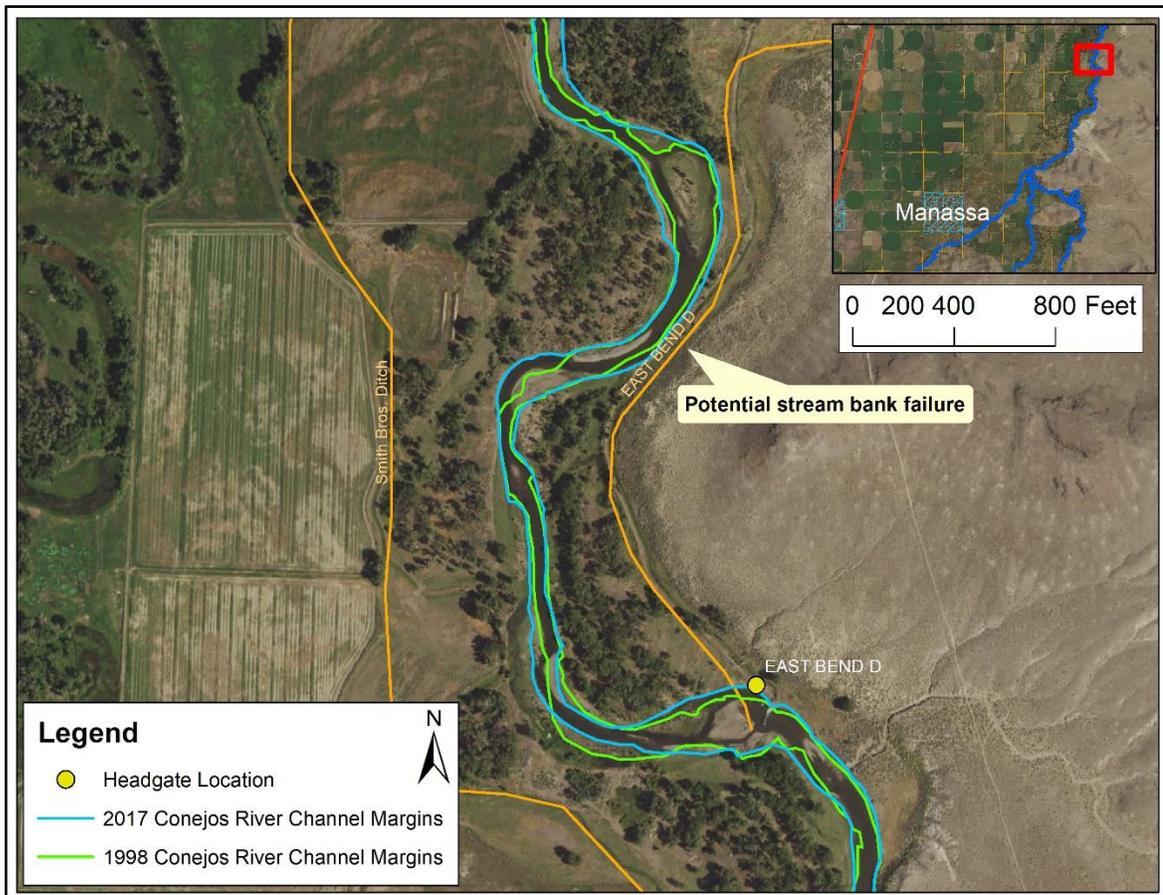
Map of ditch location with 1998 and 2015 channel margins overlaid. This image also indicates the location of stream bank failure & ditch wash out.
