# CONEJOS RIVER

## DIVERSION INFRASTRUCTURE INVENTORY

**Structure Name:** LOS OJOS D NO 1

**Date:** April 16, 2019

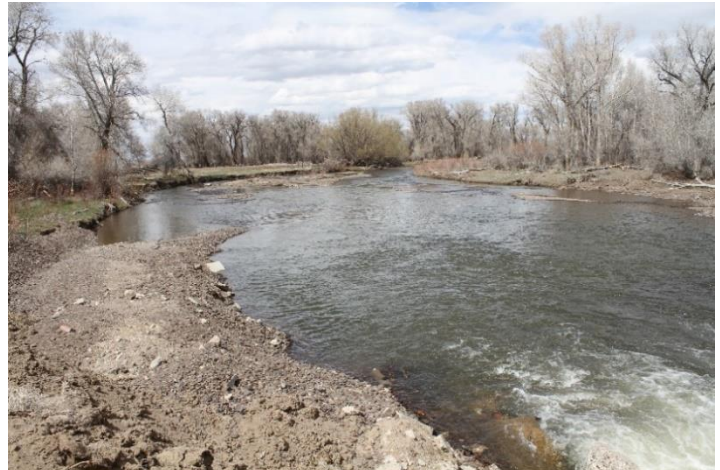
Channel downstream of diversion dam

**Structure Description:** This structure is located just downstream of County Road V. A concrete diversion dam spans the river and directs flow to a short feeder channel on the west bank of the river. Just upstream of the headgate, a trash rack made up a fence and a 4 inch welded wire panel crosses the feeder channel. This structure creates a barrier to fish passage, especially at low flows. However, a barrier is needed within this reach to prevent nonnative carp from traveling upstream and this structure could serve that role. Downstream of the diversion, the channel is experiencing significant lateral migration and accelerated erosion. Immediately below the diversion, the west bank of the river is eroding and the river is widening.

**Repair(s) or Improvement(s) Currently Needed:** Given these issues, the SMP Technical Advisory Team (TAT) recommends erosion mitigation and riparian revegetation. Channel shaping and/or riparian revegetation would address bank erosion.
