CONEJOS RIVER

DIVERSION INFRASTRUCTURE INVENTORY

Structure Name: MANASSA D

Date: April 15, 2019

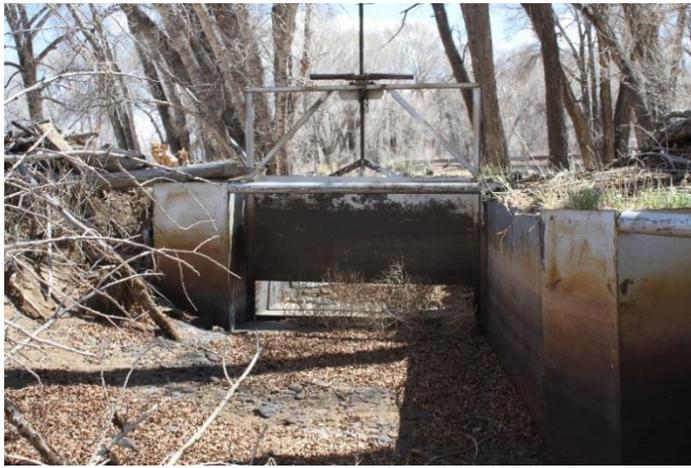
Repair(s) or Improvement(s) Currently Needed: The headgate is slightly crooked and there are plans to straighten and repair it.

Headgate looking downstream

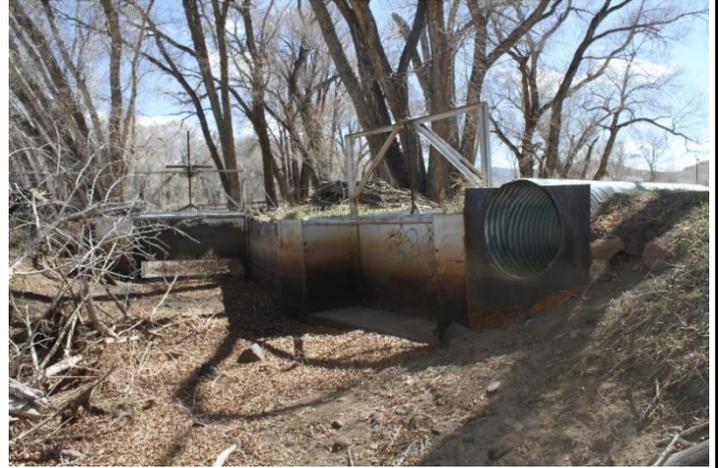
Headgate and diversion dam

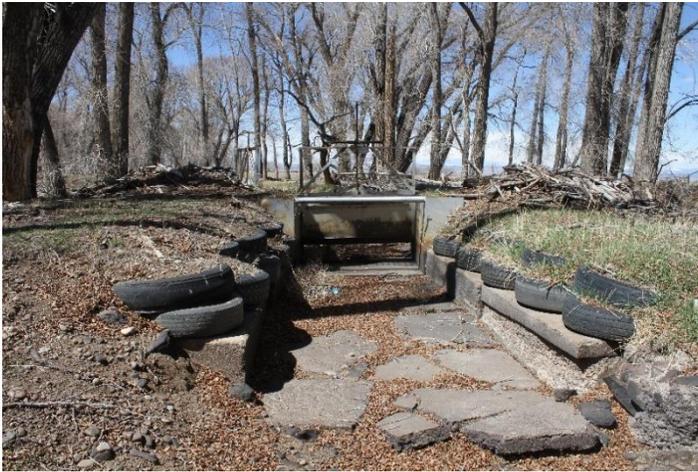
Headgate outlet

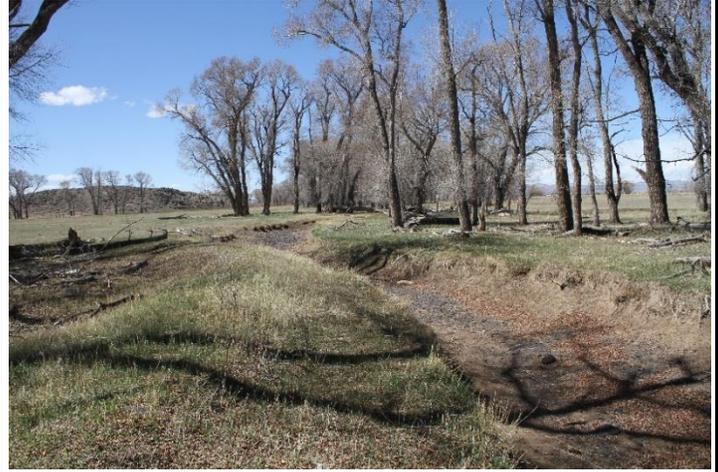
North branch Conejos looking upstream of structure

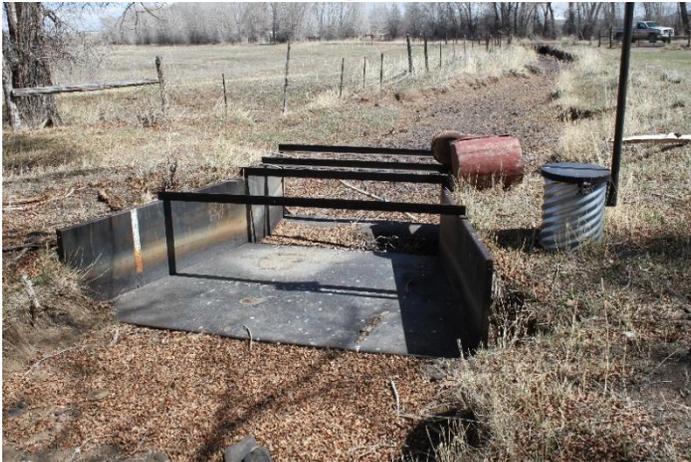
Flume looking downstream

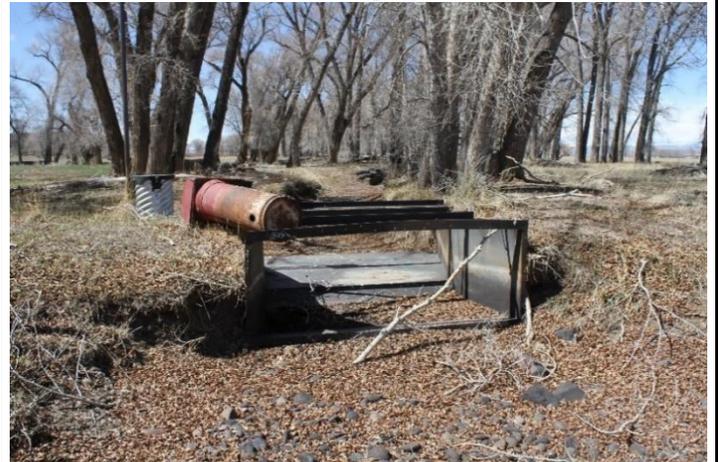
Flume looking upstream
