CONEJOS RIVER DIVERSION INFRASTRUCTURE INVENTORY

Structure Name: MANASSA WESTFIELD D

Date: April 15, 2019

Conejos River Stream Management Plan

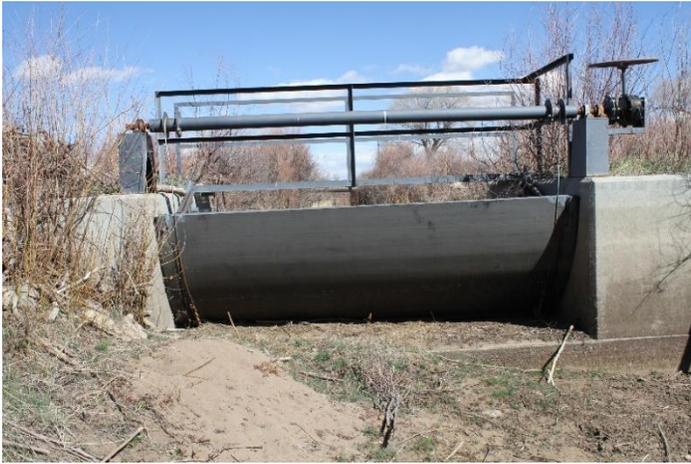
Headgate looking downstream

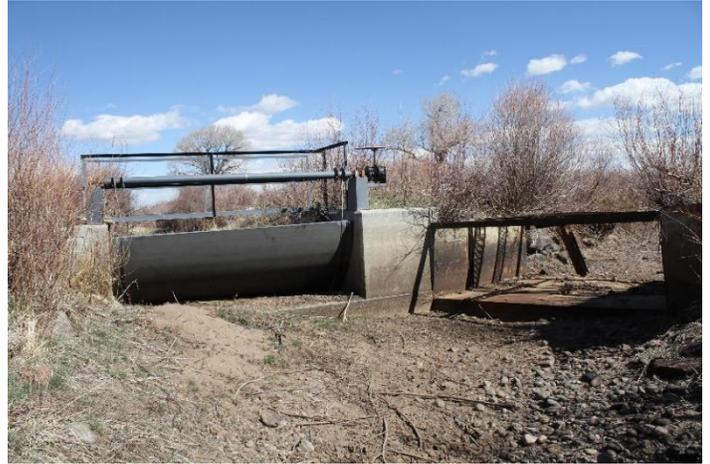
Structure Description: A steel check board diversion directs flow to the headgate, which is located on the west bank of the channel. Check boards can be added or removed from the diversion dam to control flows however the diversion functions poorly and requires regular maintenance. Bank erosion upstream of this structure is causing sedimentation at the diversion and headgate.

Headgate and diversion structure

Repair(s) or Improvement(s) Currently Needed: Given the issues identified at this structure, the SMP Technical Advisory Team (TAT) recommends repairing or replacing the diversion and implementing bank stabilization and riparian revegetation. An improved or new diversion would increase efficiency and bank stabilization would prevent accelerated erosion upstream of the structure.

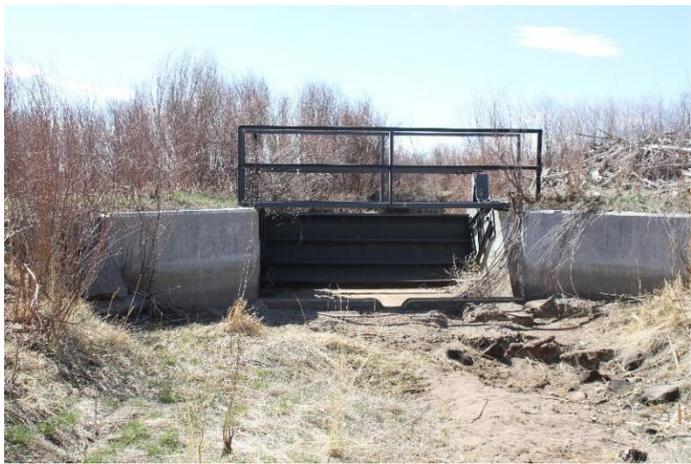
Headgate outlet

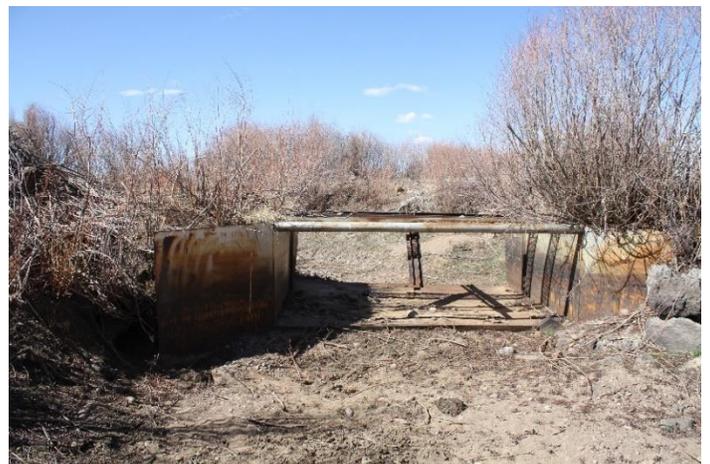
Diversion dam looking upstream

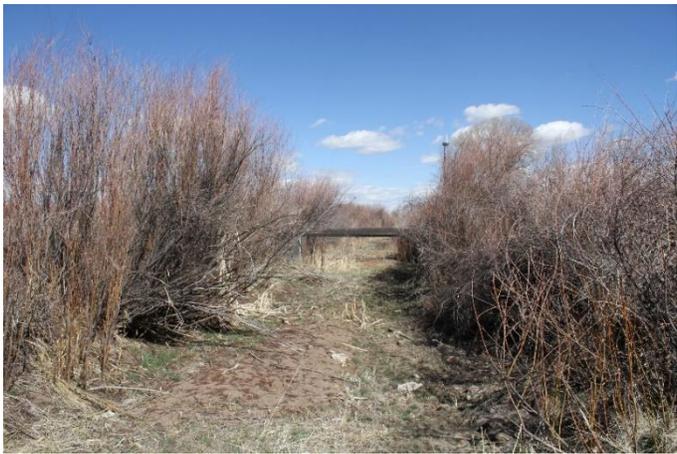
Flume looking downstream

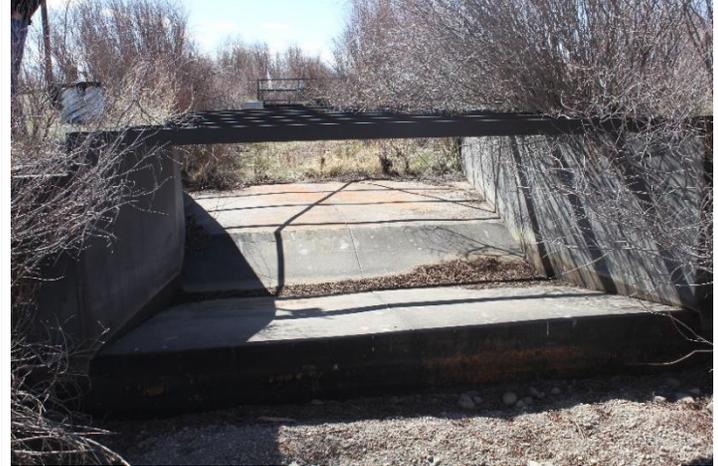
Flume looking upstream
