# CONEJOS RIVER

## DIVERSION INFRASTRUCTURE INVENTORY

**Structure Name:** WILLIAM JACKSON D

**Date:** April 16, 2019

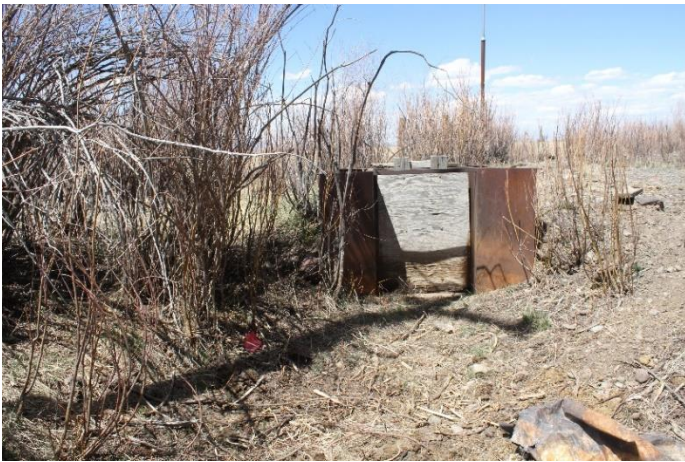
**Structure Description:** This structure is located just downstream of Highway 142. The channel gradient here is very low and sediment accumulation is an issue. The channel is unstable and prone to erosion. A low stacked rock diversion dam directs water to the headgate, located on the north bank of the river. The headgate functions poorly.

Headgate looking downstream

**Repair(s) or Improvement(s) Currently Needed:** The SMP Technical Advisory Team (TAT) recommends installing a new headgate, which would increase efficiency and reduce maintenance.

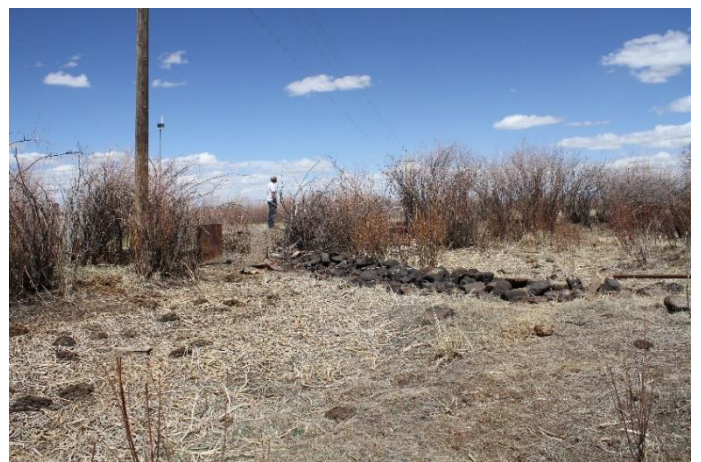
Headgate and diversion dam

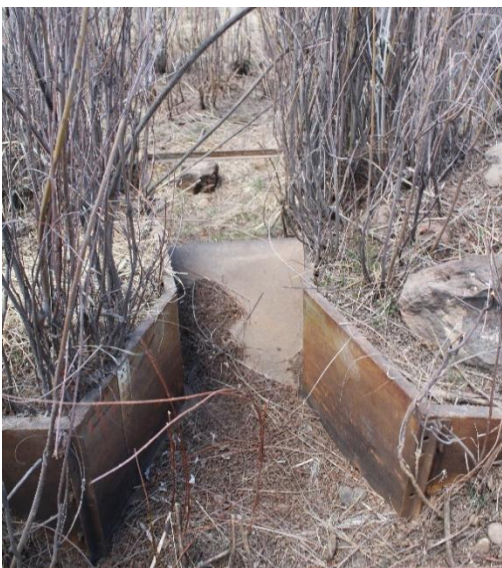
Headgate outlet

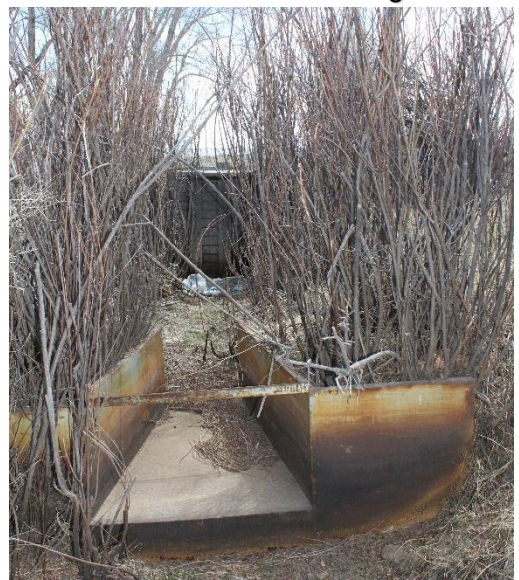
Parshall flume and headgate

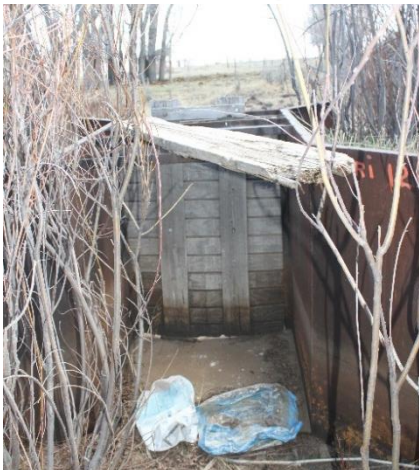
Parshall flume looking downstream

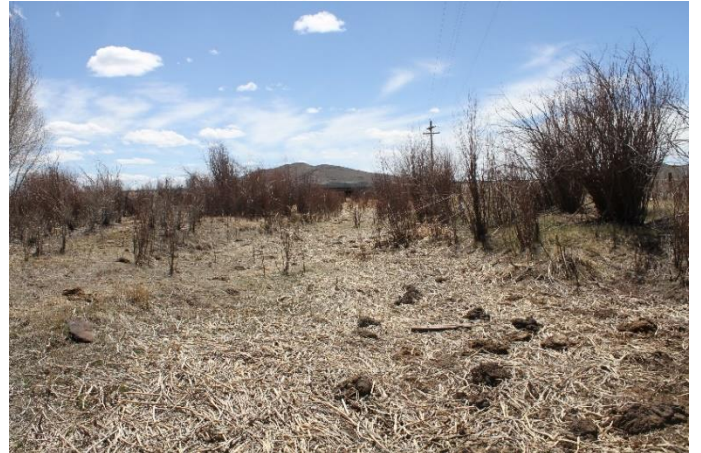
North Branch Conejos River looking upstream
