RIO GRANDE DIVERSION INFRASTRUCTURE INVENTORY

Structure Name: RIO GRANDE D 2

Date: April 9, 2019

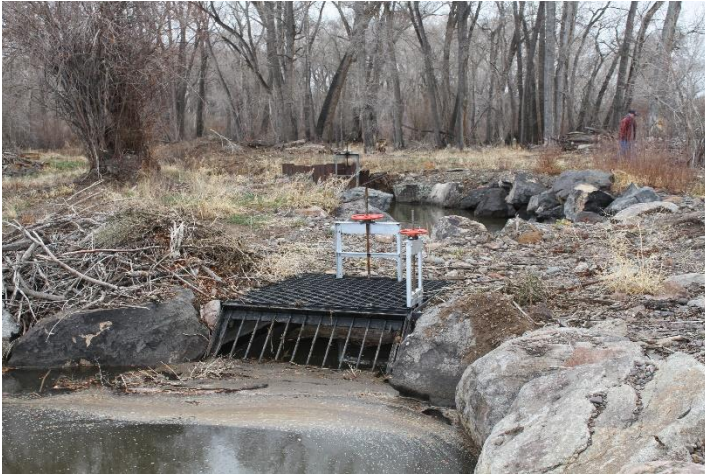
Headgate looking downstream

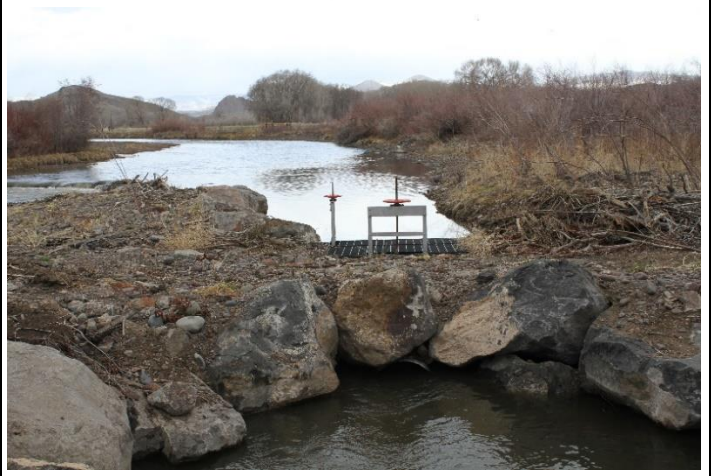
Headgate outlet

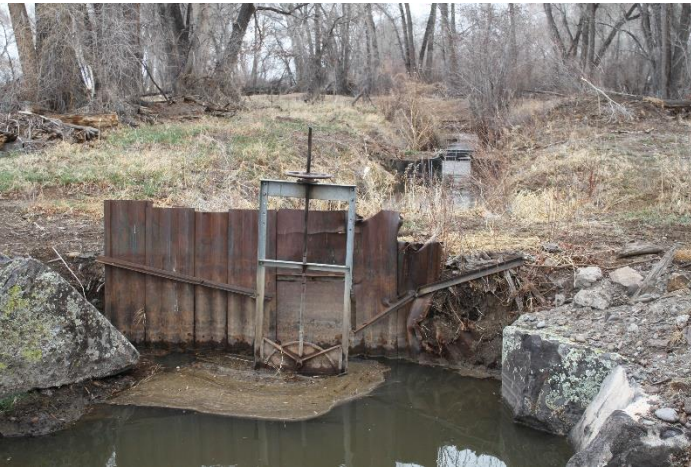
Structure Description: This structure is located on the north bank of the river in the transition zone between two meanders. The river has migrated very little in the last 40 years and is not expected to migrate significantly in the future. A rock cross vane diversion dam diverts water to the headgate, which is located on the north bank of the river. The old headgate still exists downstream of the main headgate (see photos below).

Old headgate below new headgate

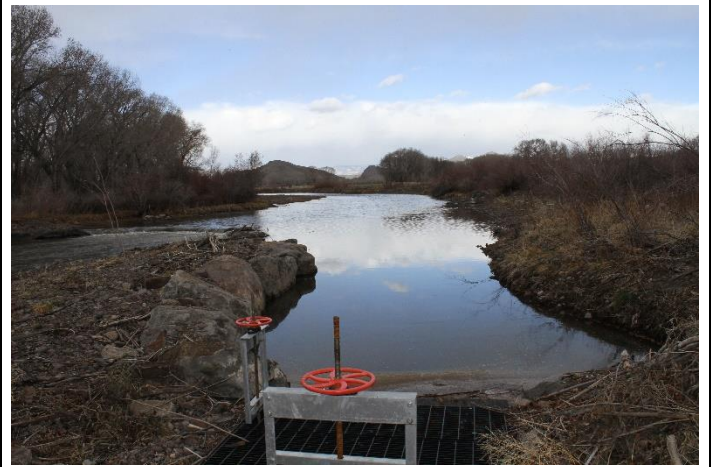
Headgate and diversion dam

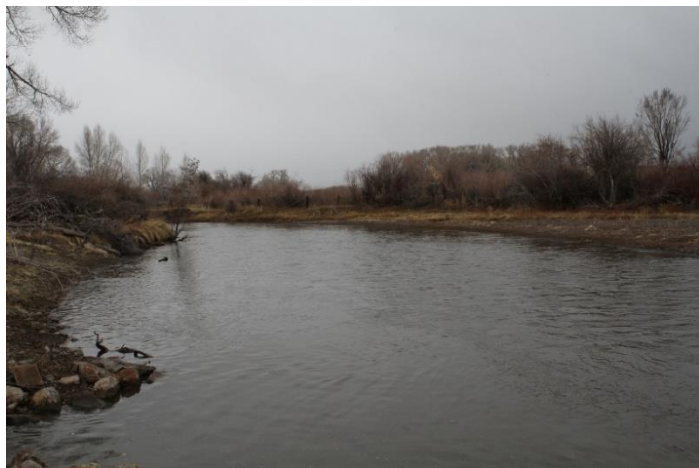
Channel looking downstream

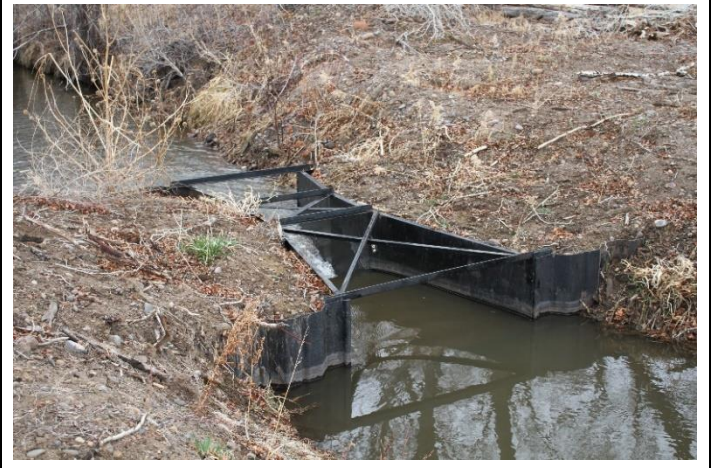
Flume looking downstream
