RIO GRANDE DIVERSION INFRASTRUCTURE INVENTORY

Structure Name: RIO GRANDE LARIAT D

Reported By: Daniel Boyes

Date: April 1, 2019

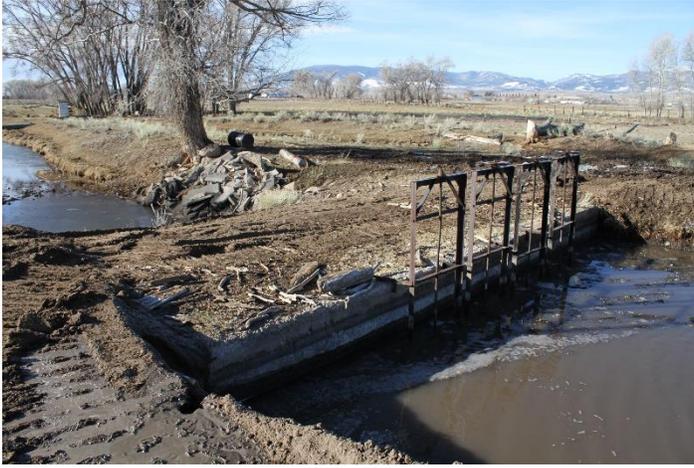
Headgate looking downstream

Repair(s) or Improvement(s) Currently Needed: No major repairs were noted, but the headgates leak slightly and the SMP Technical Advisory Team (TAT) recommends repairs or improvements to eliminate the leak.

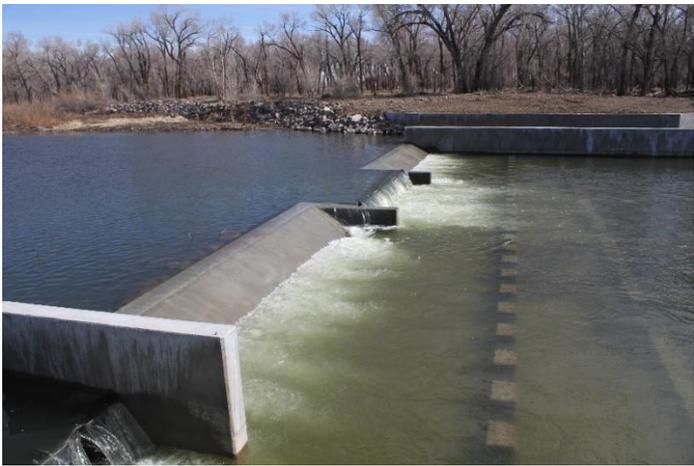
Diversion dam (Consolidated D diversion)

Repair(s) or Improvement(s) Completed Since 2006: The headgate and diversion dam on the Rio Grande were replaced in 2019 as part of the Rio Grande Headwaters Restoration Project's 5 Ditches Project, in partnership with the NRCS, RGHRP, and the ditch company. They now function well.
