RIO GRANDE DIVERSION INFRASTRUCTURE INVENTORY

Structure Name: RIO GRANDE SAN LUIS D

Date: April 1, 2019

RIO GRANDE SAN LUIS DITCH

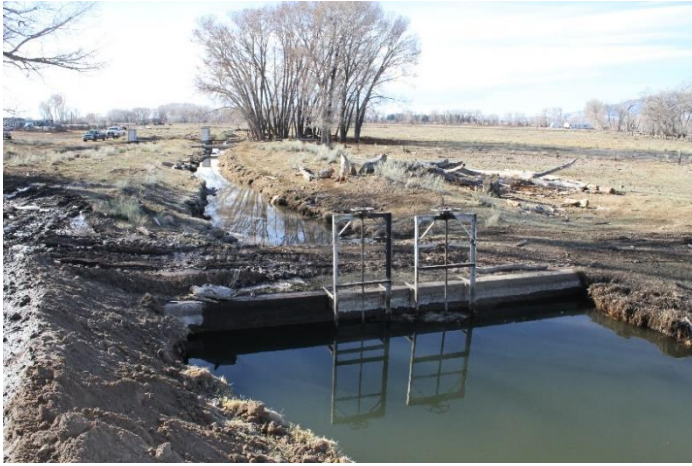
Structure Description: Water is diverted off the Rio Grande via the Consolidated Slough Ditch diversion located on the south bank of the river. The Consolidated Slough Ditch headgate delivers water to the feeder channel, which transports water approximately 3.12 miles to the Rio Grande San Luis Ditch headgate. The headgate is adjacent to the Anderson Ditch, Rio Grande Lariat Ditch, and Atencio Ditch. The Consolidated Slough Weir diverts water to a short feeder channel and to the Rio Grande San Luis Ditch headgate. The headgate leaks badly, however the headwall is sound.

Headgate looking downstream

Repair(s) or Improvement(s) Currently Needed: The SMP Technical Advisory Team (TAT) recommends headgate replacement to increase water delivery efficiency and reduce maintenance.

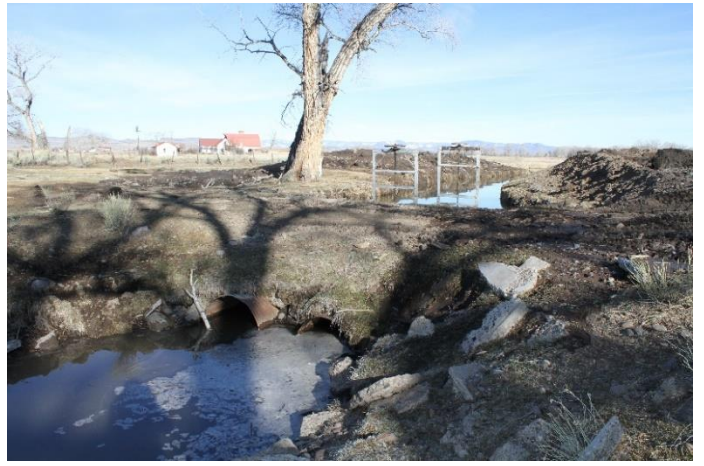
Headgate outlet

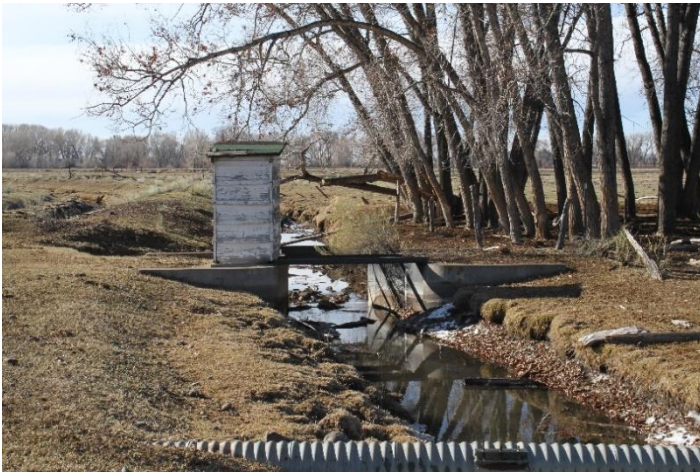
Ditch downstream of headgate

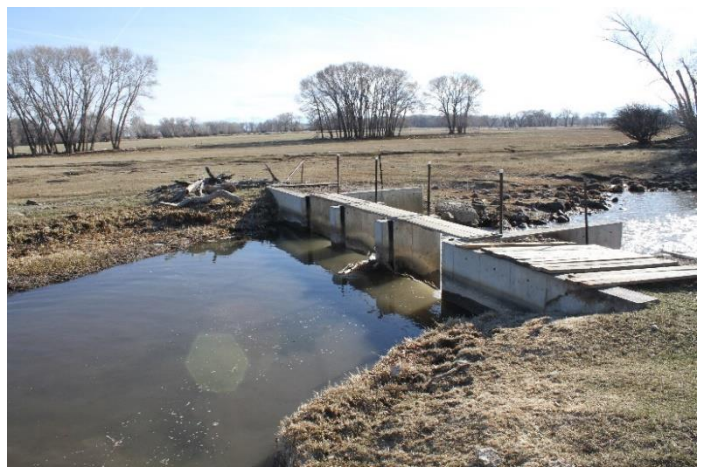
Repair(s) or Improvement(s) Completed Since 2006: The headgate and diversion dam on the Rio Grande were replaced in 2019 as part of the Rio Grande Headwaters Restoration Project's 5 Ditches Project, in partnership with the NRCS, RGHRP, and the ditch company. They now function well.

Diversion dam (Consolidated Slough Weir)

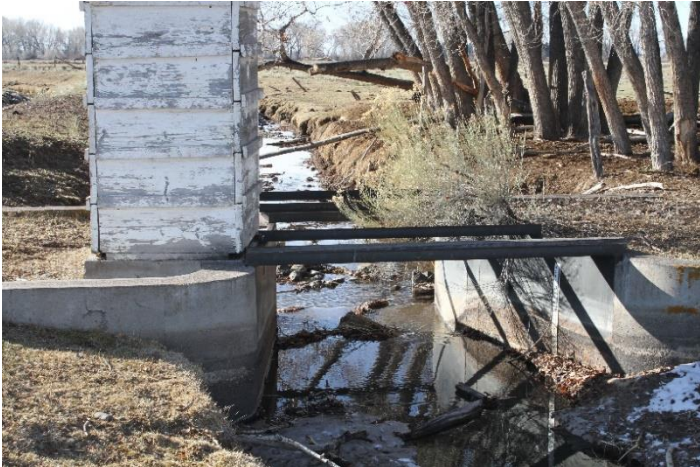
Flume looking downstream

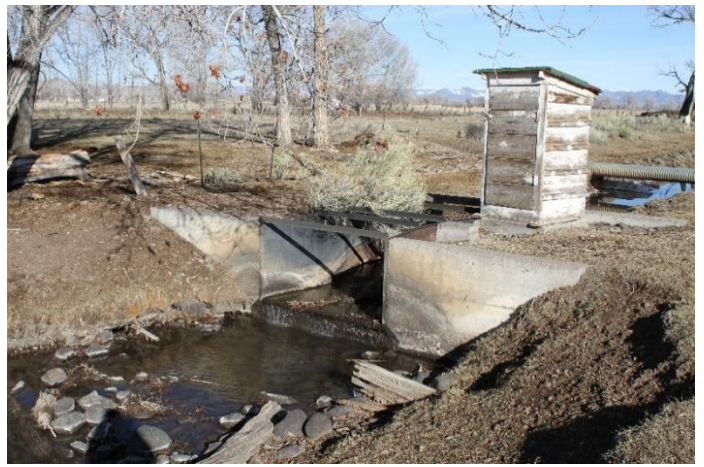
Flume looking upstream
