RIO GRANDE DIVERSION INFRASTRUCTURE INVENTORY

Structure Name: ANACONDA D

ANACONDA DITCH

**Rio Grande Stream
Management Plan**

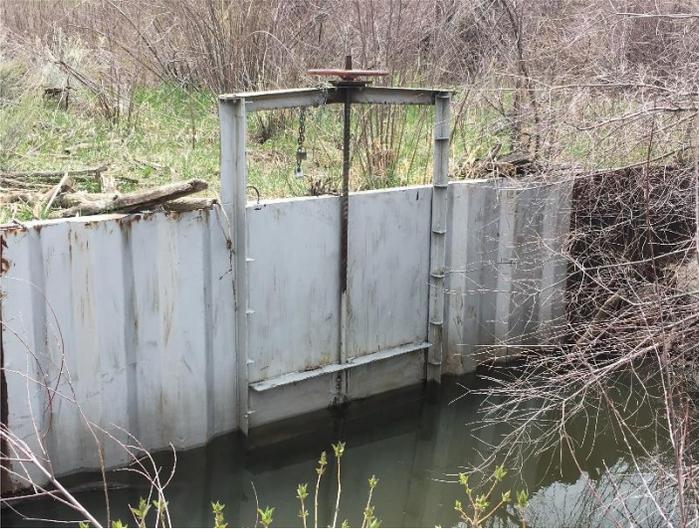
Headgate looking downstream

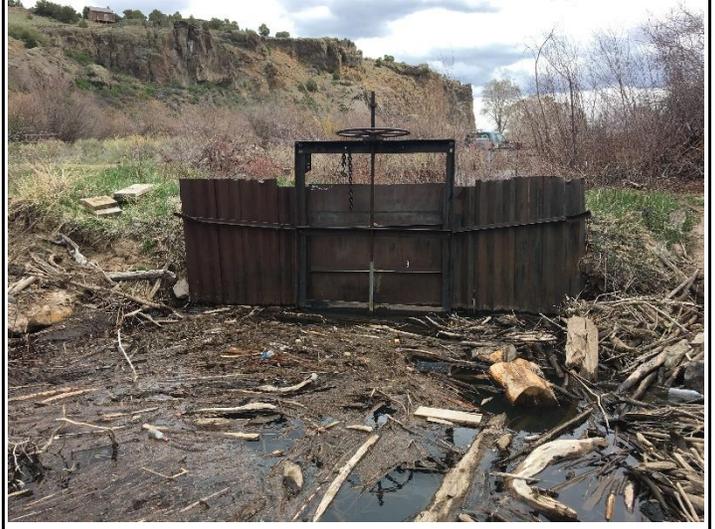
Old headgate upstream of new headgate

Repair(s) or Improvement(s) Currently Needed: Given the issues at this structure, the SMP Technical Advisory Team (TAT) recommends removing the old headgate and installing a trash rack in front of the new headgate as well as stabilizing the south bank. Additionally, if any future improvements are made to the diversion dam, the TAT recommends maintaining fish passage and also creating safe boat passage at the diversion.

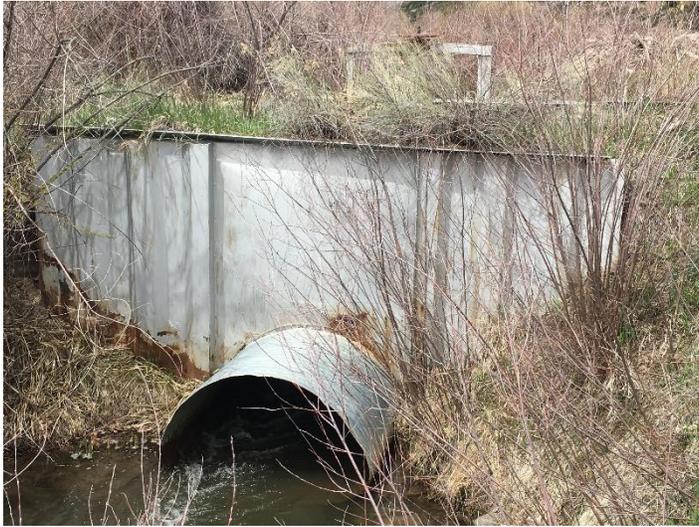
Headgate outlet

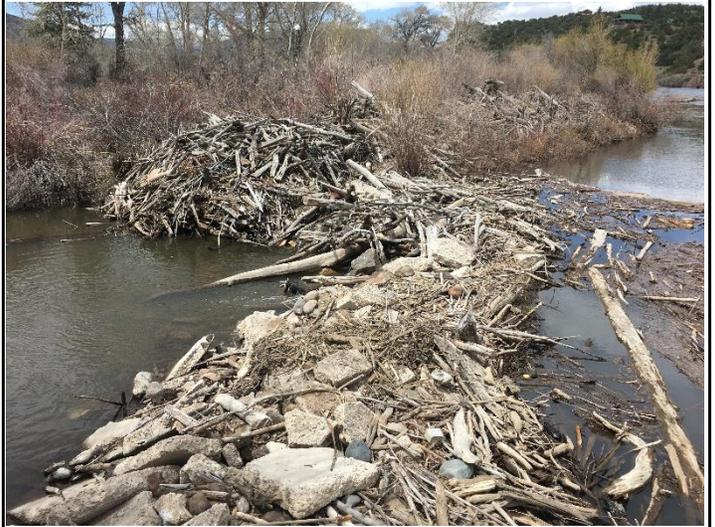
Diversion dam on feeder ditch

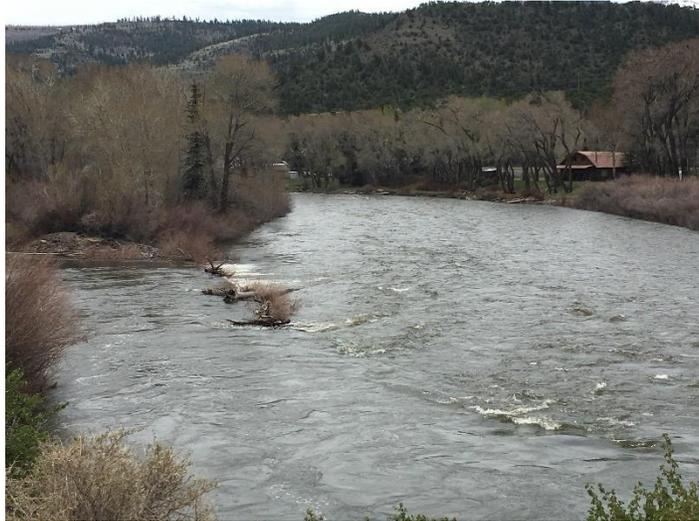
Diversion dam on Rio Grande

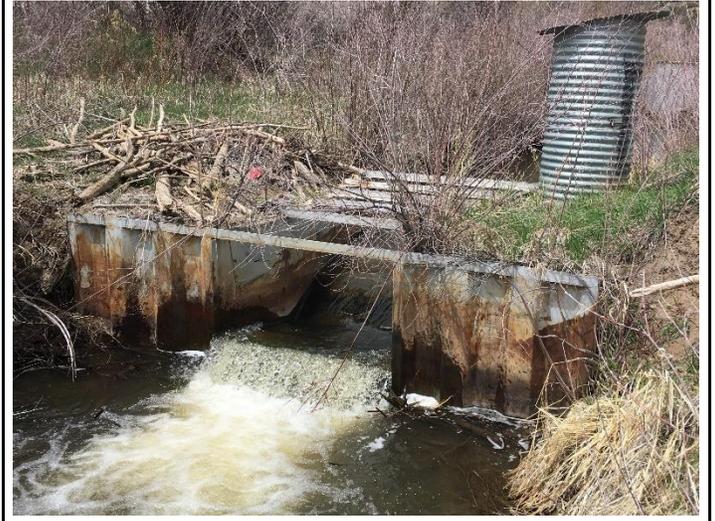
Flume looking upstream

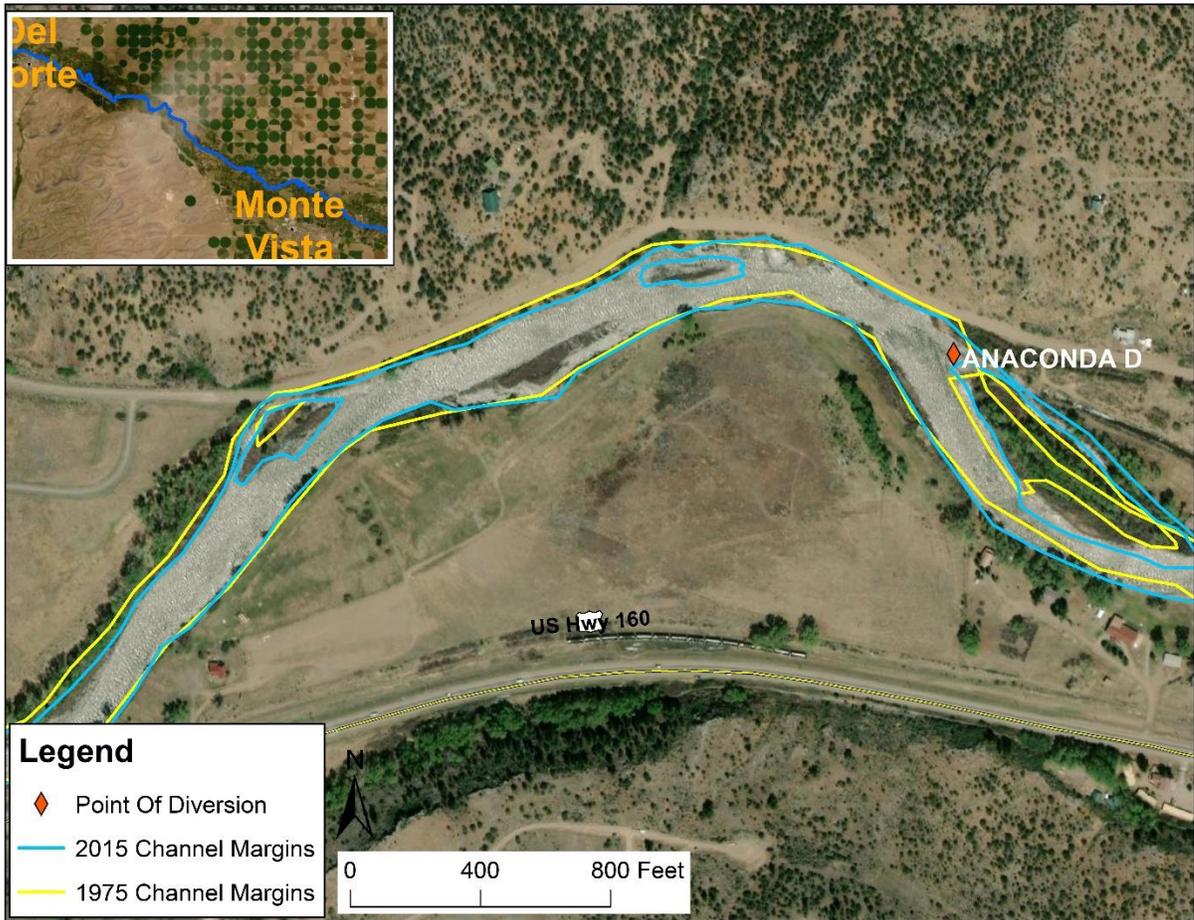
Headgate location with 1975 and 2015 channel margins overlaid

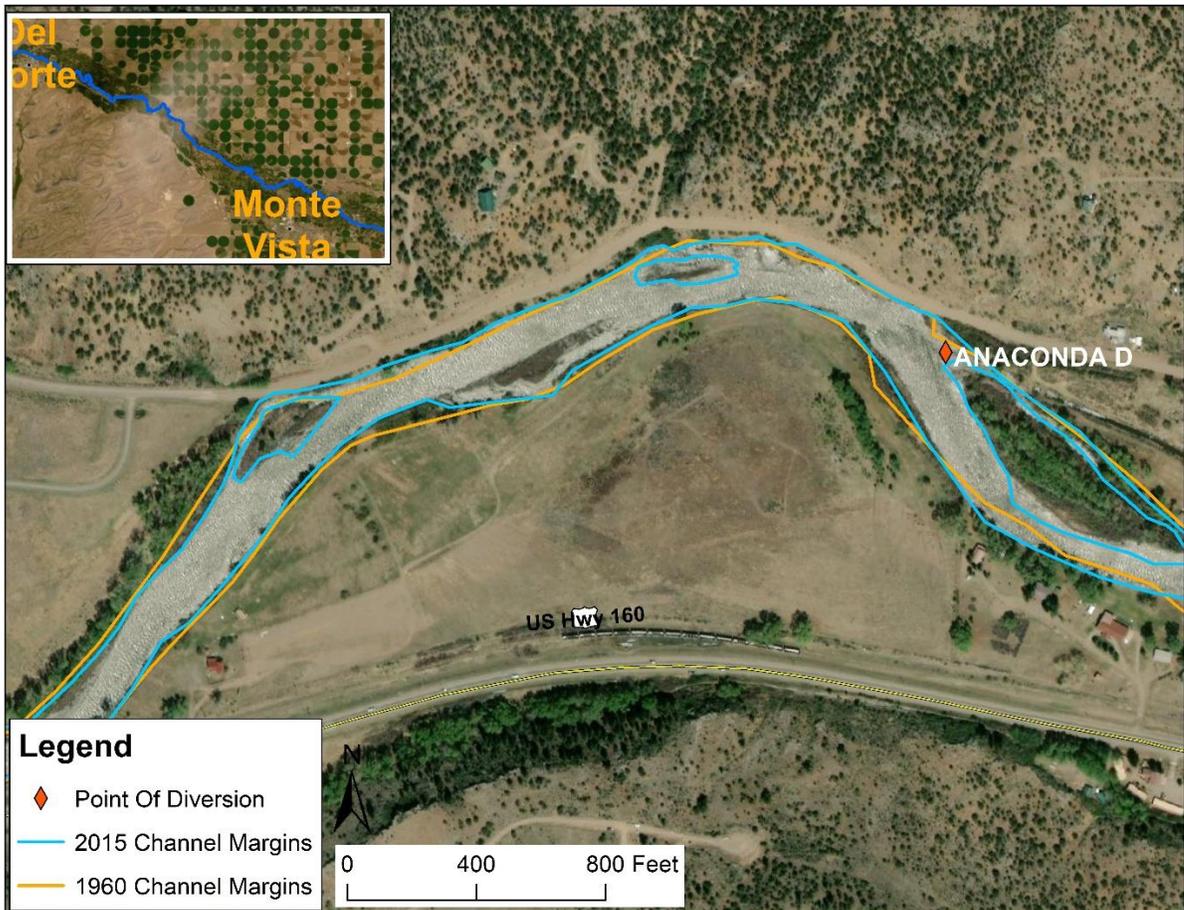
Headgate location with 1960 and 2015 channel margins overlaid

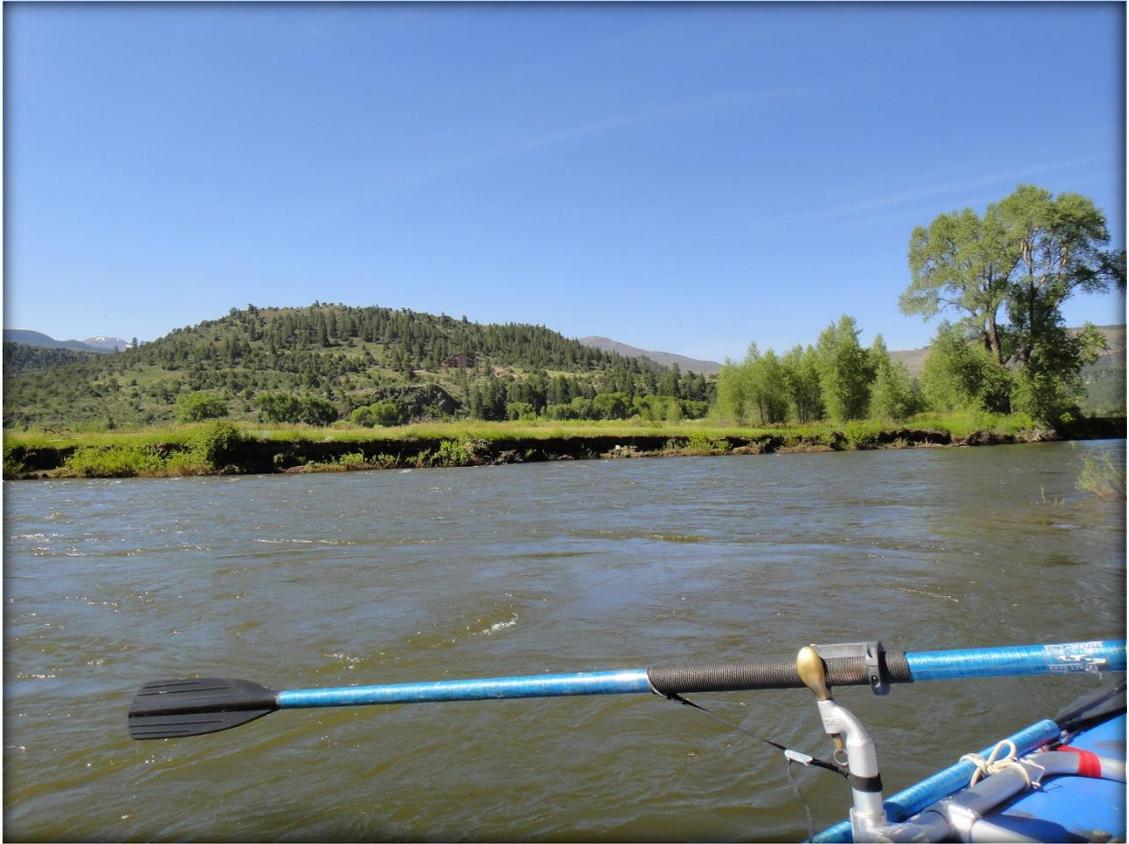
Bank erosion on south river bank upstream of Anaconda Ditch diversion
