# RIO GRANDE DIVERSION INFRASTRUCTURE INVENTORY

**Structure Name:** ANDERSON D

**Reported By:** Daniel Boyes

**Date:** April 1, 2019

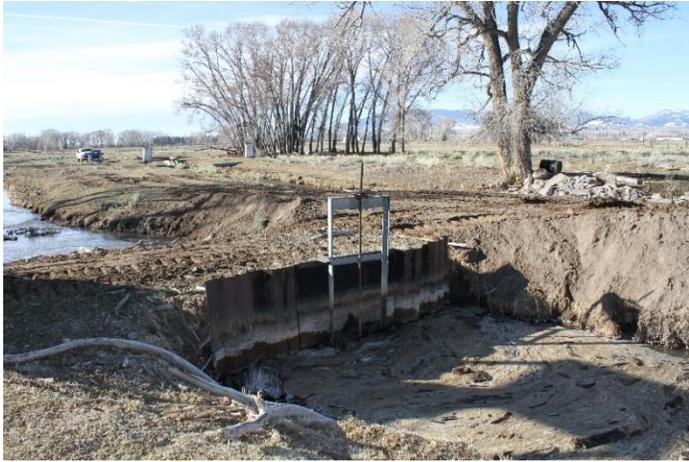
Headgate looking downstream

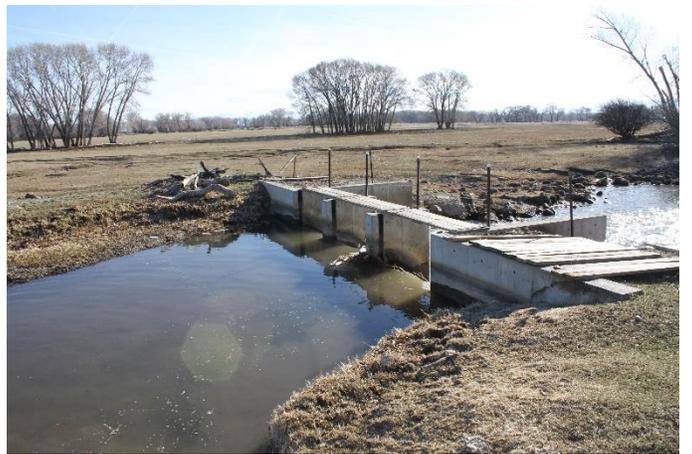
Feeder ditch diversion (Consolidated Slough Weir)

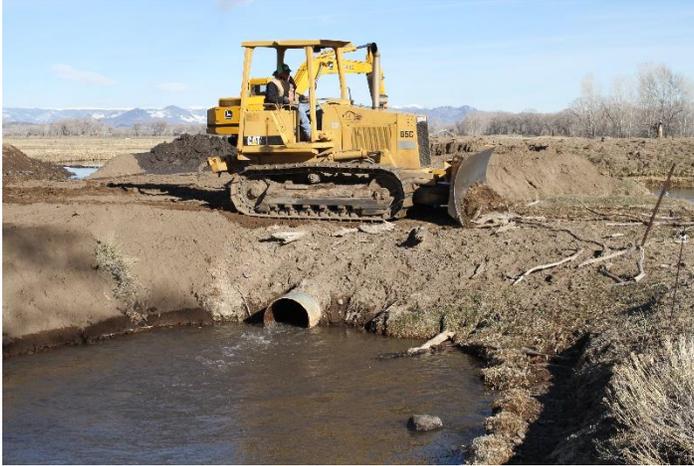
Headgate outlet

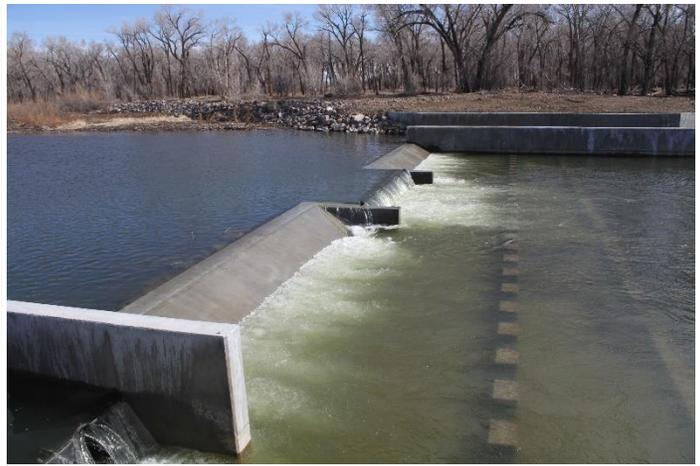
Diversion dam (Consolidated Slough)

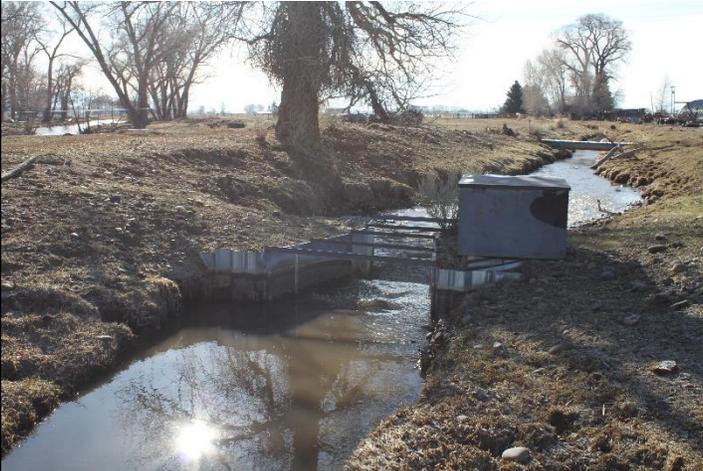
**Repair(s) or Improvement(s) Currently Needed:** Erosion is occurring downstream of the flume and the SMP Technical Advisory Team (TAT) recommends addressing this erosion to maintain measurement accuracy.

Flume looking downstream

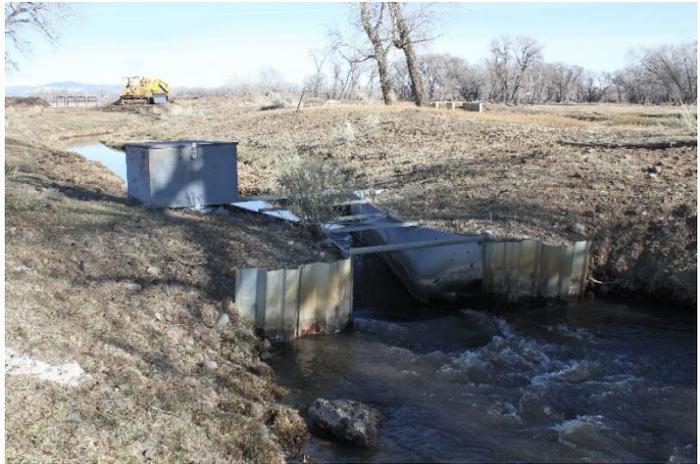
Flume looking upstream
