RIO GRANDE DIVERSION INFRASTRUCTURE INVENTORY

Structure Name: ANNA RABER D

Date: April 9, 2019

ANNA RABER DITCH

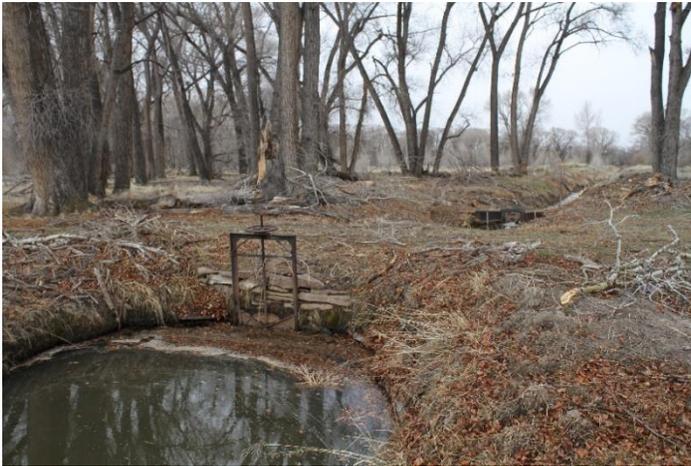
Structure Description: Channel migration analysis shows the river is stable in the area near this structure. A rock boulder diversion dam directs water to a short feeder channel, located on the south bank of the Rio Grande. The headgate is located on the inside of a bend. The diversion is just upstream of a river bridge. The feeder channel travels underneath the bridge to the headgate. The headgate leaks and is difficult to operate. The diversion dam collects some woody debris, but otherwise functions well.

Headgate looking downstream

Repair(s) or Improvement(s) Currently Needed: The SMP Technical Advisory Team (TAT) recommends headgate repair or replacement to increase efficiency and reduce maintenance. Debris mitigation, either through installation of a sluice gate or continued maintenance, is also recommended.

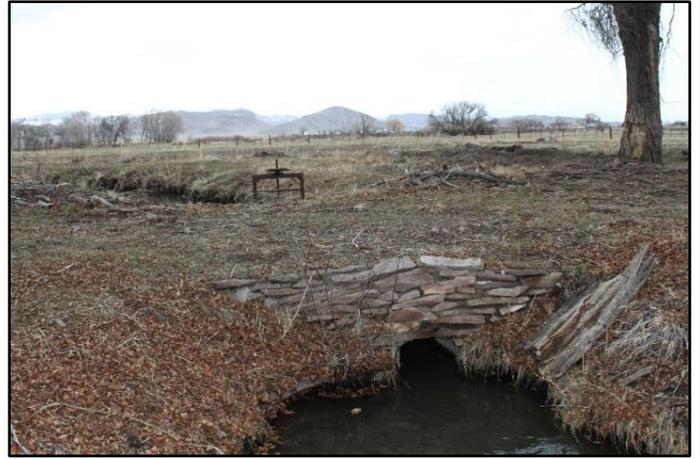
Headgate outlet

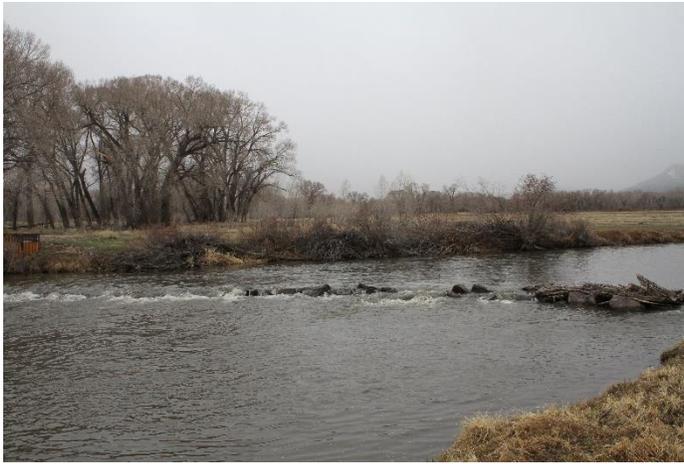
Diversion dam looking upstream

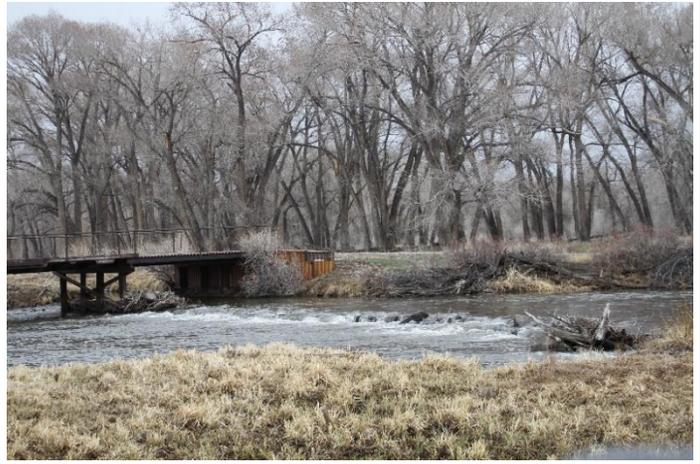
Diversion dam and feeder ditch

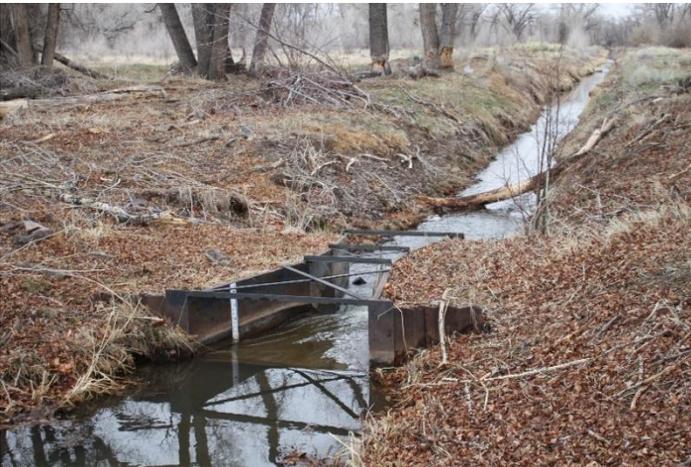
Flume looking downstream

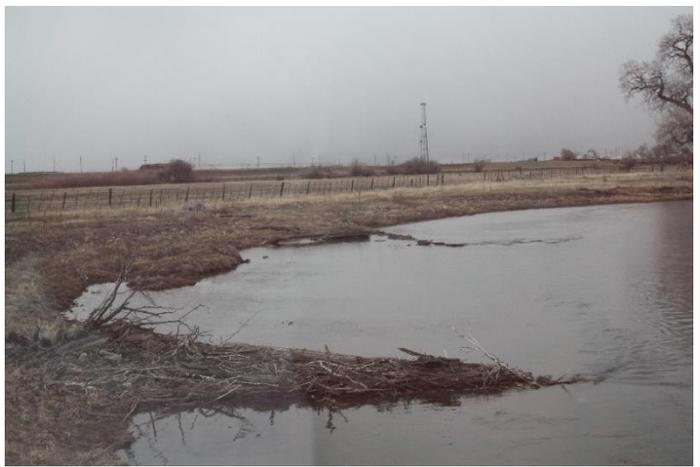
North branch Rio Grande looking downstream
