# RIO GRANDE DIVERSION INFRASTRUCTURE INVENTORY

**Structure Name:** ATENCIO D 2

**Date:** April 9, 2019

Rio Grande Stream  
Management Plan

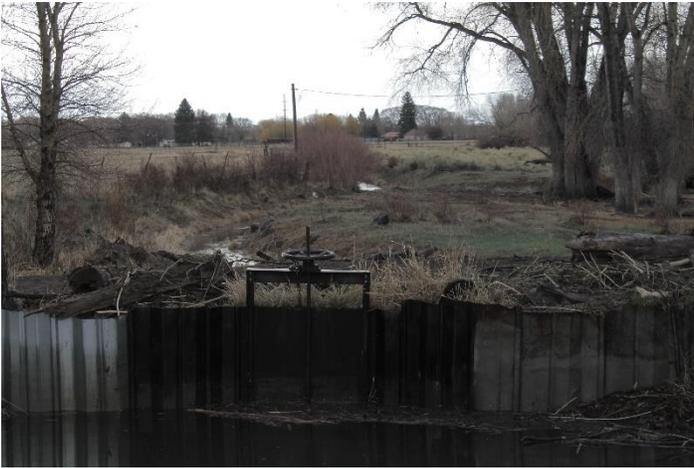
Headgate looking downstream

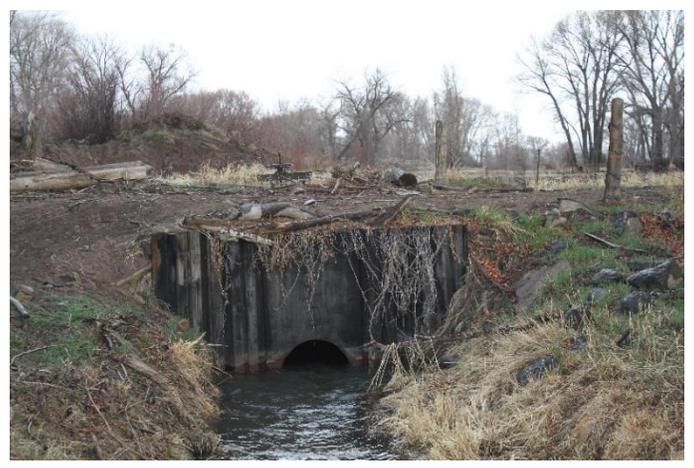
Headgate outlet

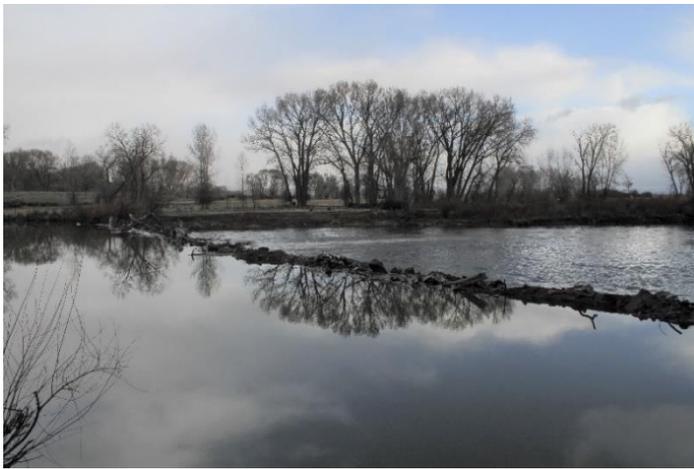
**Structure Description:** This ditch shares a diversion dam and short feeder channel with the Silva Ditch, which holds the #1 priority water right on the Rio Grande. The diversion dam is a stacked rock structure, which was recently supplemented with additional rock. Despite recent improvements, this diversion accumulates woody debris and sediment and is a significant maintenance challenge for water users. It is a hazard for recreational boaters and can also form a barrier to fish passage during low flow conditions. Water is directed to the headgate, located down a short feeder channel off the south bank of the Rio Grande. The headgate functions well. The flume was replaced in 2018 and also functions well. The channel both upstream and downstream of the diversion experiences lateral migration. Meanders have continued to grow over the last 40 years (see map in report card). However, migration at the diversion dam is limited due to bedrock control. A secondary channel begins approximately 0.9 miles upstream of the diversion and flows around the structure.

Diversion dam

**Repair(s) or Improvement(s) Currently Needed:** Given the issues identified, the SMP Technical Advisory Team (TAT) recommends replacing the diversion dam. A new diversion could be designed to increase diversion and irrigation efficiencies, reduce maintenance, create fish and boat passage, and improve sediment and debris transport.

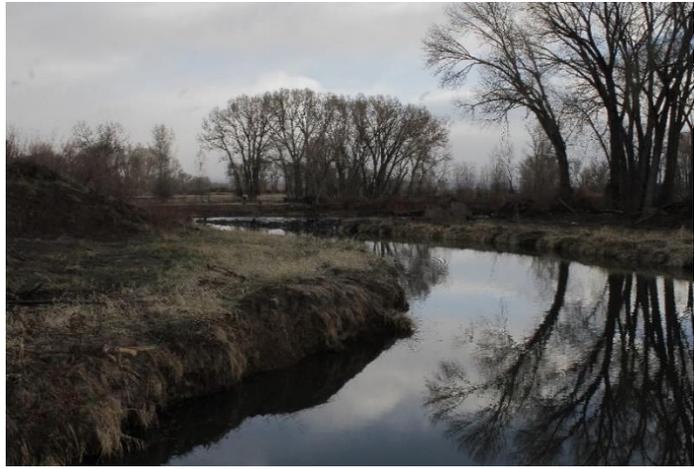
Feeder ditch (also serves Silva Ditch)

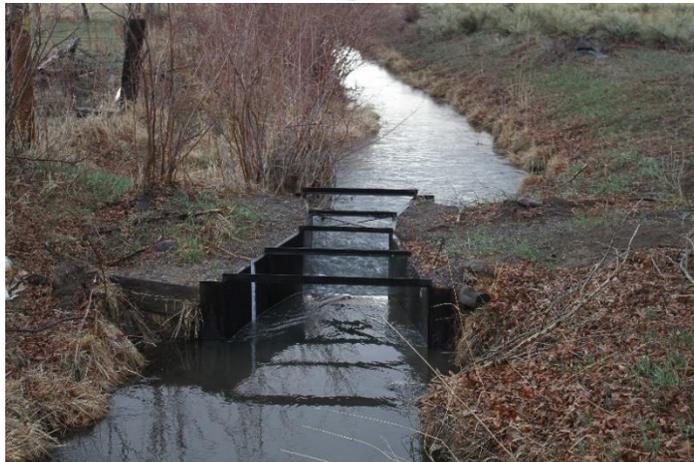
**Repair(s) or Improvement(s) Completed Since 2006:** The flume was replaced in 2018.

Flume looking downstream

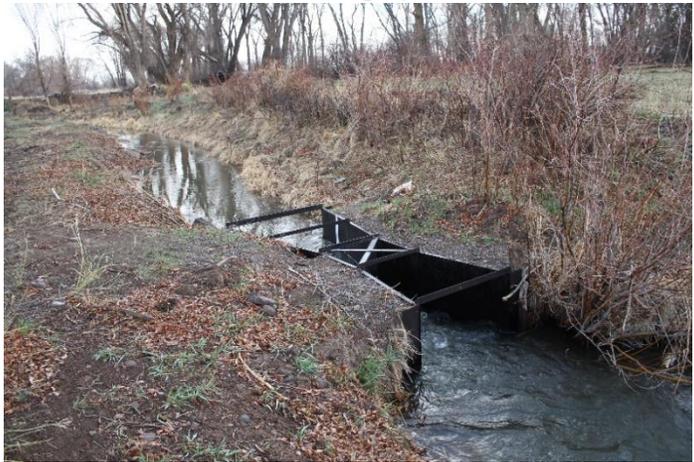
Flume looking upstream

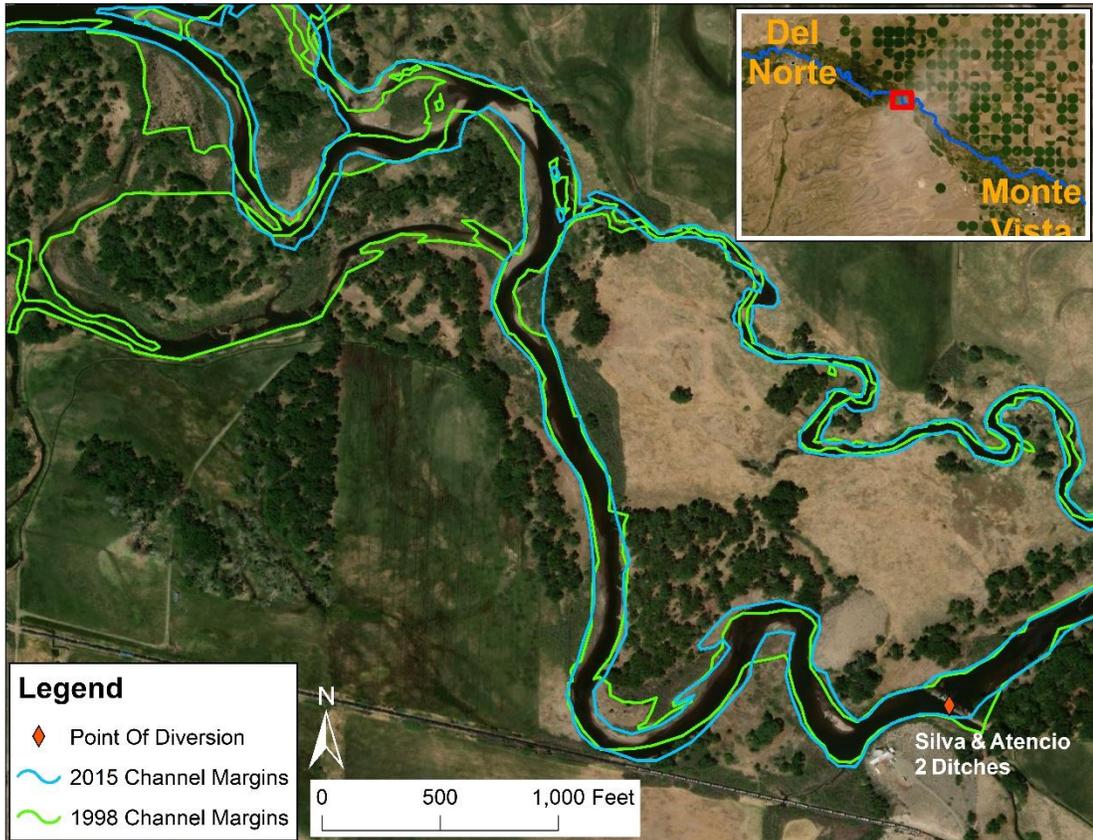
Atencio Ditch 2 point of diversion with 1998 and 2015 channel margins overlaid

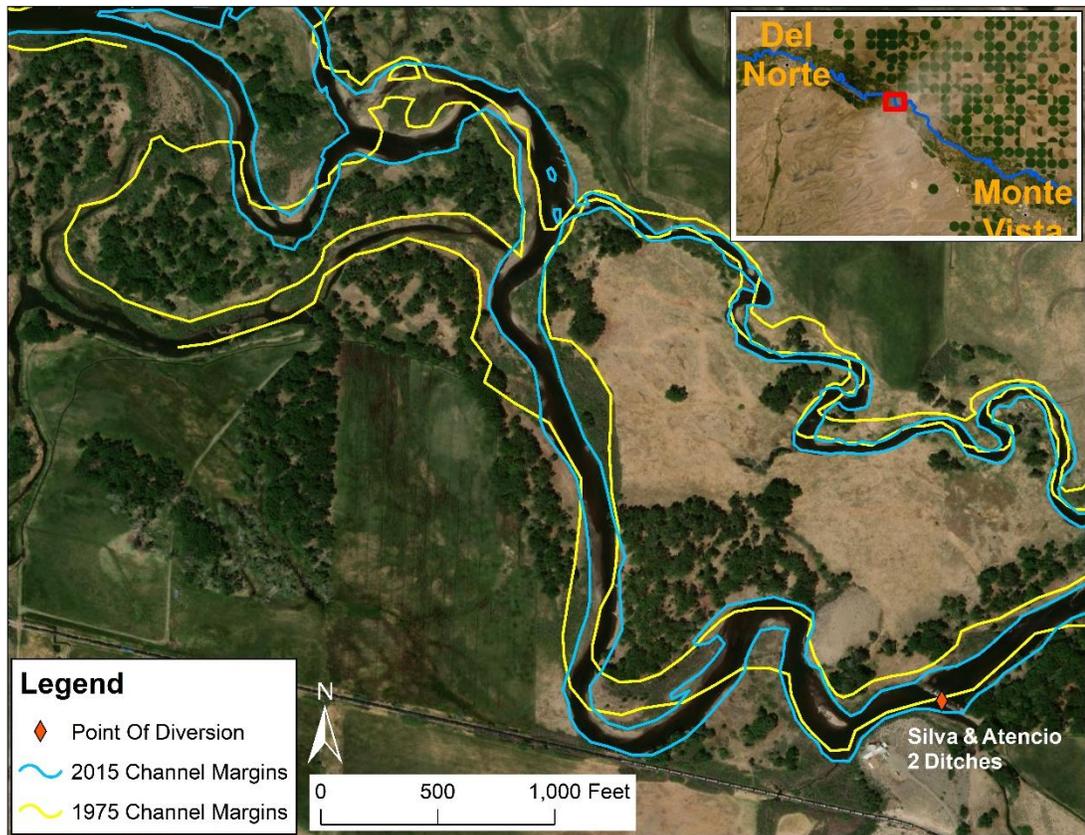
Atencio Ditch 2 point of diversion with 1975 and 2015 channel margins overlaid

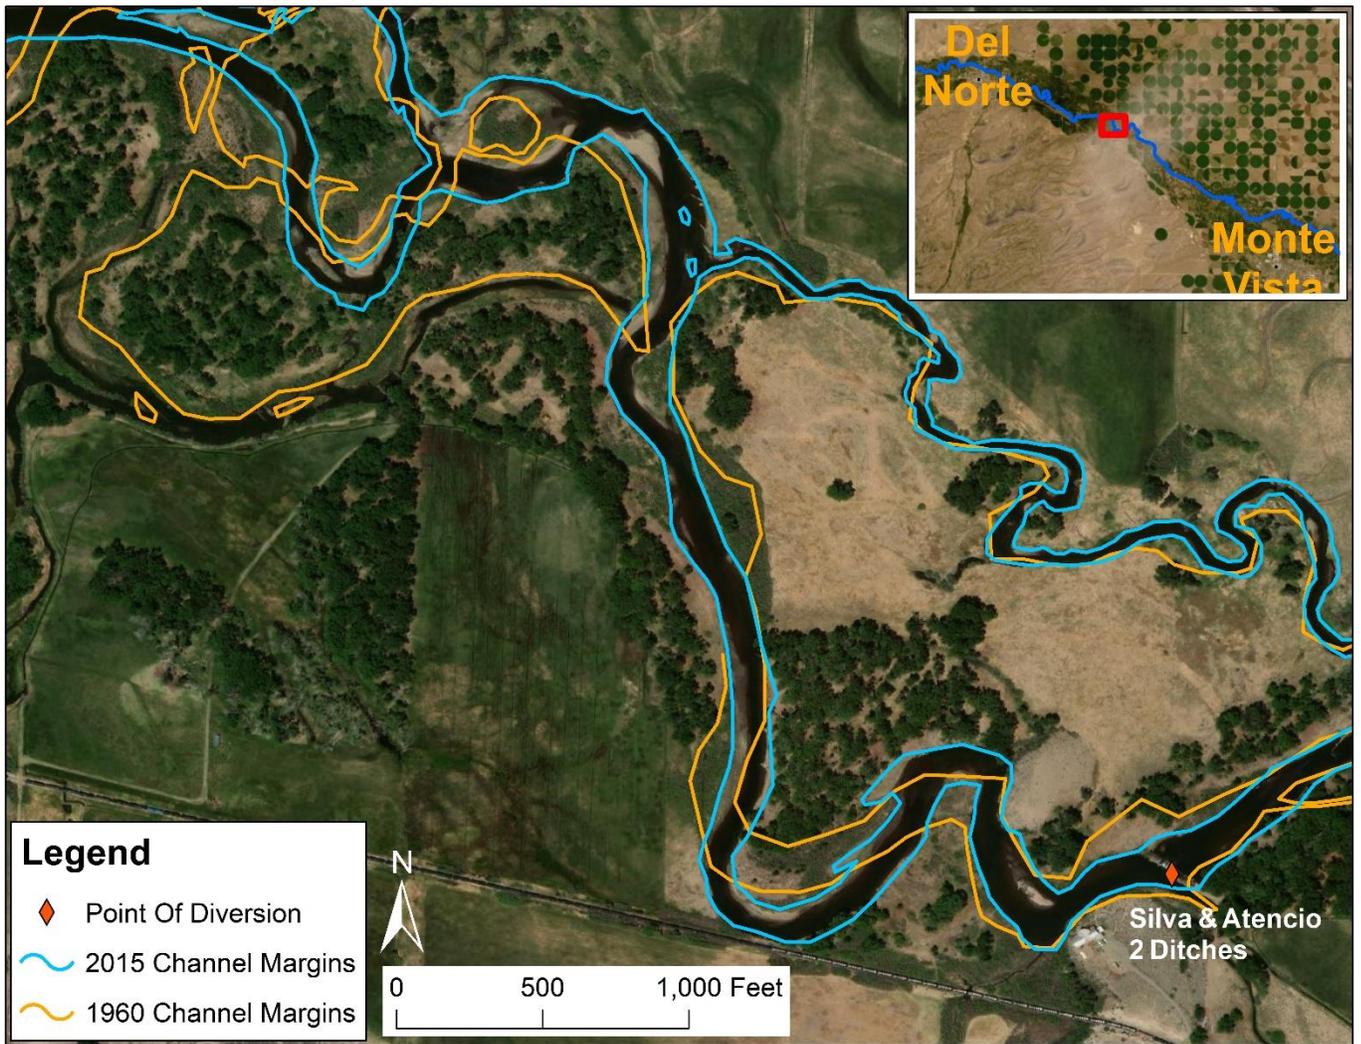
Atencio Ditch 2 point of diversion with 1960 and 2015 channel margins overlaid.
