# RIO GRANDE DIVERSION INFRASTRUCTURE INVENTORY

**Structure Name:** ATENCIO D

**Reported By:** Daniel Boyes

**Date:** April 1, 2019

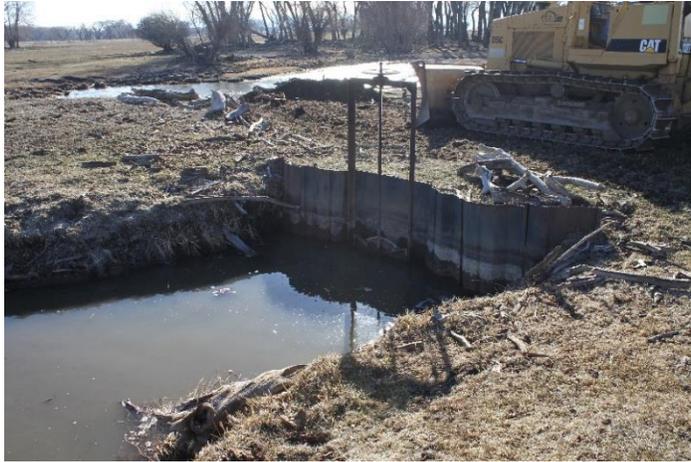
Headgate looking downstream

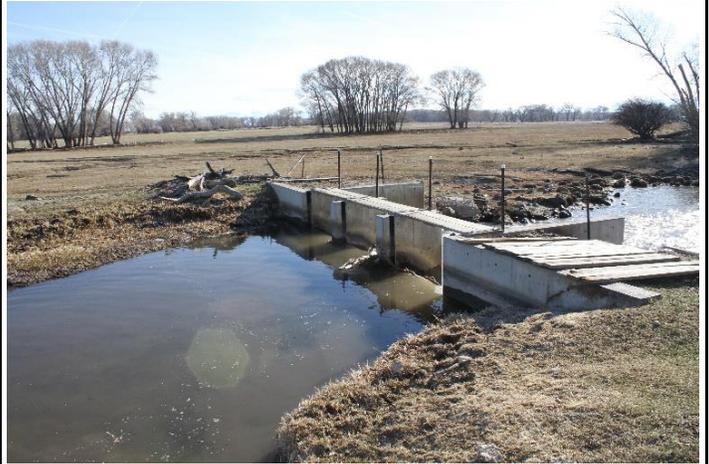
Feeder ditch diversion (CONSOLIDATED SLOUGH WEIR)

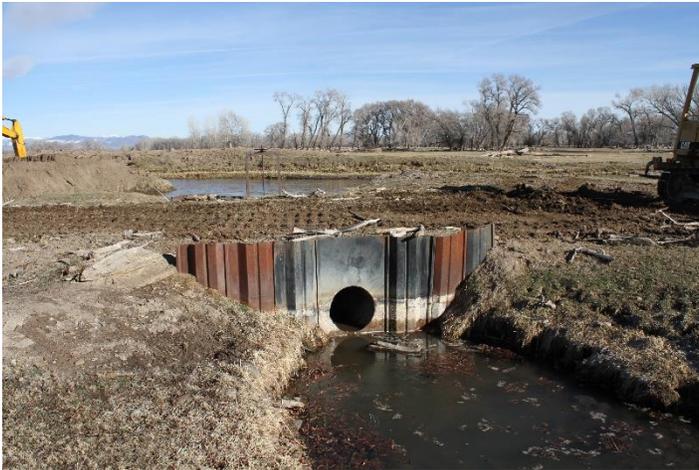
Headgate outlet

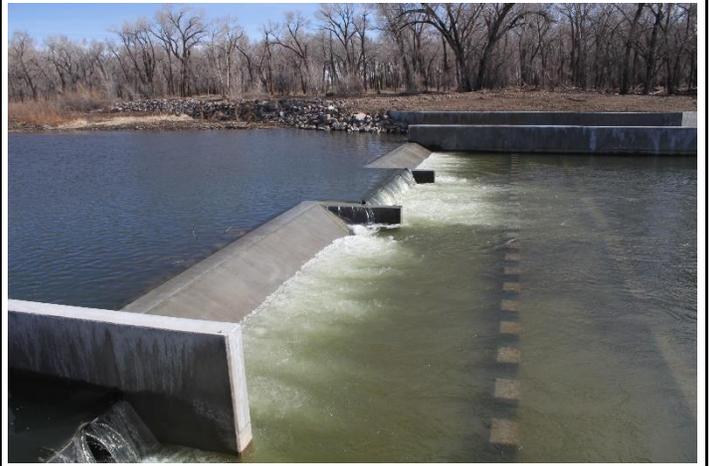
Diversion dam (CONSOLODATED SLOUGH)

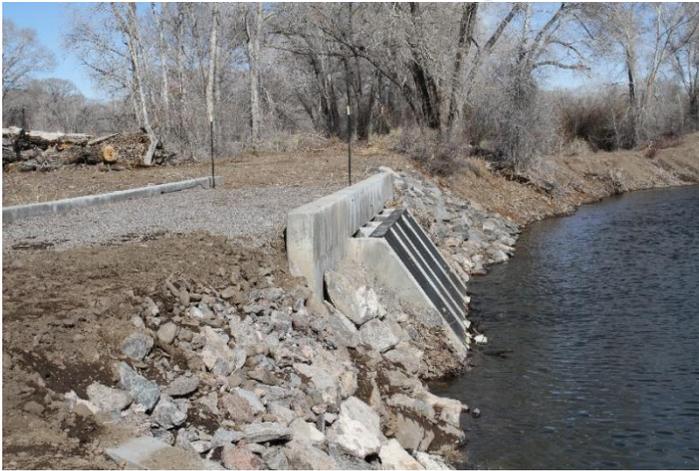
Trash rack at river headgate

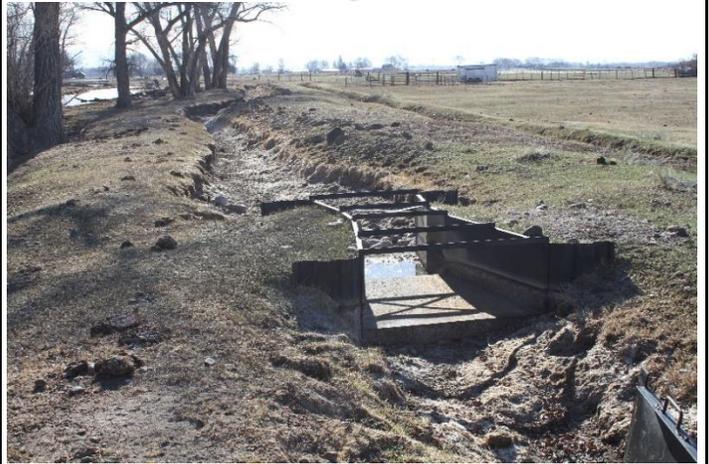
**Structure Description:** Water is diverted off the Rio Grande via the Consolidated Ditch diversion located on the south bank of the river. The Consolidated Ditch headgate delivers water to the feeder channel, which transports water approximately 3.12 miles to the Atencio Ditch headgate. The headgate is adjacent to the Anderson Ditch, Rio Grande Lariat Ditch, and Rio Grande San Luis Ditch. The Consolidated Slough Weir diverts water to a short feeder channel and to the Atencio Ditch. The flume gets submerged at high flows.

Flume looking downstream

**Repair(s) or Improvement(s) Currently Needed:** The SMP Technical Advisory Team (TAT) recommends resetting or replacing the flume, which would increase water delivery efficiency and reduce maintenance.
