RIO GRANDE DIVERSION INFRASTRUCTURE INVENTORY

Structure Name: ATKINS D

Date: May 7, 2019

ATKINS DITCH

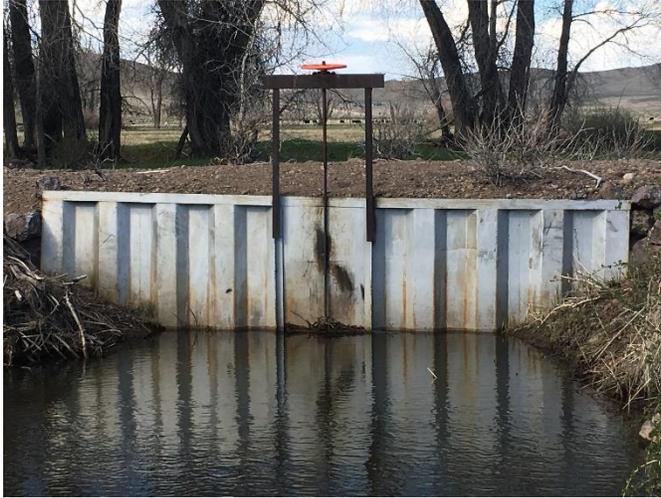
Headgate Type: Manually operated 2' wide steel slide gate

Headgate Condition:	A <input checked="" type="checkbox"/>	Diversion and Other Condition:	A <input type="checkbox"/>	River Miles from New Mexico State Line (Point of Diversion):	Structure Submerged: Yes <input checked="" type="checkbox"/>
	B <input type="checkbox"/>		B <input checked="" type="checkbox"/>		No <input type="checkbox"/>
	C <input type="checkbox"/>		C <input type="checkbox"/>	106.81 mi	
	D <input type="checkbox"/>		D <input type="checkbox"/>		
	F <input type="checkbox"/>		F <input type="checkbox"/>

Headgate looking downstream

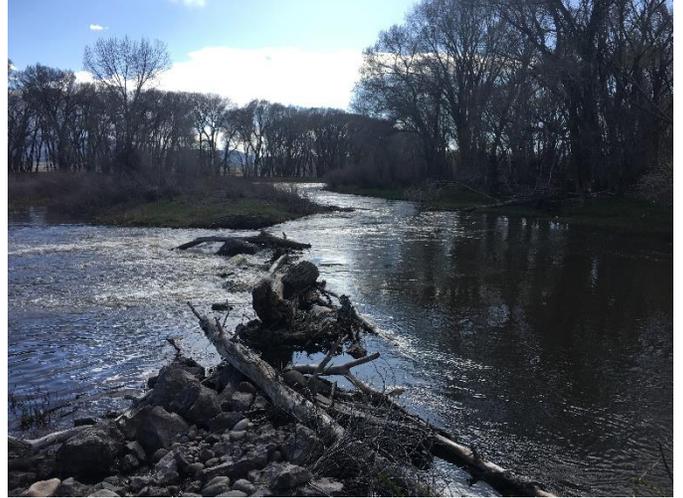
Structure Description: The diversion directs water from the Rio Grande to a short feeder channel located on the north bank of the river. The feeder channel, a small rock diversion dam, directs flow to the headgate. The headgate was replaced about six years ago and functions well. The feeder channel returns to the river just downstream of the headgate. As the channel has migrated away from the point of diversion, a gravel bar has been forming at the mouth of the feeder channel and gravel material continually needs to be removed for the structure to access its full decree. See photo in report card labeled, "diversion dam and feeder channel on Rio Grande." The south bank has also experience erosion as a result of channel migration. The channel migration away from the point of diversion may cause the diversion dam to function less effectively and/or require repairs in the future.

Diversion dam on feeder ditch

Repair(s) or Improvement(s) Currently Needed: Given these current and potential future challenges, the SMP Technical Advisory Team (TAT) recommends bank stabilization on the south bank and possible diversion dam improvements or diversion relocation if channel migration accelerates. Bank stabilization would mitigate lateral channel migration and if migration accelerates, a modified diversion dam and/or relocating the diversion upstream may be necessary for this structure to function properly.

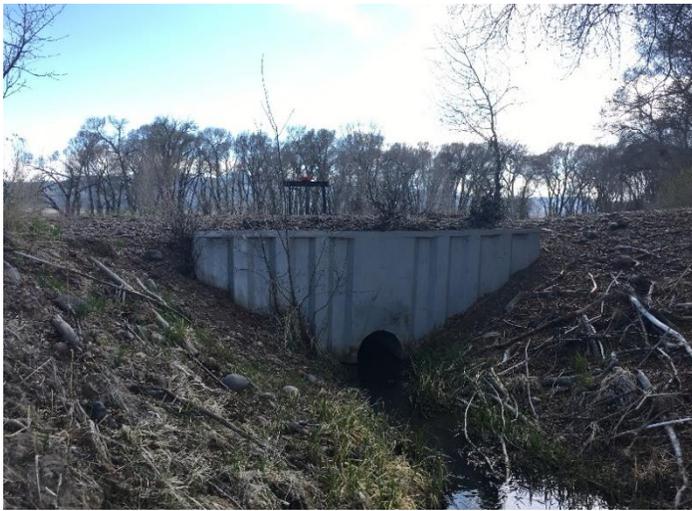
Headgate outlet

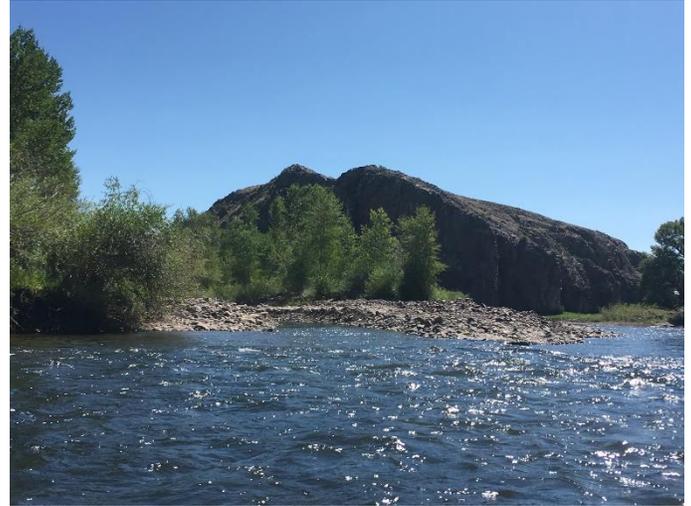
Repair(s) or Improvement(s) Completed Since 2006: This structure's diversion was improved in 2009 and is now a stacked rock structure with boulders anchored on the south bank of the river, similar to a J-Hook.

Diversion dam and feeder ditch on Rio Grande

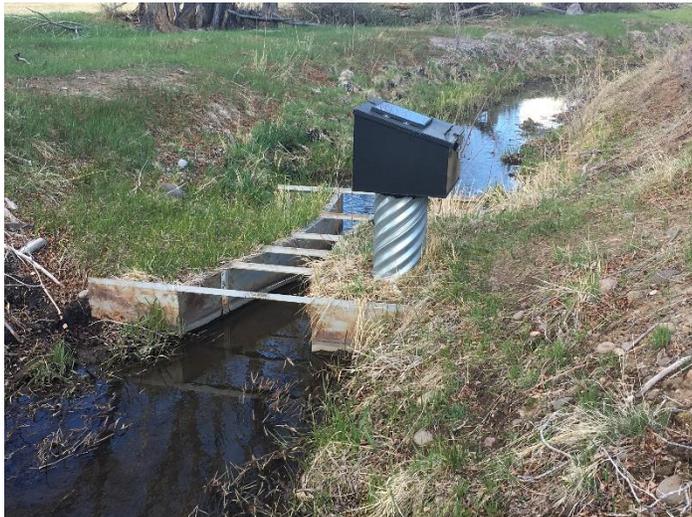
Flume looking downstream

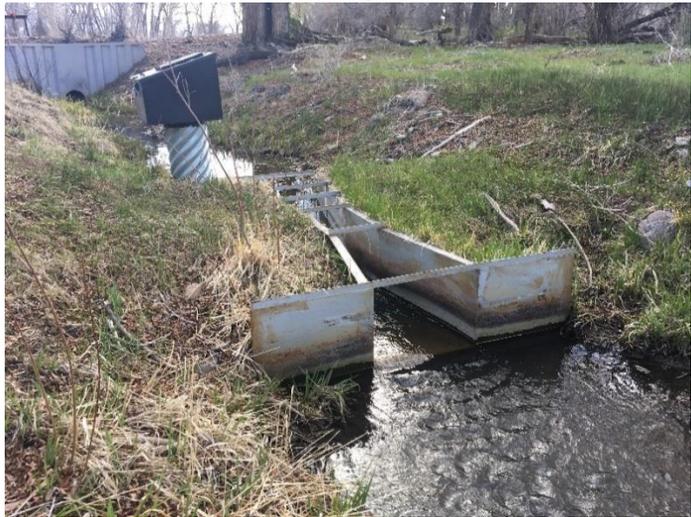
Flume looking upstream

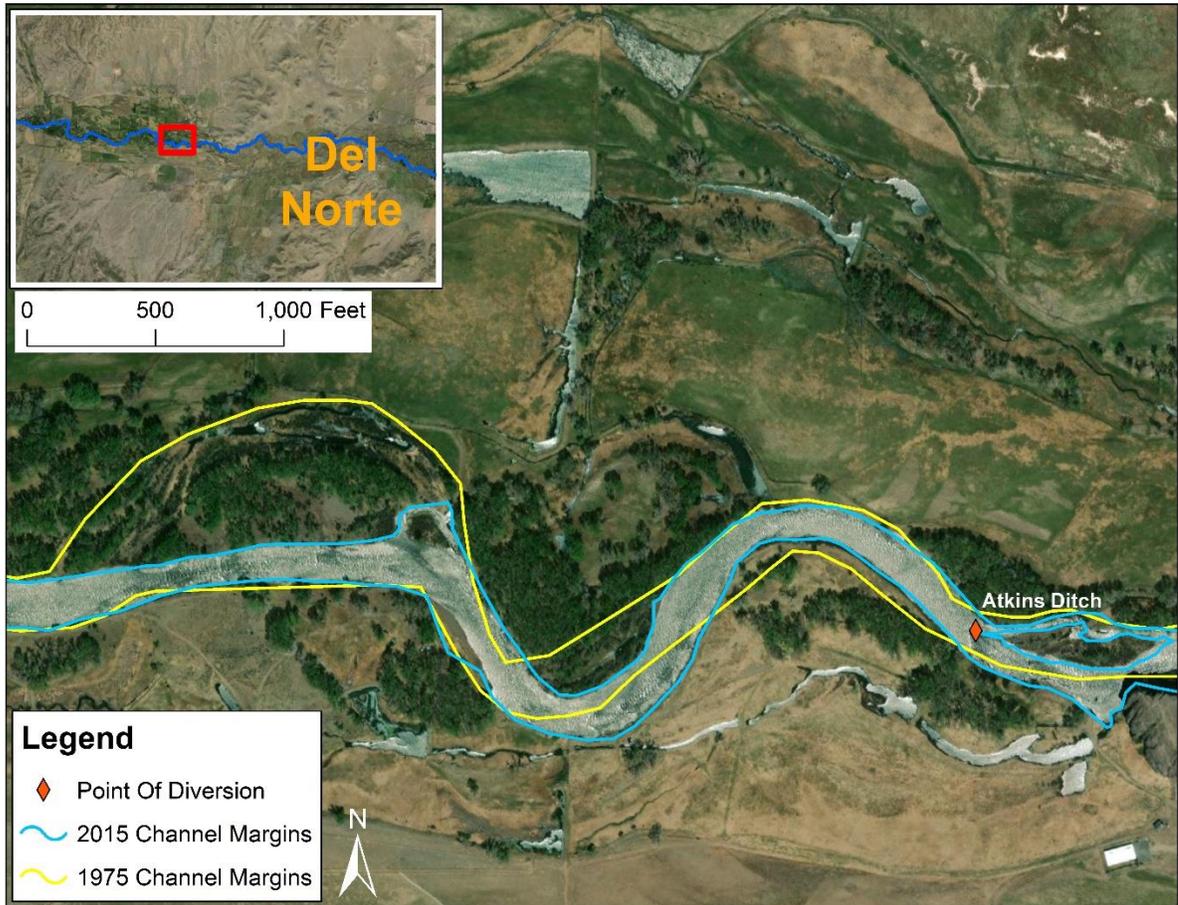
Map showing 1975 and 2015 channel margins.

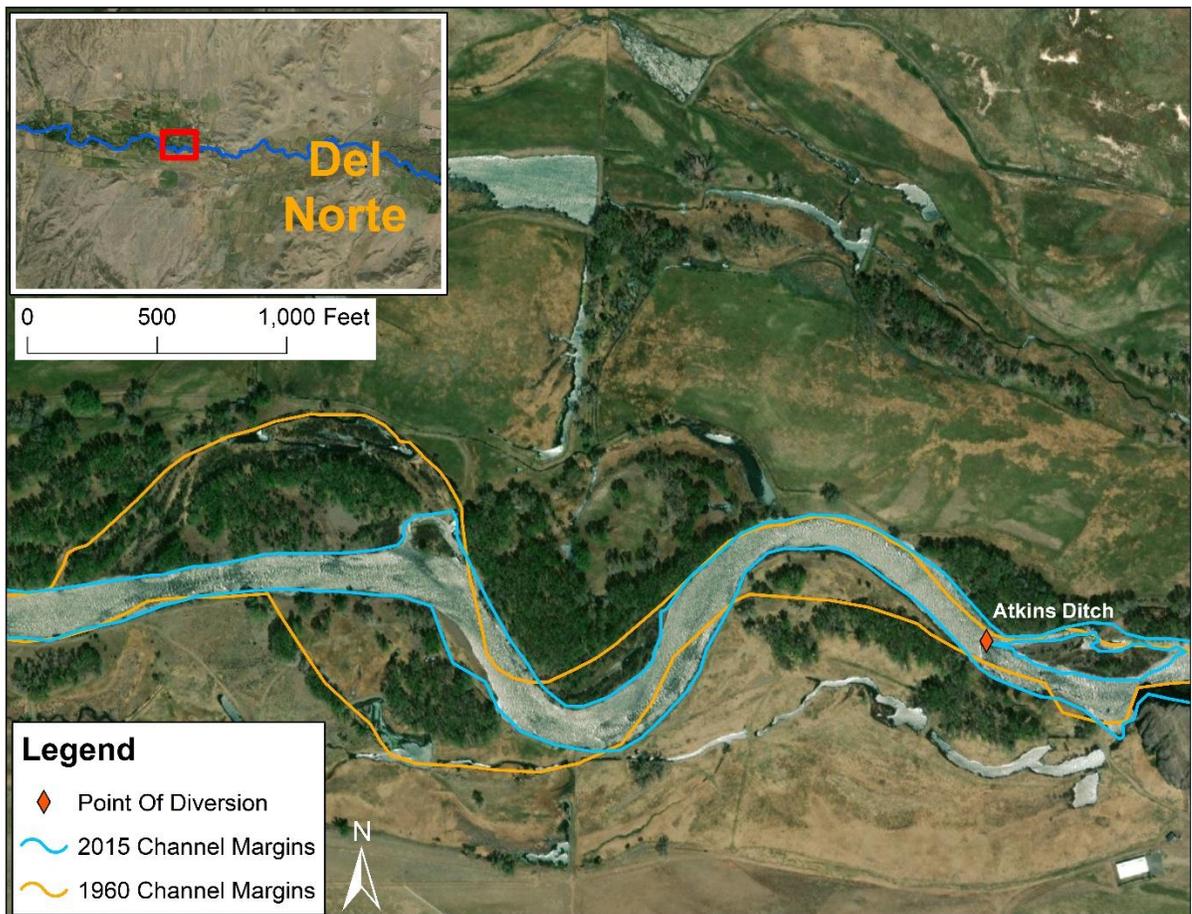
Map showing 1960 and 2015 channel margins.

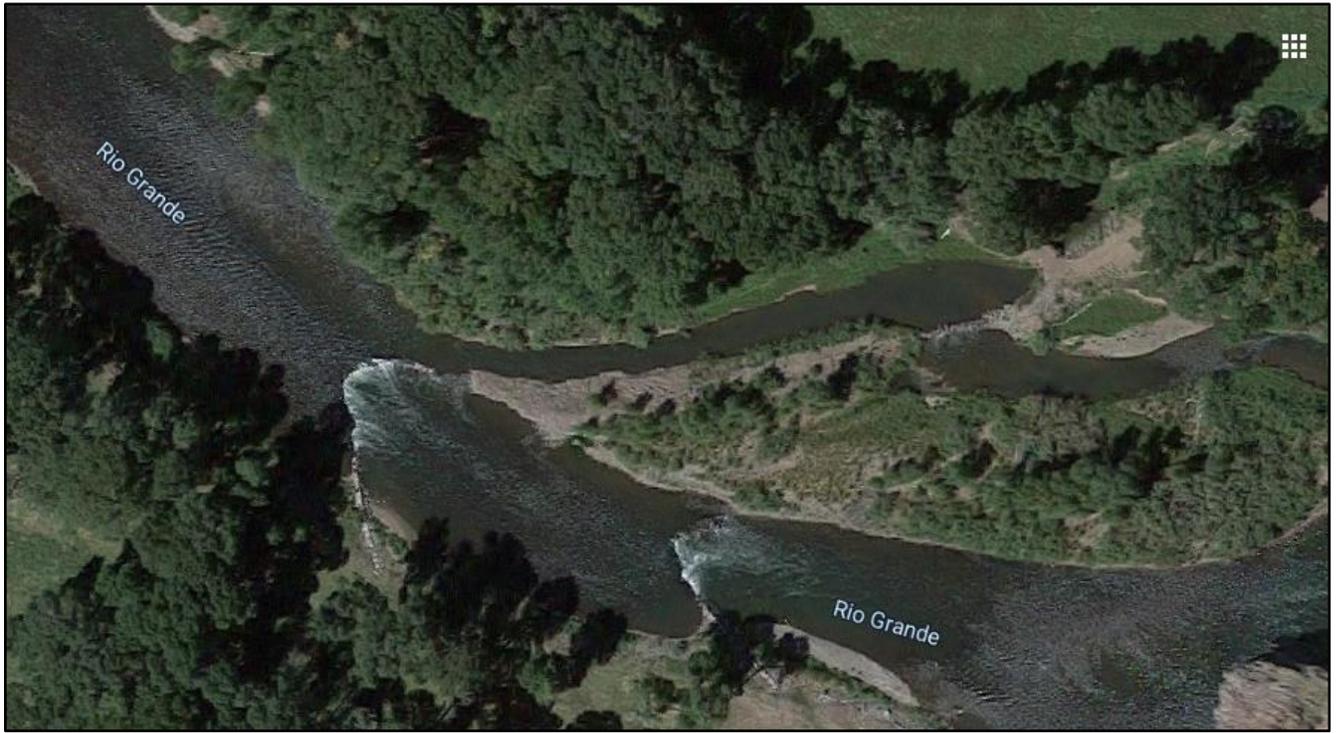
Aerial imagery from 2018 showing diversion dam and downstream bank stabilization structure.

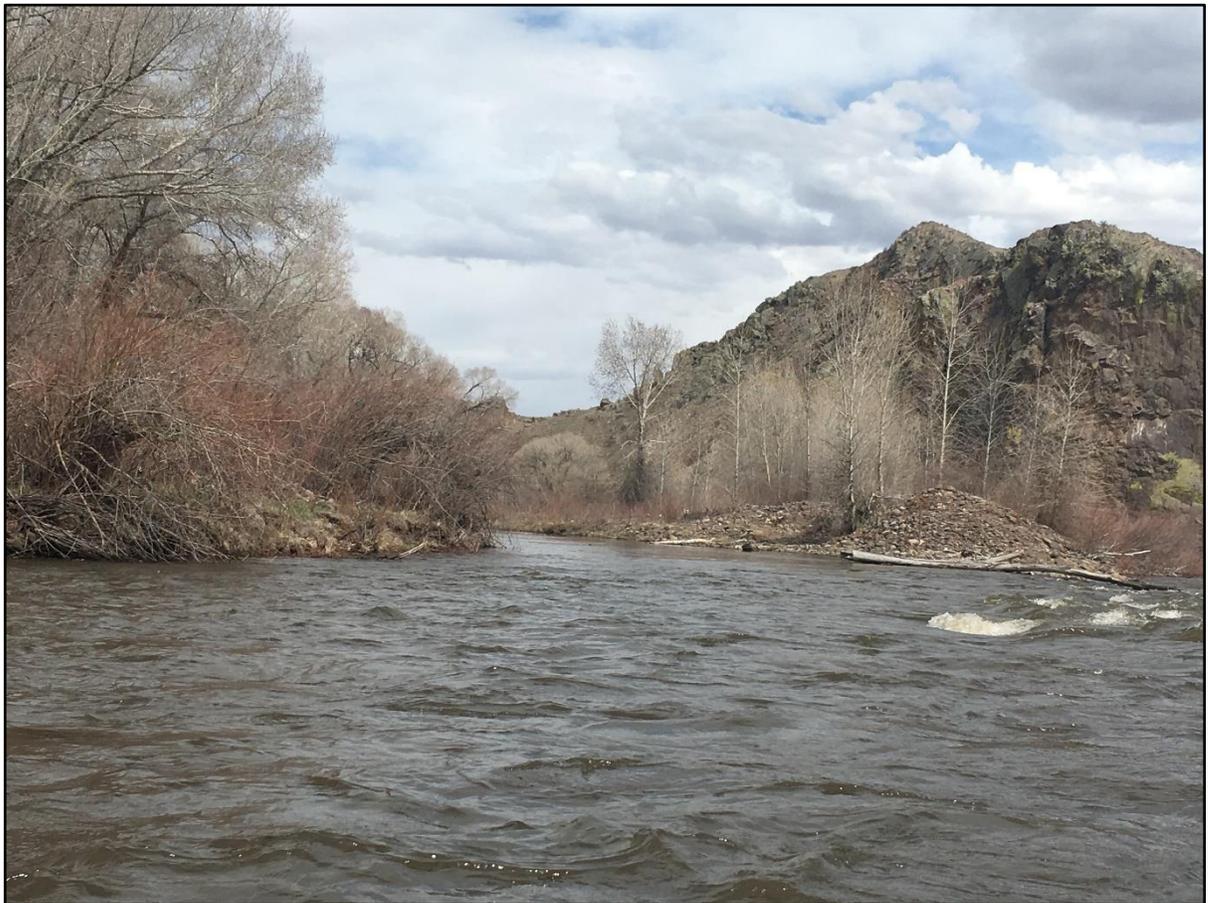
Diversion dam and feeder channel entrance during high flow in spring 2019
