# RIO GRANDE DIVERSION INFRASTRUCTURE INVENTORY

**Structure Name:** BAUER D

**Date:** May 7, 2019

**PHOTO LOG**

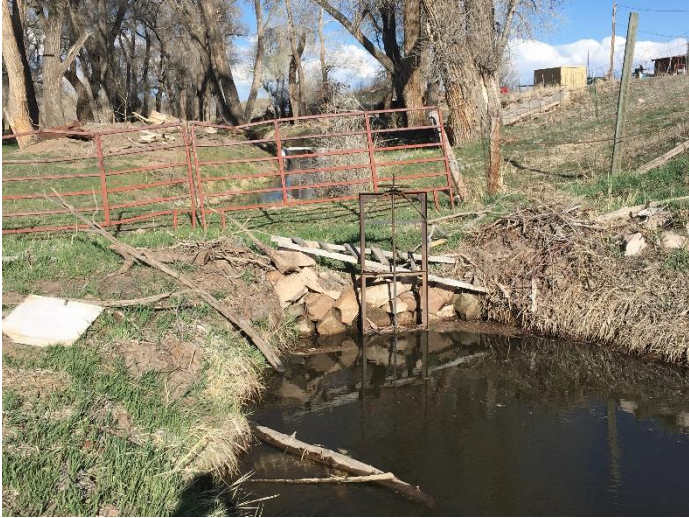
**Repair(s) or Improvement(s) Completed Since 2006:** The headgate is relatively new (installed in the end of 2017), and functions well.

Headgate looking downstream

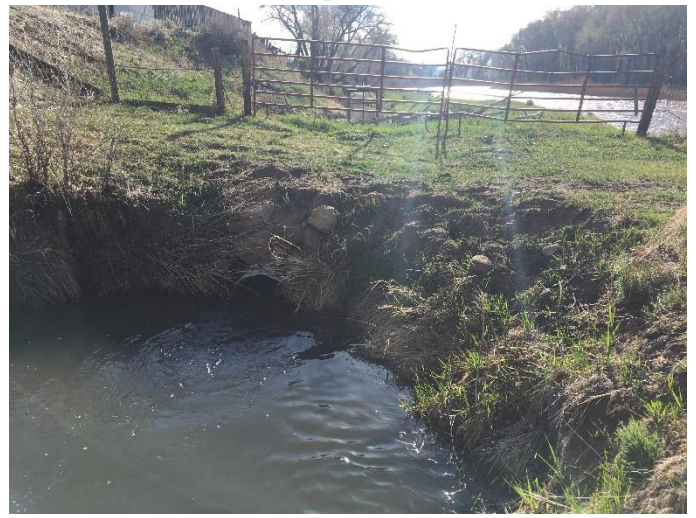
Headgate outlet

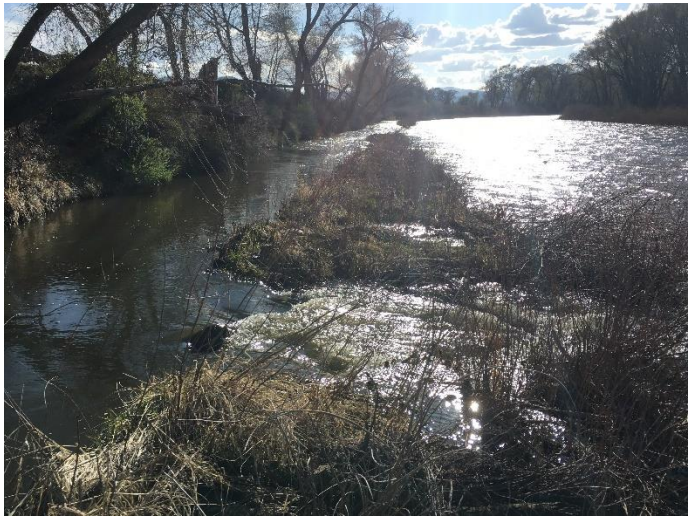
**Structure Description:** There is no diversion dam, but this ditch functions on grade with the river. Occasionally, this ditch has difficulty diverting its full decree due to the lack of a diversion dam. The point of diversion is located on the outside bend of the river, just downstream of the apex. The river channel has migrated very little in the last 45 years, although localized bank erosion has occurred. Bank stabilization structures were installed upstream and downstream of this structure in 2009 to mitigate bank erosion. Flows are directed into a feeder channel located on the south bank. The feeder channel is approximately 1,200 ft long and delivers water to the headgate. A 2 ft culvert (see report card) returns overflow water to the Rio Grande. The feeder channel and a significant portion below the headgate are within the floodplain. This is problematic due to constant erosion by the river as well as sediment deposition in the feeder channel.

Diversion dam and feeder ditch

**Repair(s) or Improvement(s) Currently Needed:** The Technical Advisory Team (TAT) recommends raising the elevation of the feeder channel and/or installing a sluice gate to mitigate sediment accumulation. Additionally, a small diversion dam would enable the ditch to operate at all flow levels.

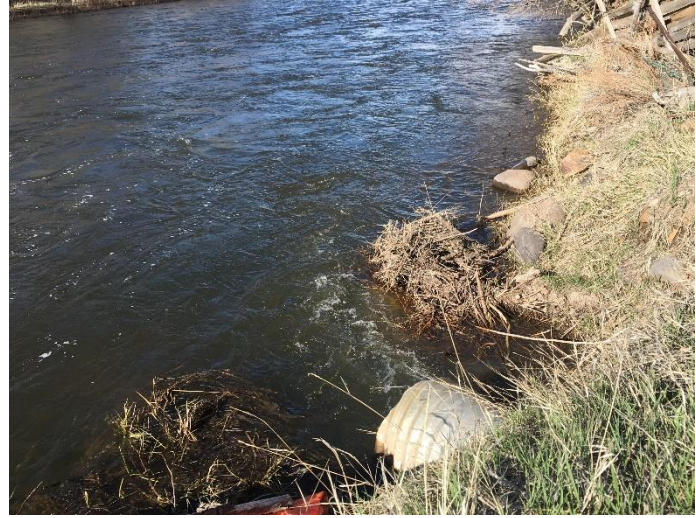
Diversion dam

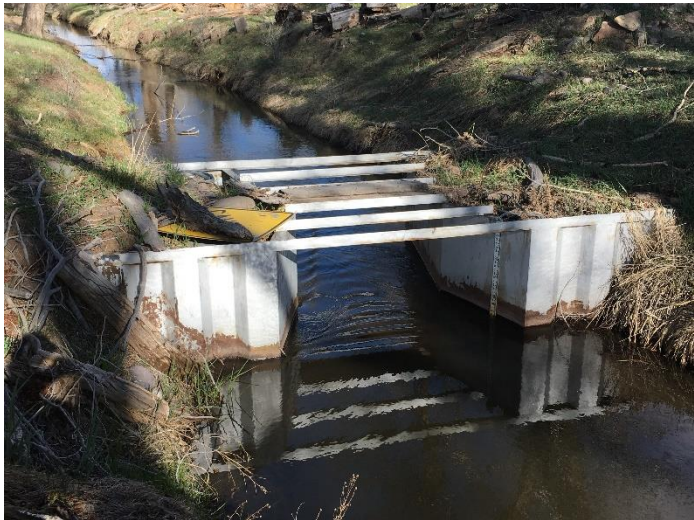
Flume looking downstream

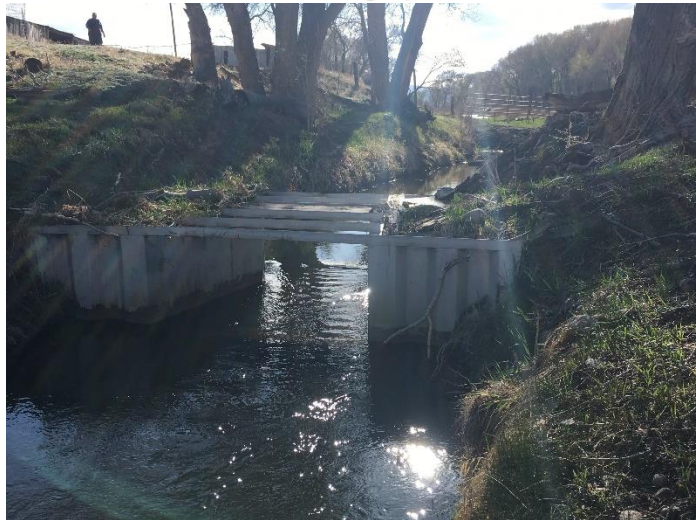
Flume looking upstream

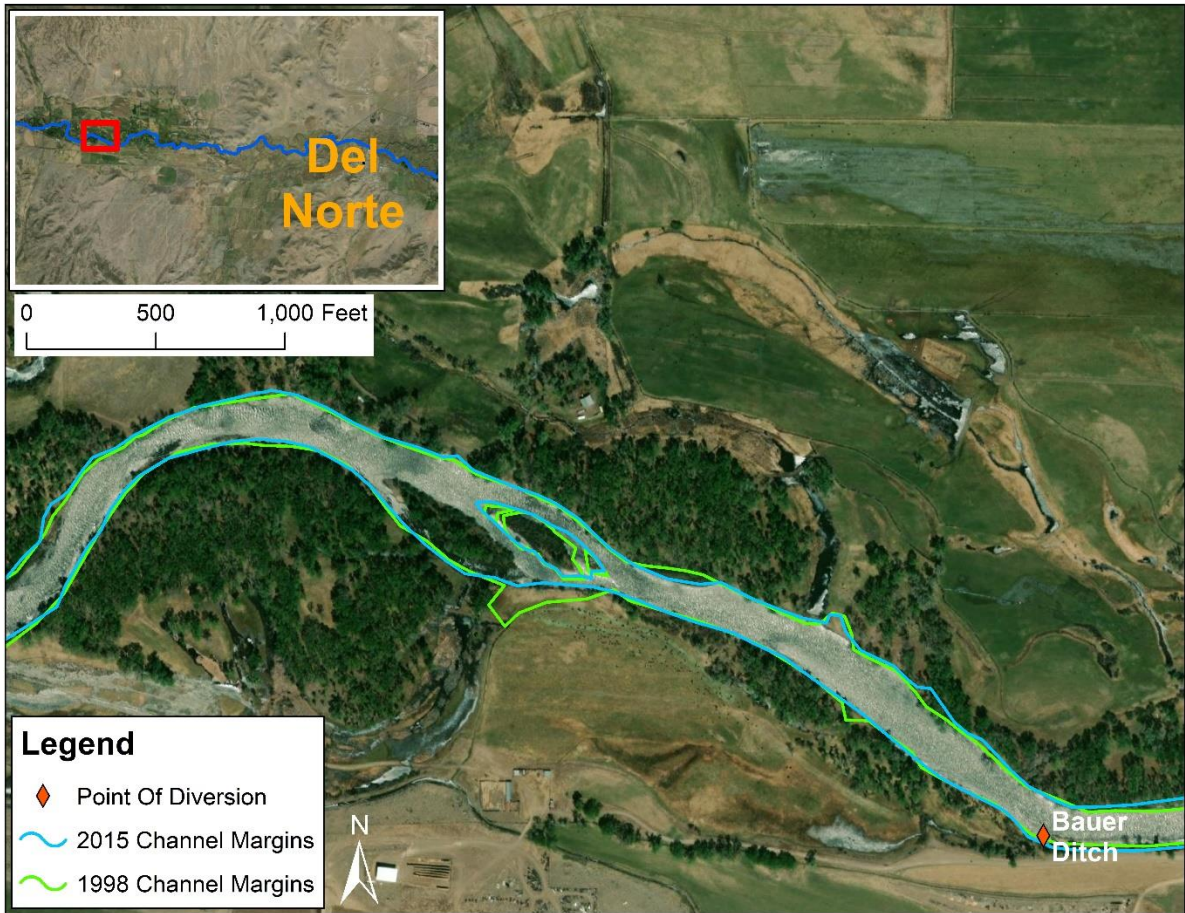
Map of Bauer headgate location with 1998 and 2015 channel margins overlaid.

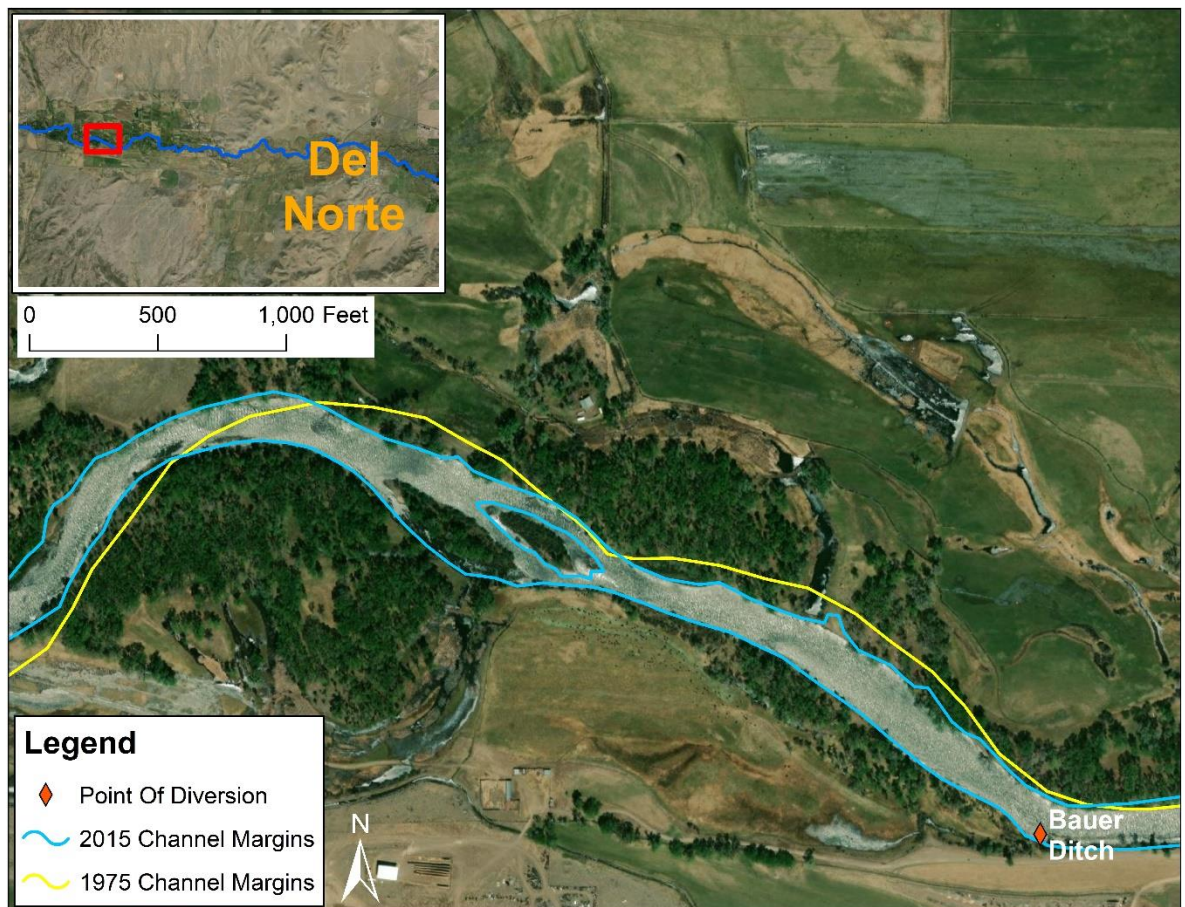
Map of Bauer Ditch headgate location with 1975 and 2015 channel margins overlaid.
