# RIO GRANDE DIVERSION INFRASTRUCTURE INVENTORY

**Structure Name:** BILLINGS D

BILLINGS DITCH

PHOTO LOG

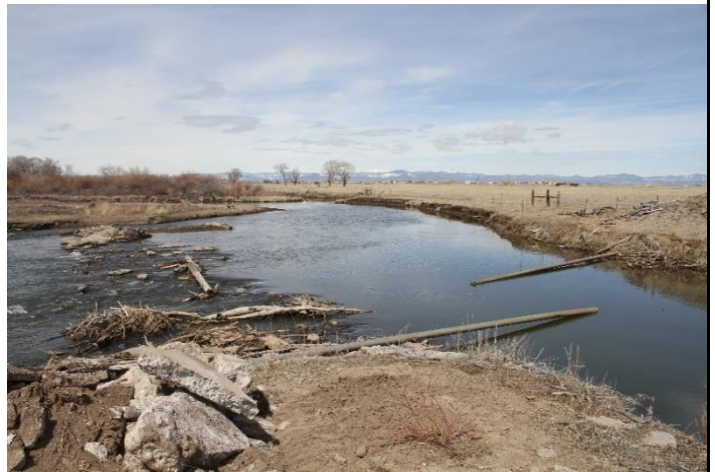
Diversion dam looking upstream

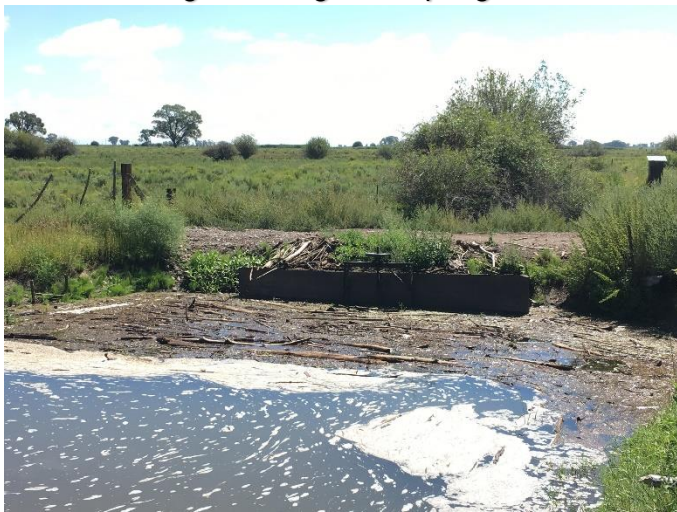
Headgate during 2019 spring runoff

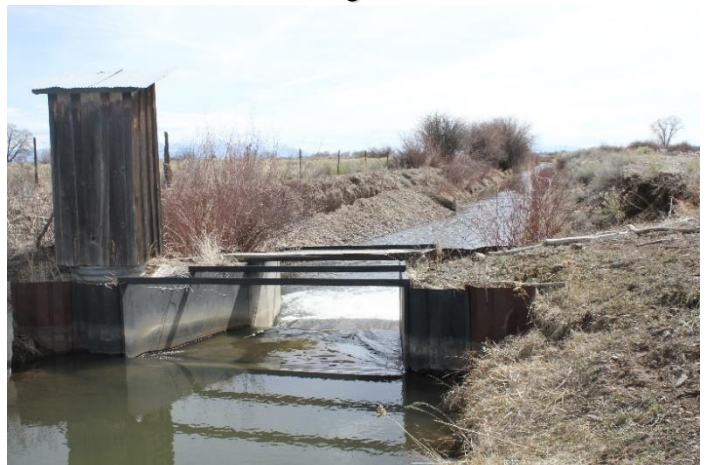
**Structure Description:** This structure is located near the apex of a meander. Channel migration analysis shows the meander is tightening and may be cut off in the future (see map in report card). If this occurs, the ditch will no longer be functional. A diversion dam composed of rocks and debris directs flow to a short feeder channel with a log trash boom at its entrance. At the end of the feeder channel is a welded steel plate headwall and attached headgate. The headgate does not seal properly. Debris accumulates on the diversion dam and, despite the trash boom, is especially an issue at the headgate. Sediment accumulation is also an issue at this structure. The ditch company also has difficulty diverting water during low flow conditions. Additionally, the flume is too large for the volume of the ditch and does not measure accurately at low flows.

Flume looking downstream

**Repair(s) or Improvement(s) Currently Needed:** Given the issues identified at this structure, the SMP Technical Advisory Team (TAT) recommends installing a new diversion dam, headgate (with an adjacent sluice), and flume at this location. The TAT also recommends implementing bank stabilization and riparian revegetation, especially upstream of the diversion. CPW recommends fish passage in this reach and the TAT recommends also creating safe boat passage and allowing for adequate sediment transport. A new diversion dam and headgate would improve sediment transport and debris-passing capabilities. Bank stabilization and riparian revegetation would reduce erosion, help prevent the meander from being cut off, and maintain ditch and river function. As an alternative solution, the TAT recommends the ditch company consider moving the point of diversion and headgate upstream to avoid the potential impact of channel avulsion.

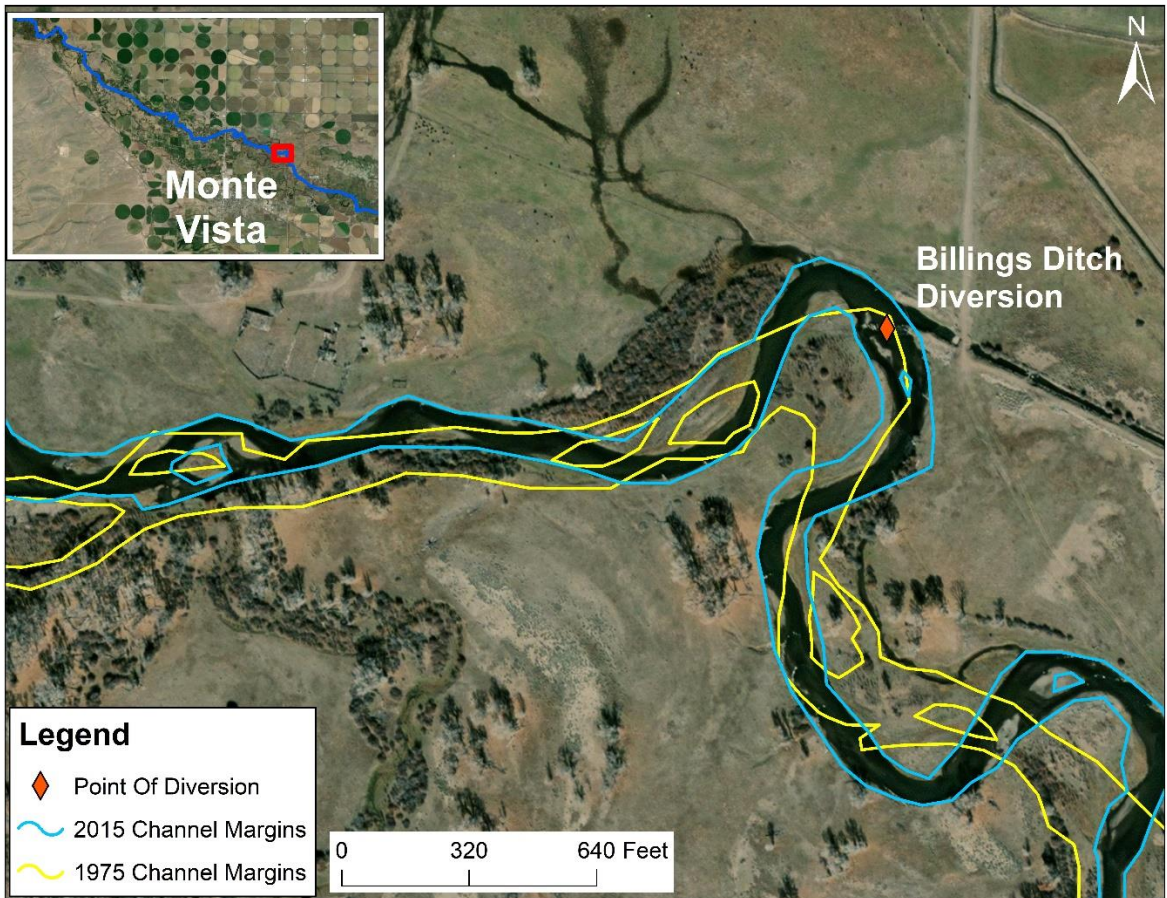
Map showing Rio Grande margins in 1975 and 2015. Channel migration analysis shows the channel has migrated north and east since 1975, which has led to increased bank erosion, sediment and debris accumulation, and other challenges for Billings Ditch.

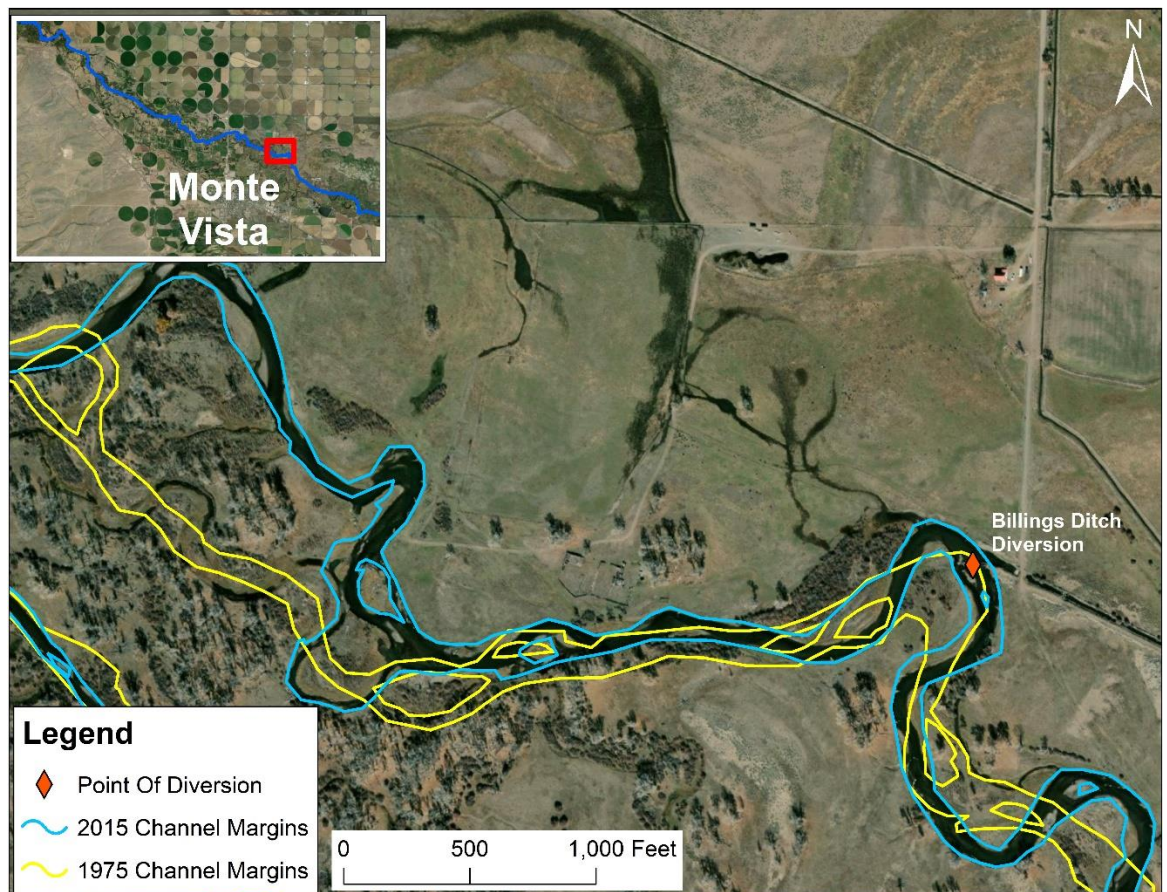
Map of 1975 and 2015 channel margins upstream of Billings Ditch.
