RIO GRANDE DIVERSION INFRASTRUCTURE INVENTORY

Structure Name: BUTLER IRR D

Date: April 1, 2019

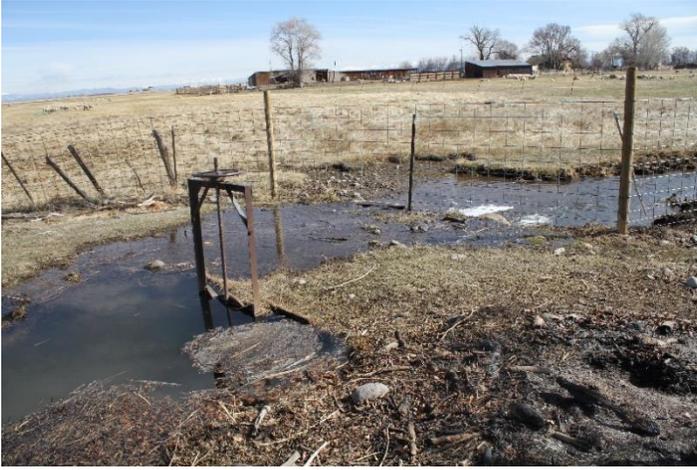
Headgate looking downstream

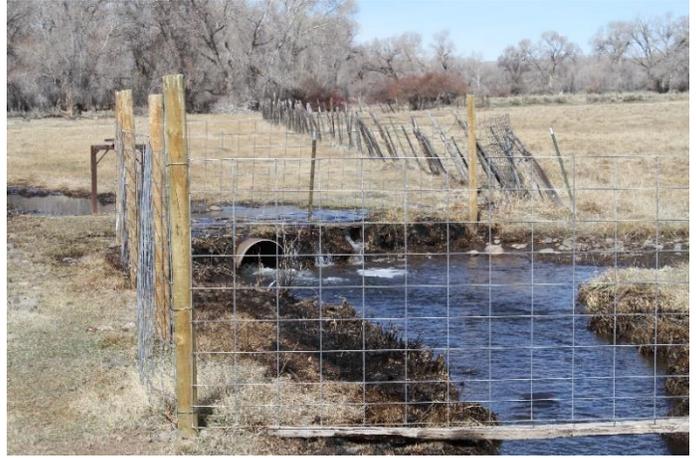
Headgate outlet

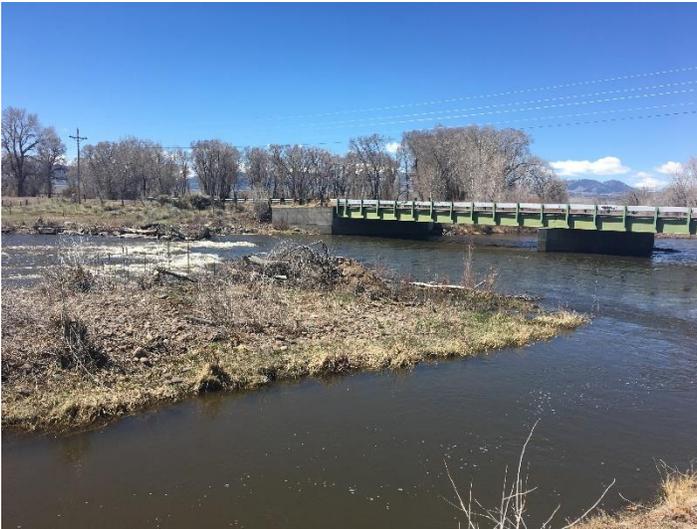
Structure Description: The channel in this area has shown signs of past avulsion. A "W"-shaped stacked rock diversion dam, just downstream of Co Rd 3 W, directs river flow to the feeder channel. Boulders making up the diversion dam have shifted in recent years and, as a result, the diversion does not function optimally. There is a small diversion dam on the feeder ditch that directs water to the first headgate, a 3' wide steel slide gate. Any flow not diverted returns to the river ~500 ft downstream. The ditch travels ~0.3 miles to the main headgate. Sediment accumulation at the feeder channel and up to the headgate is a minor issue for this structure.

Diversion dam and feeder ditch

Repair(s) or Improvement(s) Currently Needed: The SMP Technical Advisory Team (TAT) recommends repairing the diversion dam at this location and addressing sediment accumulation in the headgate and feeder channel. Colorado Parks and Wildlife (CPW) recommends fish passage in this reach and the TAT recommends also creating safe boat passage. Diversion dam repairs would improve the ditch's ability to effectively divert its water rights at all water levels. Sediment removal in the feeder channel and near the headgate would also improve ditch function.

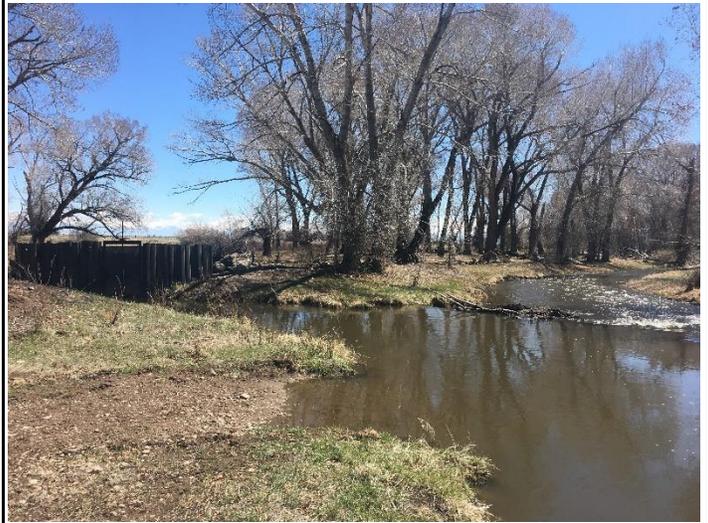
Adjustment headgate and diversion dam

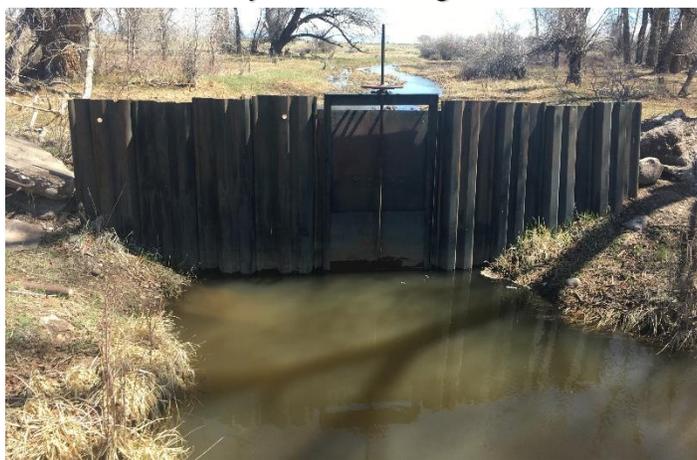
Adjustment headgate

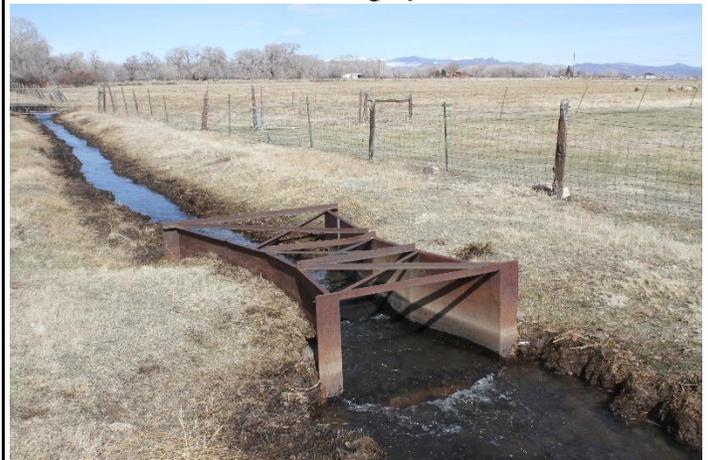
Flume looking upstream
