RIO GRANDE DIVERSION INFRASTRUCTURE INVENTORY

Structure Name: CENTENNIAL D

Date: April 1, 2019

CENTENNIAL DITCH

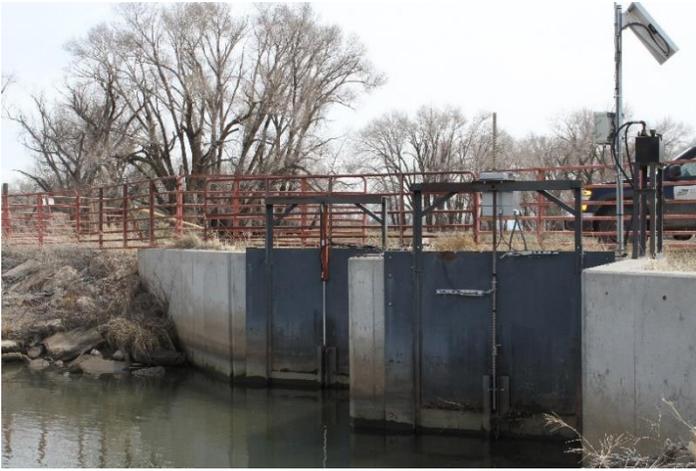
Headgate looking downstream

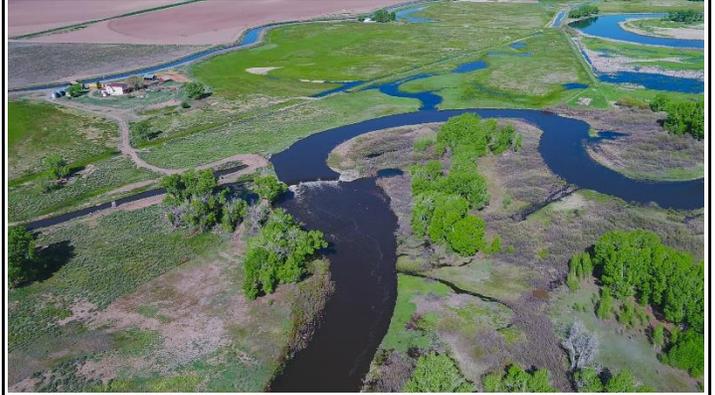
Aerial view of diversion structure

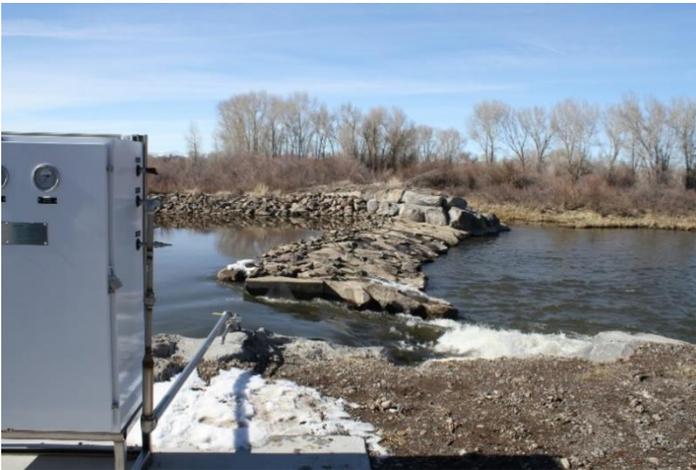
Diversion dam looking north

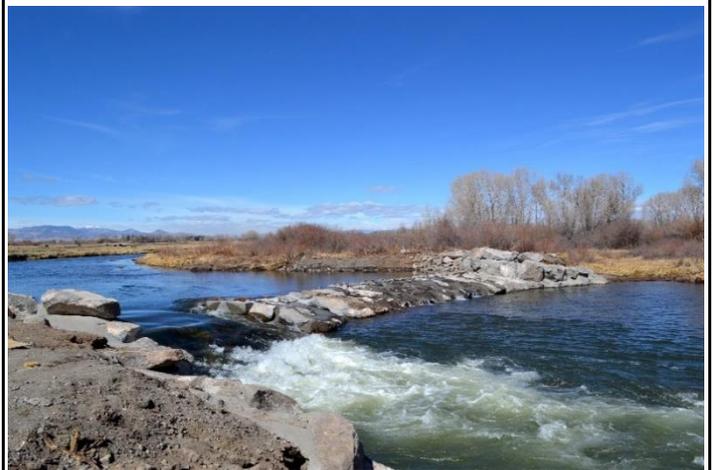
Diversion dam looking upstream

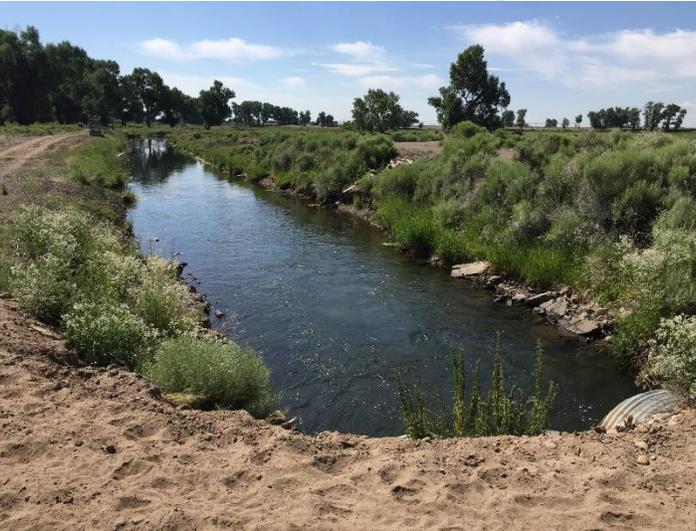
Ditch downstream of headgate

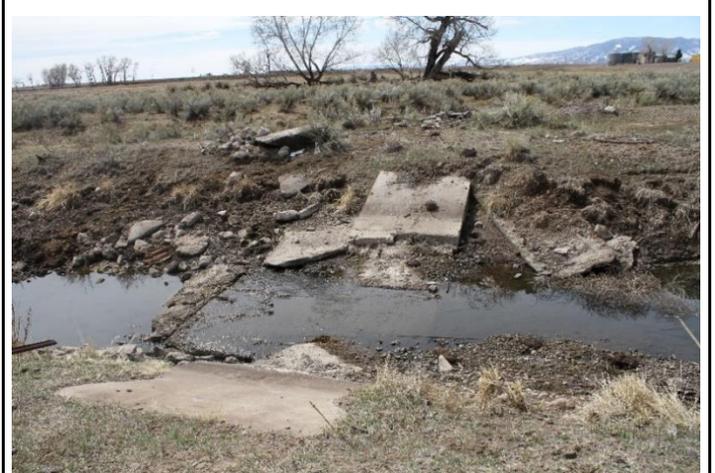
Measurement flume

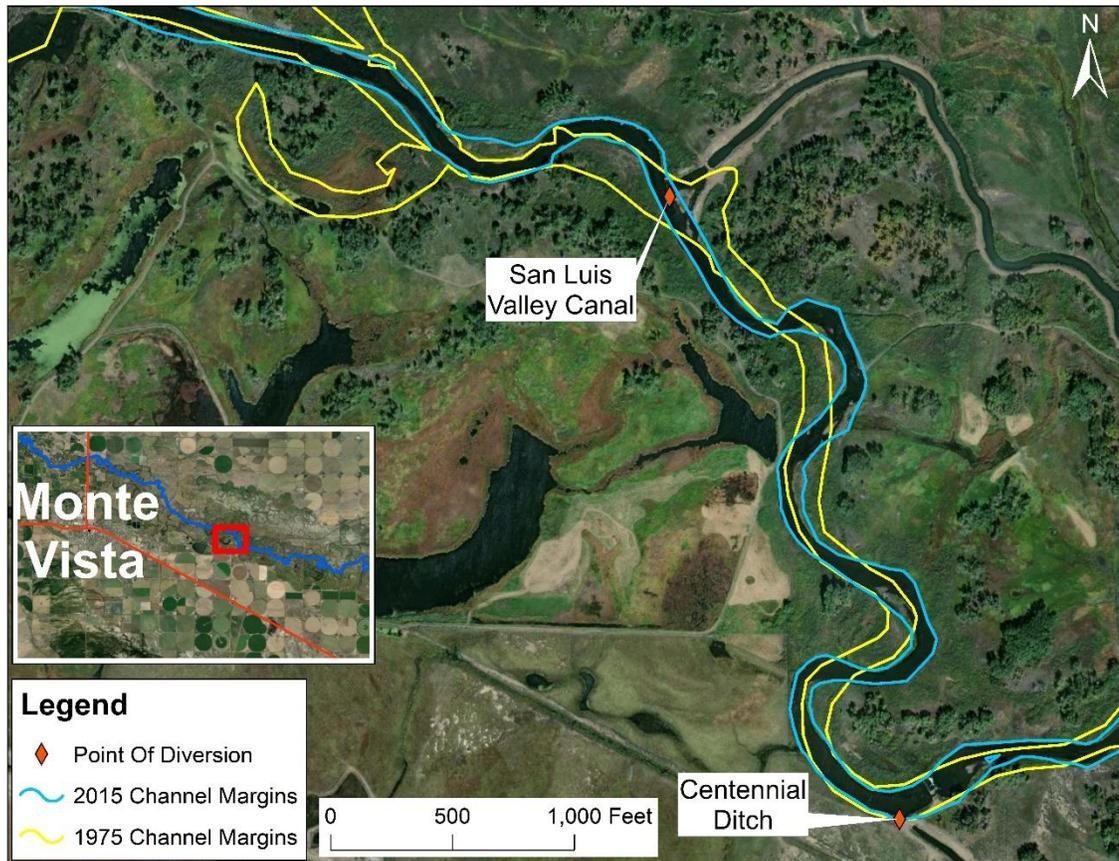
Repair(s) or Improvement(s) Currently Needed: Despite recent improvements, the channel is unstable both upstream and downstream of the diversion dam. Immediately upstream of the diversion, the meanders are tightening and, during a high flow event, the meander could be cut off. If this occurs, it would cause the diversion to also be cut off. The SMP Technical Advisory Team (TAT) recommends monitoring the risk of a meander cutoff given its potential impact on this structure.

Centennial Ditch headgate with 1975 and 2015 channel margins overlaid

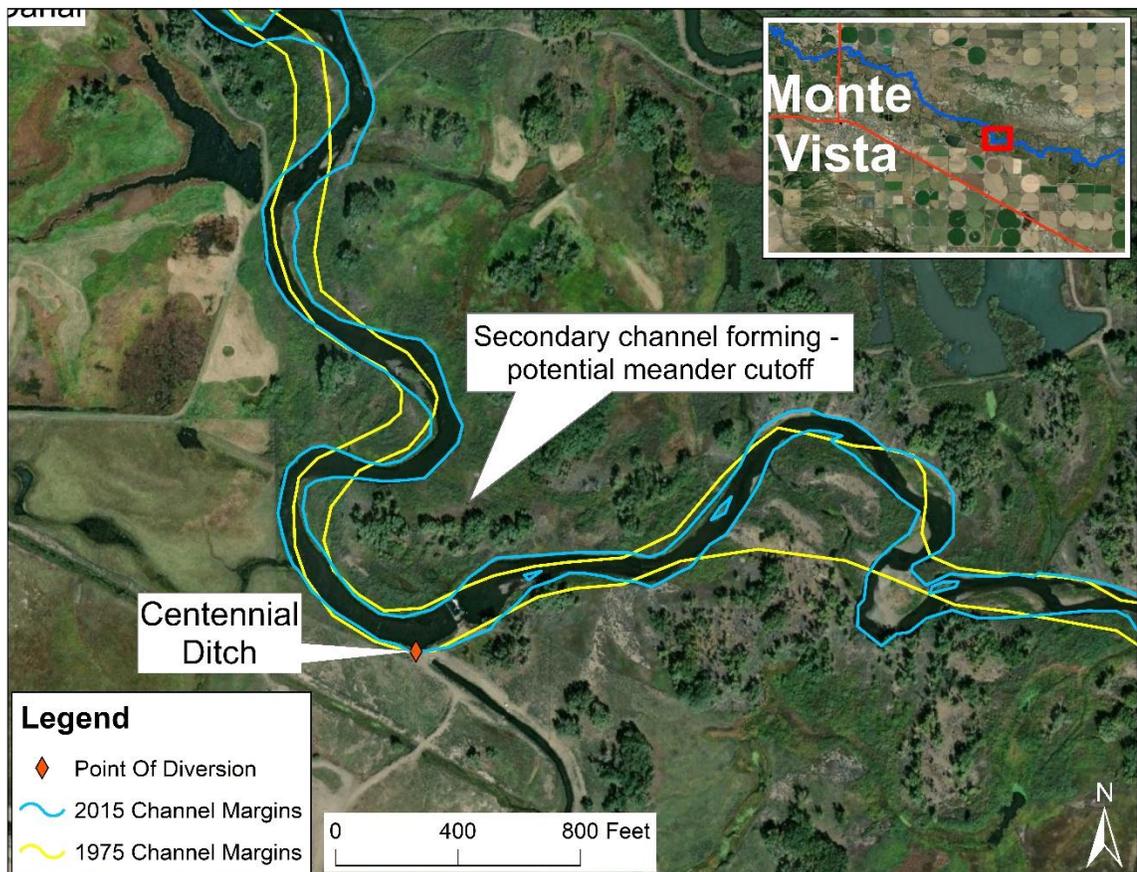
Zoomed image of Centennial Ditch headgate 1975 and 2015 channel margins overlaid. Approximate location of secondary channel and potential meander cutoff also shown.

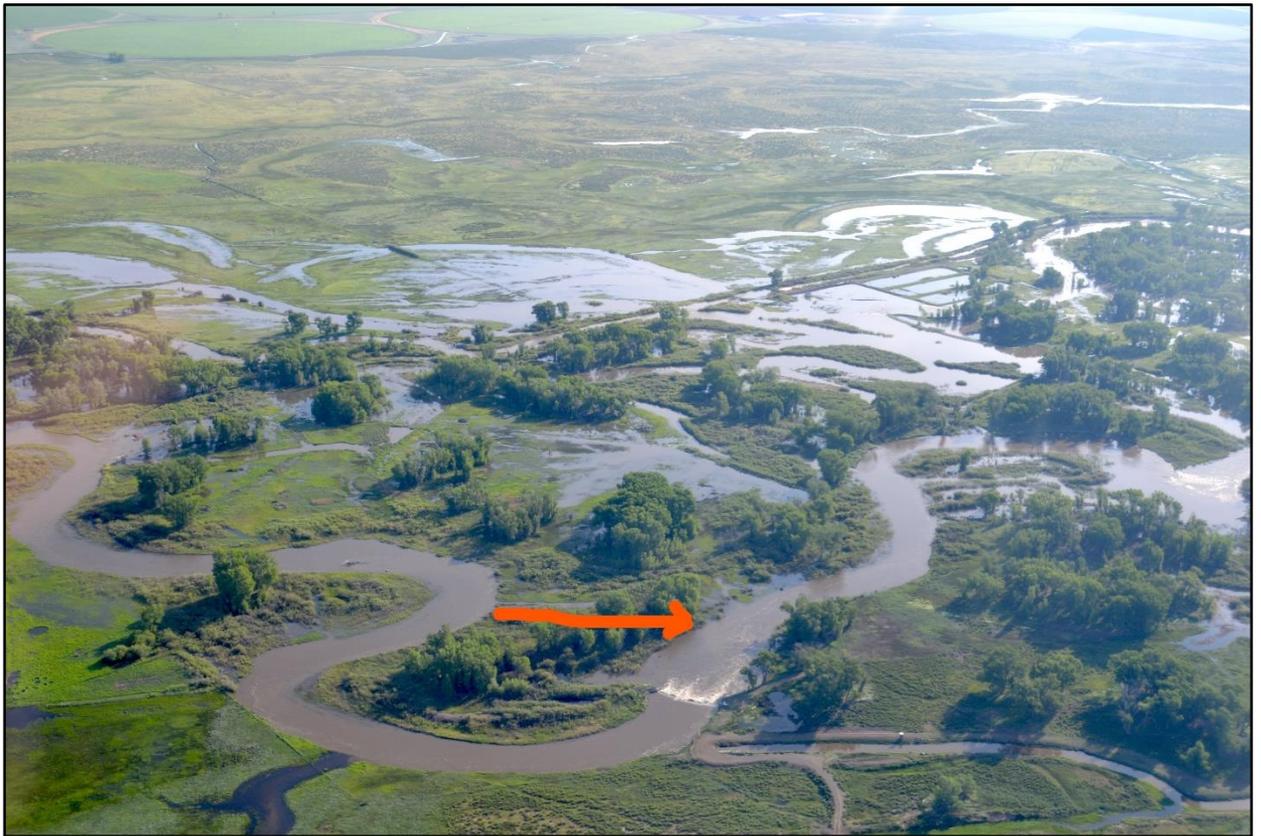
Photo taken June 18, 2019 showing high water at Centennial Ditch, looking downstream. Arrow indicates the approximate path of the secondary channel.

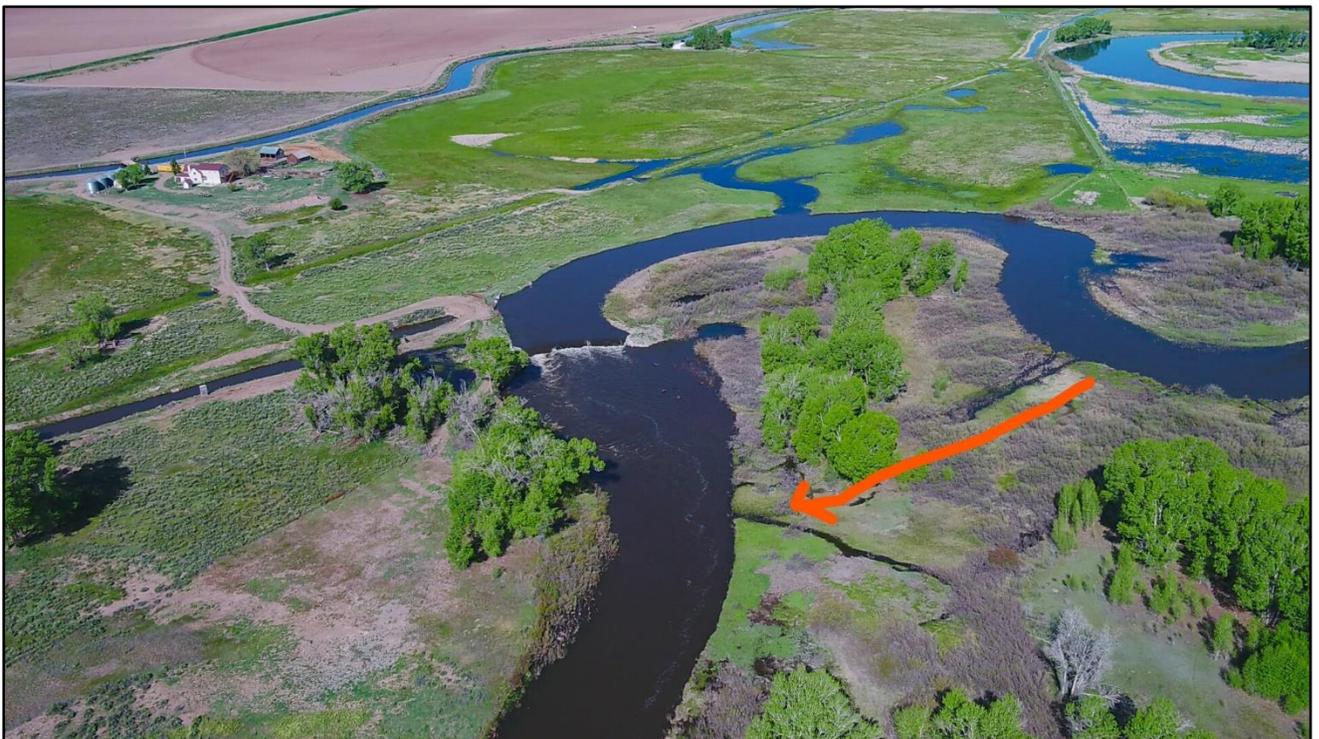
Photo taken June 3, 2019 showing high water at Centennial Ditch, looking upstream. Arrow indicates the approximate path of the secondary channel.
