RIO GRANDE DIVERSION INFRASTRUCTURE INVENTORY

Structure Name: CHICAGO D

Date: April 11, 2019

CHICAGO DITCH

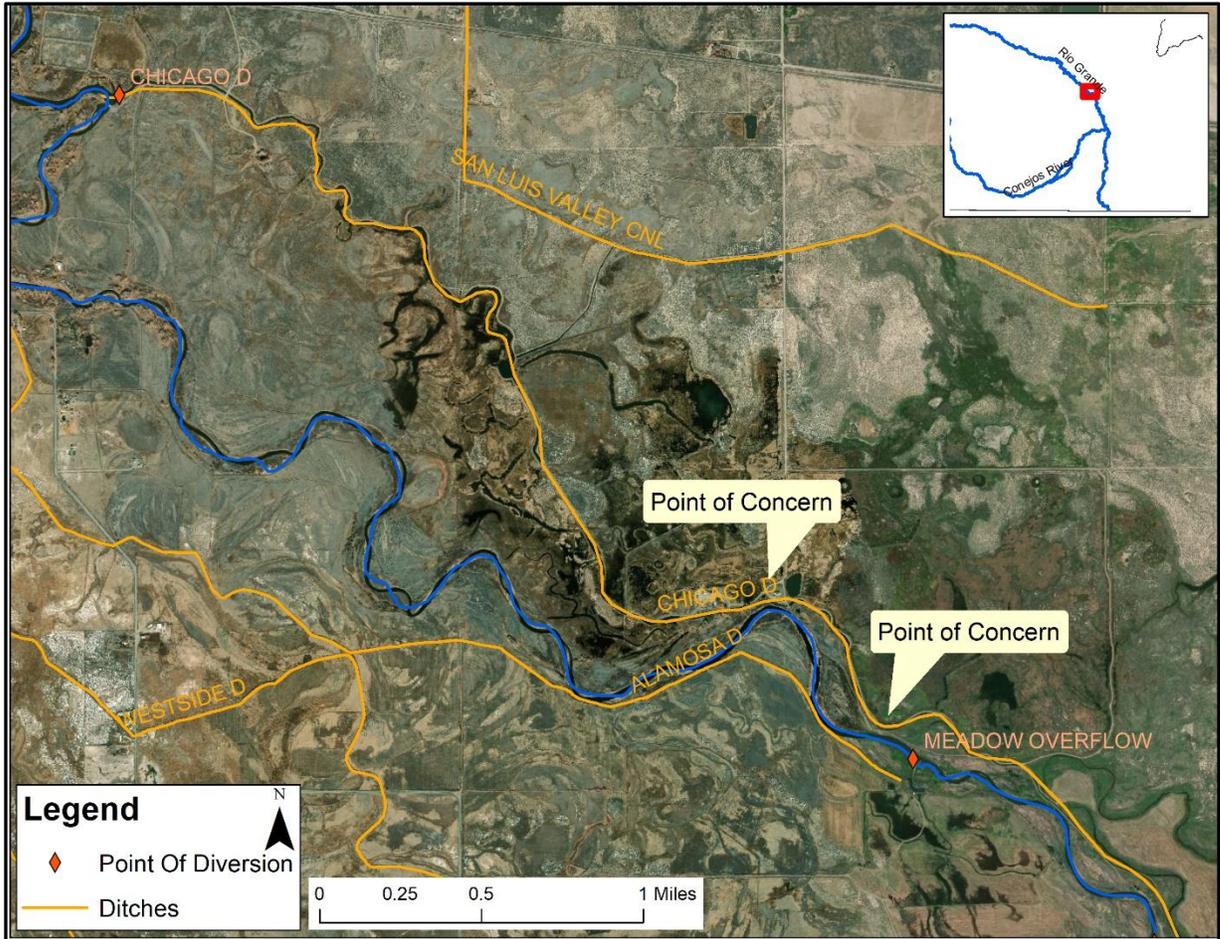
Structure Description: This structure is located approximately 1.3 miles downstream of the Westside Ditch. Historic channel avulsion is evident both upstream and downstream of the diversion. The concrete diversion dam creates head pressure for the headgate, located approximately 230 ft upstream. Woody debris accumulates in front of the headgate, but it is not a significant issue for water users. There is a radial adjustment/overflow gate on the east side of the diversion dam. The diversion functions well for water rights holders, but forms a barrier to boating and fish passage, especially at low flows. At two locations downstream of the headgate (approximately 3.4 miles and 4 miles, respectively), the ditch is very close to the Rio Grande, in part due to channel migration. If channel migration continues, the ditch could be washed out in these locations (see map below).

Points of concern on Chicago Ditch where ditch is very close to river channel.

Repair(s) or Improvement(s) Currently Needed: Based on the issues identified, the Technical Advisory Team (TAT) recommends bank stabilization or relocating the path of the ditch to avoid potential ditch failure. The TAT also recommends stabilization, floodplain reconnection, and riparian revegetation downstream of the diversion to reduce erosion. Colorado Parks and Wildlife (CPW) recommends fish passage in this reach and the TAT also recommends creating safe boat passage at the diversion. If implemented, these recommendations would improve ditch function, enhance river health, and provide new recreational opportunities.
