RIO GRANDE DIVERSION INFRASTRUCTURE INVENTORY

COCHRAN PIONEER DITCH

PHOTO LOG

Rio Grande Stream Management Plan

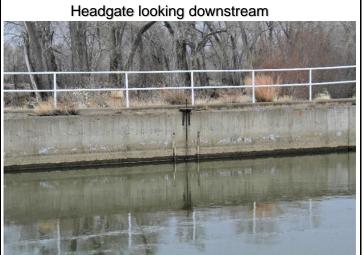
Headgate outlet
