RIO GRANDE DIVERSION INFRASTRUCTURE INVENTORY

Structure Name: CONSOLIDATED SLOUGH WEIR

Date: April 1, 2019

Rio Grande Stream
Management Plan

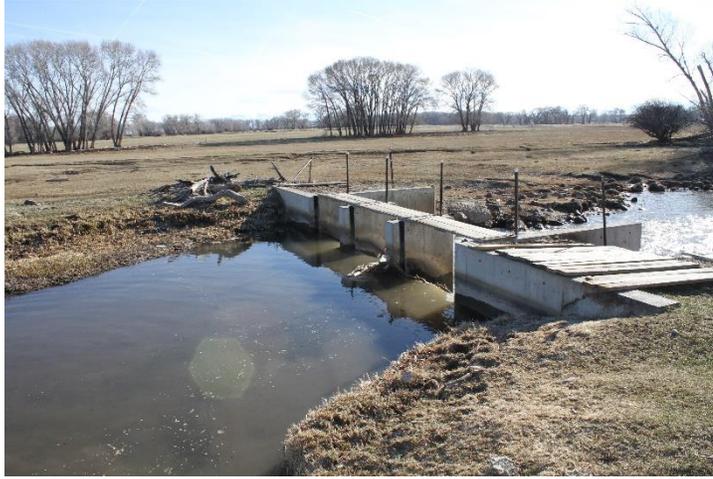
Weir looking downstream

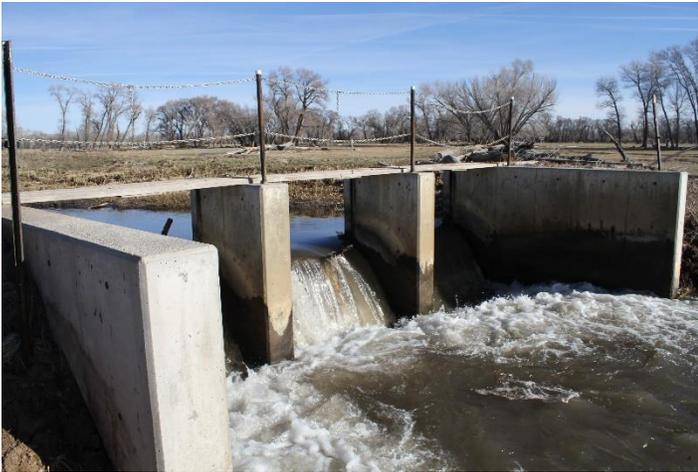
Weir looking upstream

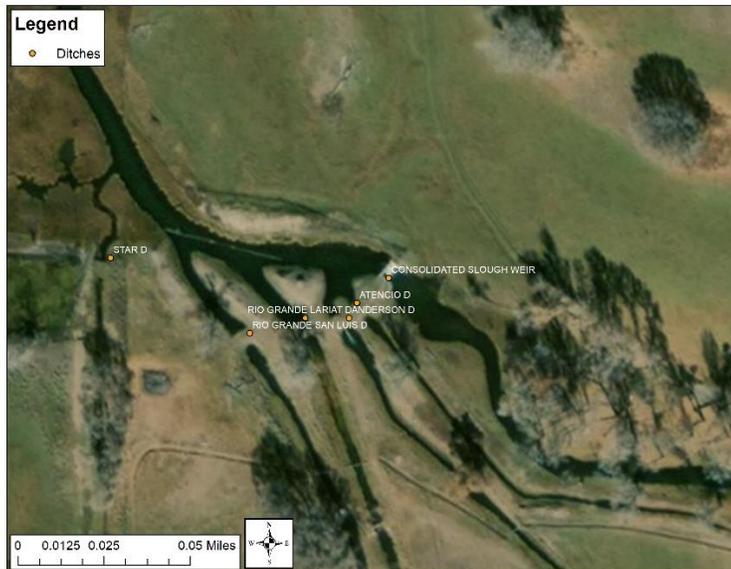
Aerial view of structure
