# RIO GRANDE DIVERSION INFRASTRUCTURE INVENTORY

**Structure Name:** COSTILLA D (CANAL)

**Date:** April 10, 2019

**Rio Grande Stream  
Management Plan**

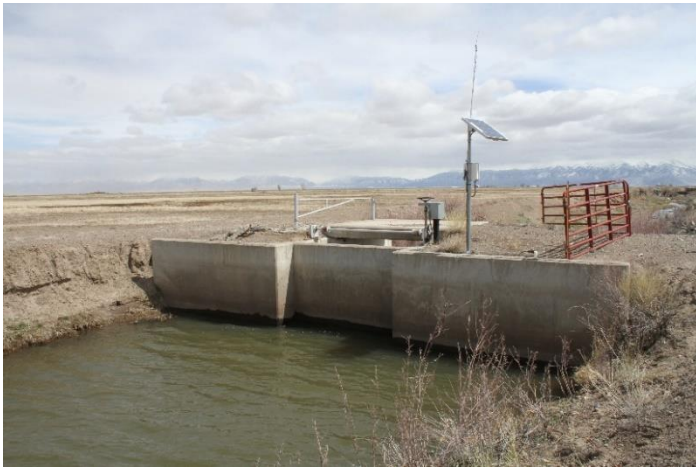
Headgate looking downstream

**Comments:** The headgate is relatively new and functions well. This ditch is a priority 293.

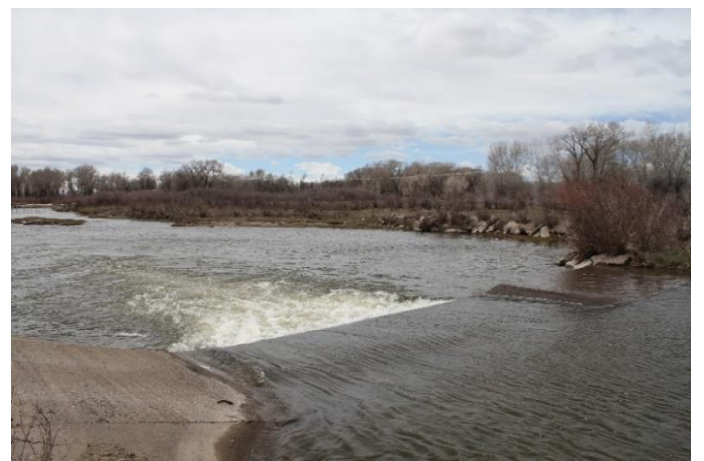
Diversion dam looking downstream

**Structure Description:** This structure is located on the outside of a meander and just downstream of its apex. A trapezoidal concrete diversion dam diverts river flow into the feeder channel on the east bank of the river. The diversion dam effectively diverts water, however it significantly reduces channel capacity at this location. The feeder channel is approximately 1,000 ft long and directs river flow to the headgate. There is a steel trash rack at the entrance of the feeder channel. There are several historic channels near the current channel, suggesting channel avulsion was historically prevalent here. For this reason, it is assumed that channel avulsion from the current channel to a historic channel during a flood event is possible. Immediately upstream of the structure, the river has not migrated significantly since the 1960s (see report card). This is due in part to riprap and concrete blocks that were placed upstream of the diversion on the east bank of the river for stabilization. Downstream of the diversion, channel avulsion has occurred historically and there is potential for meander cutoffs. This ditch's slope is very low and backs up when the ditch is in priority, resulting in a significant issue for water users.

**Repair(s) or Improvement(s) Currently Needed:** Based on these issues, the SMP Technical Advisory Team (TAT) recommends removing the concrete upstream of the diversion and replacing it with bank stabilization structures and riparian vegetation. This restoration would improve river function and reduce hazards for boaters and livestock. Additionally, if the diversion is reconstructed in the future, the TAT recommends increasing its capacity to improve river function and reduce the likelihood of the river reclaiming a historic channel during a high flow event.
