RIO GRANDE DIVERSION INFRASTRUCTURE INVENTORY

Structure Name: DEL NORTE TOWN D

Date: May 7, 2019

DEL NORTE TOWN DITCH

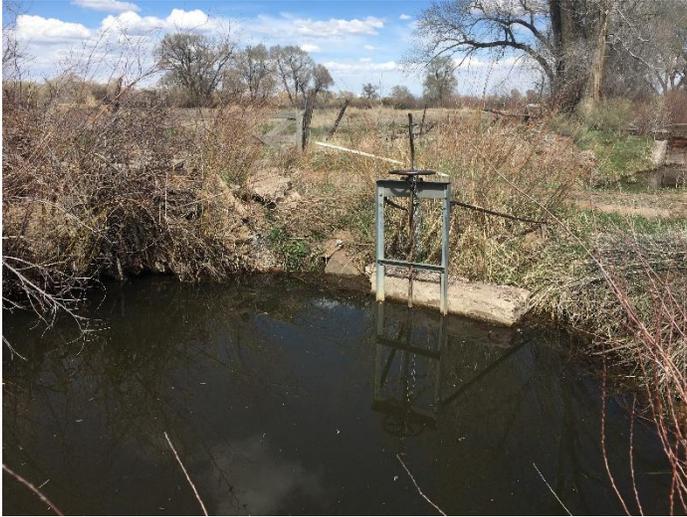
Structure Description: This structure shares a diversion with the Dyer Ditch. After passing the Dyer headgate, the channel merges with Pinos Creek and passes two overflow channels before reaching the Del Norte Town Ditch headgate (see aerial image in report card). During high flows, this ditch can also receive water from Pinos Creek. Water not diverted by the Dyer Ditch remains in the overflow channel, which merges with Pinos Creek. Both the diversion dam and headgate are aging and function poorly. At low flows, the ditch is unable to divert its full decree.

Headgate looking downstream

Repair(s) or Improvement(s) Currently Needed: The Technical Advisory Team (TAT) recommends replacing the existing diversion and headgate and removing an old headgate, which is located just downstream of the main headgate. These improvements would enhance the overall function of this ditch. See Dyer Ditch for a description of the emergency overflow channel near this structure.

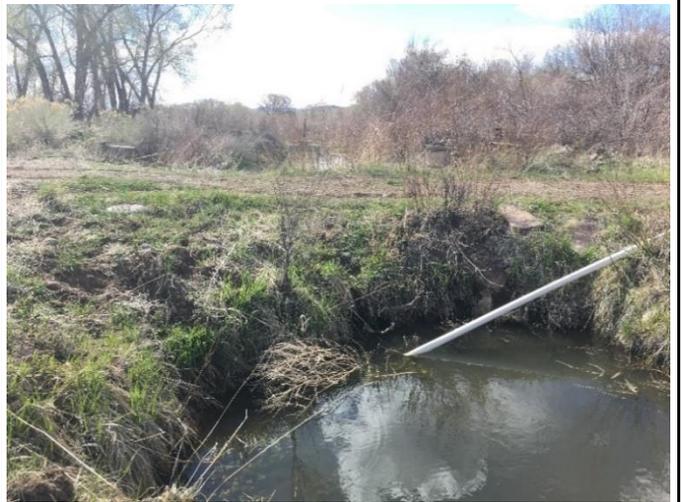
Headgate outlet

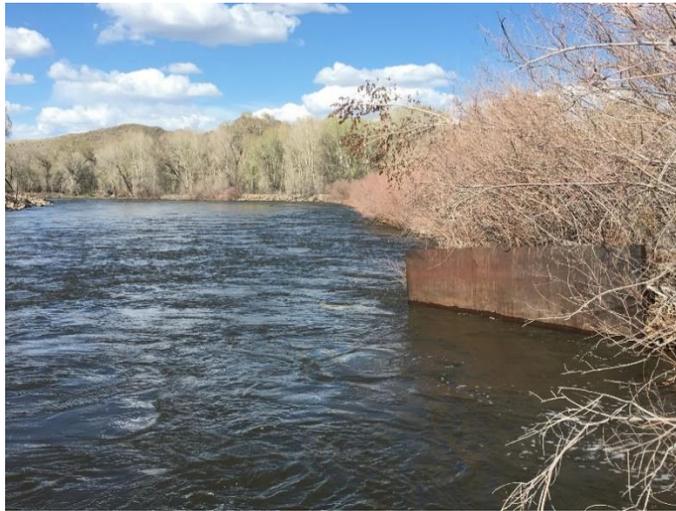
Point of diversion, headgate on Rio Grande

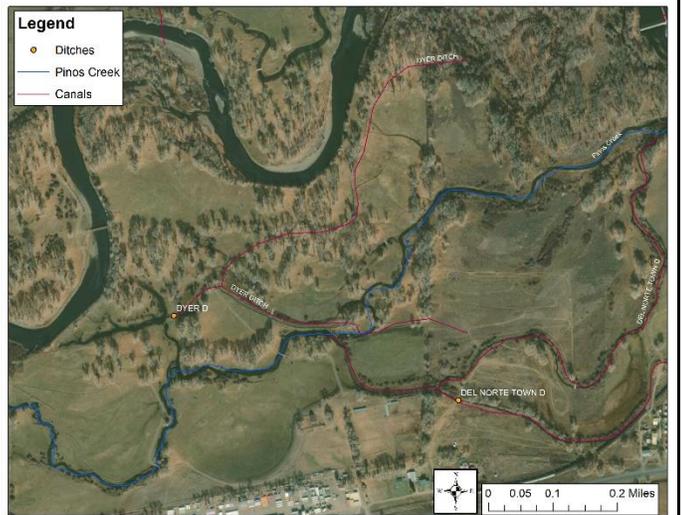
Aerial view of ditch and Pinos Creek

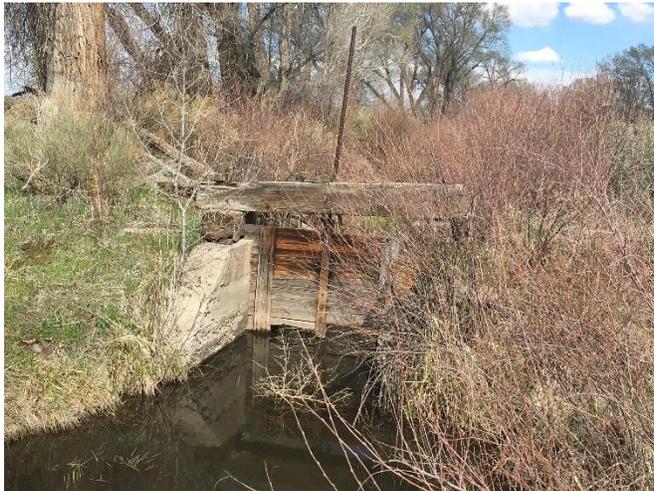
Old headgate

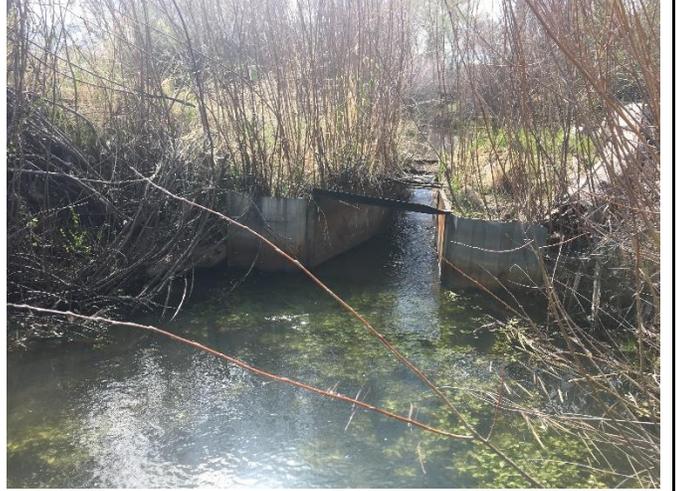
Flume looking upstream
