RIO GRANDE DIVERSION INFRASTRUCTURE INVENTORY

Structure Name: EHROWITZ D

Date: May 7, 2019

EHROWITZ DITCH

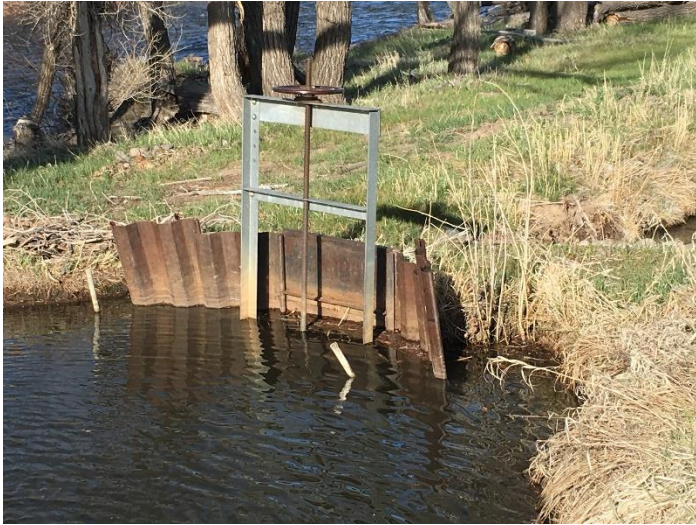
Headgate looking downstream

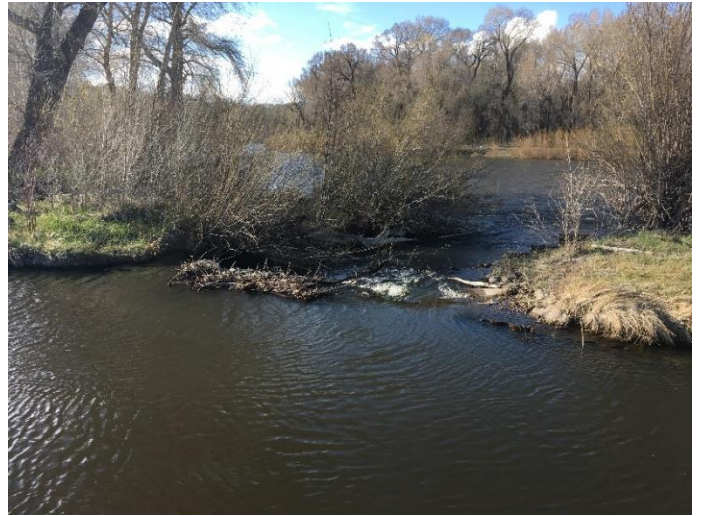
Overflow channel just upstream of headgate

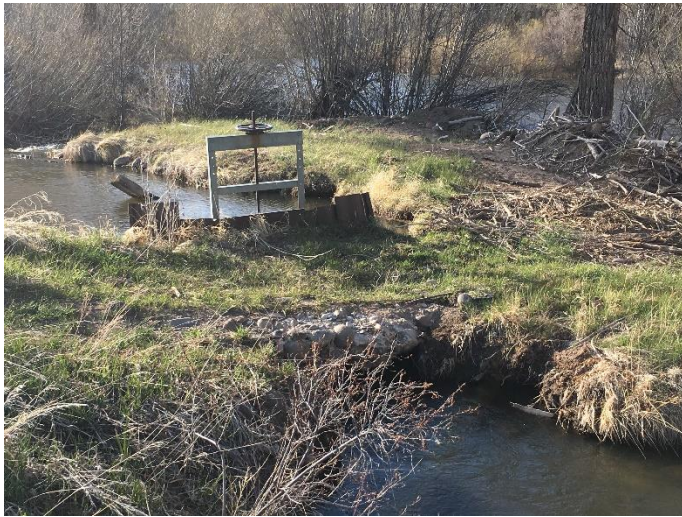
Headgate outlet

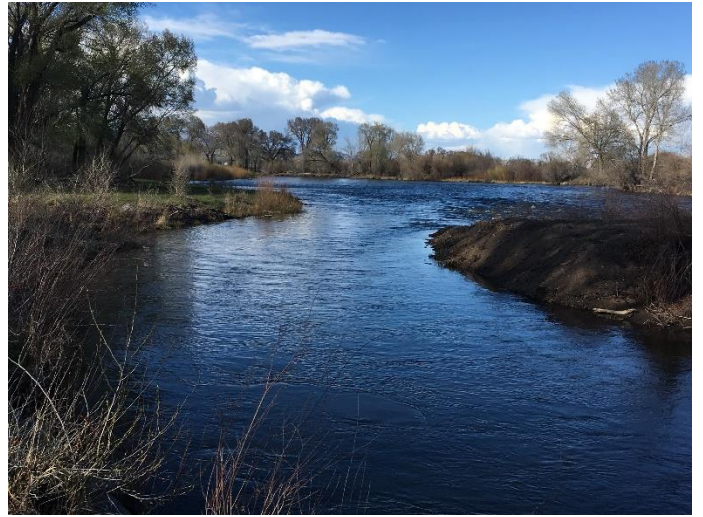
Structure Description: The original diversion dam was damaged, and currently there is no formal diversion dam for this structure. Instead, an informal sand and gravel push-up diversion dam is formed each year in an effort to divert the ditch's water rights during low flow conditions. It is typically reconfigured and/or adjusted multiple times throughout the irrigation season. Depending on its configuration, it can be difficult to navigate via boat, especially during low flows. The river is migrating east upstream of the point of diversion, which is exacerbating these challenges. The roughly 0.5 mile feeder channel directs water to the headgate and an overflow channel directs return flows back to the river. Sedimentation in the feeder channel requires regular maintenance. Additionally, the return flow structure has sunken and makes headgate control challenging.

Diversion dam

Repair(s) or Improvement(s) Currently Needed: Based on the assessment of this structure, the Technical Advisory Team (TAT) recommends either the installation of a new diversion dam at this location or relocating the diversion upstream, with the possibility of using the existing Independent Ditch 2 diversion. A new diversion dam, either in its current location or moved upstream, would effectively divert water and reduce maintenance. Repair or replacement of the return flow structure is also recommended to improve control of flows to the headgate.

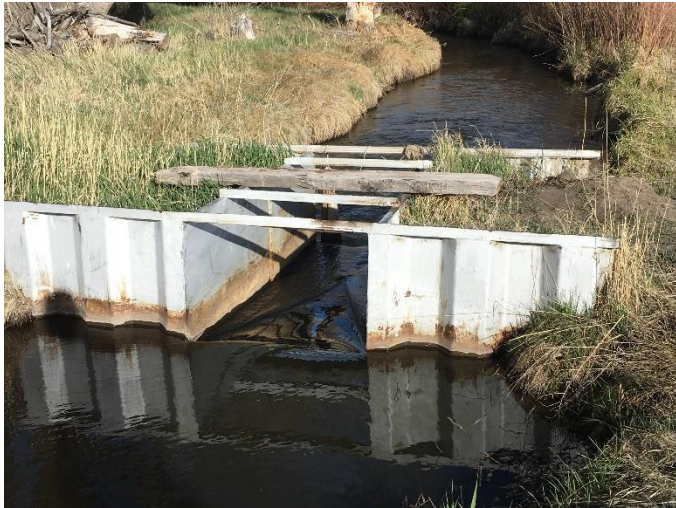
Flume looking downstream

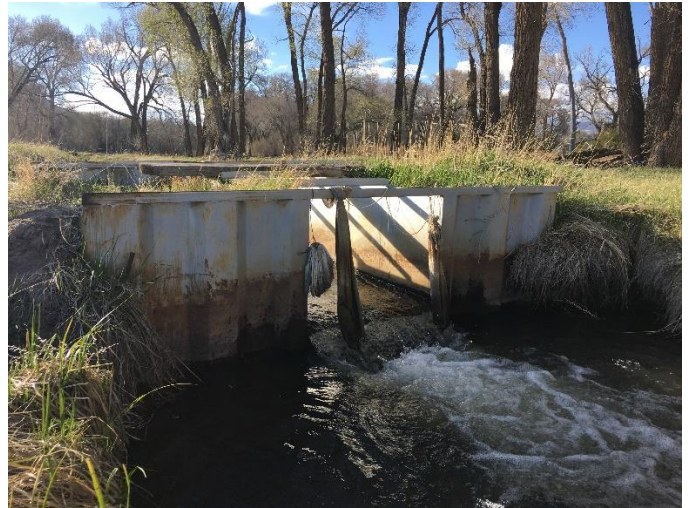
Flume looking upstream

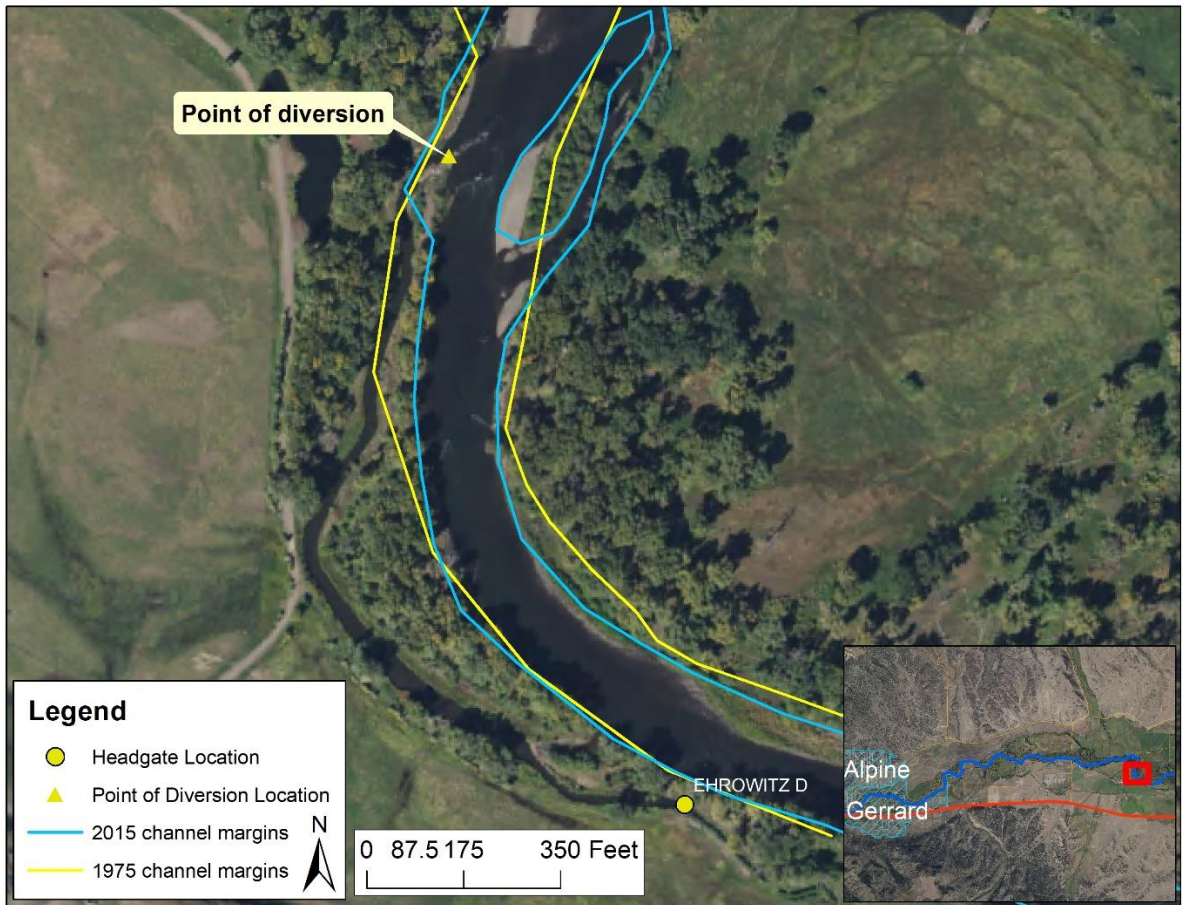
Headgate location with 1975 and 2015 channel margins overlaid

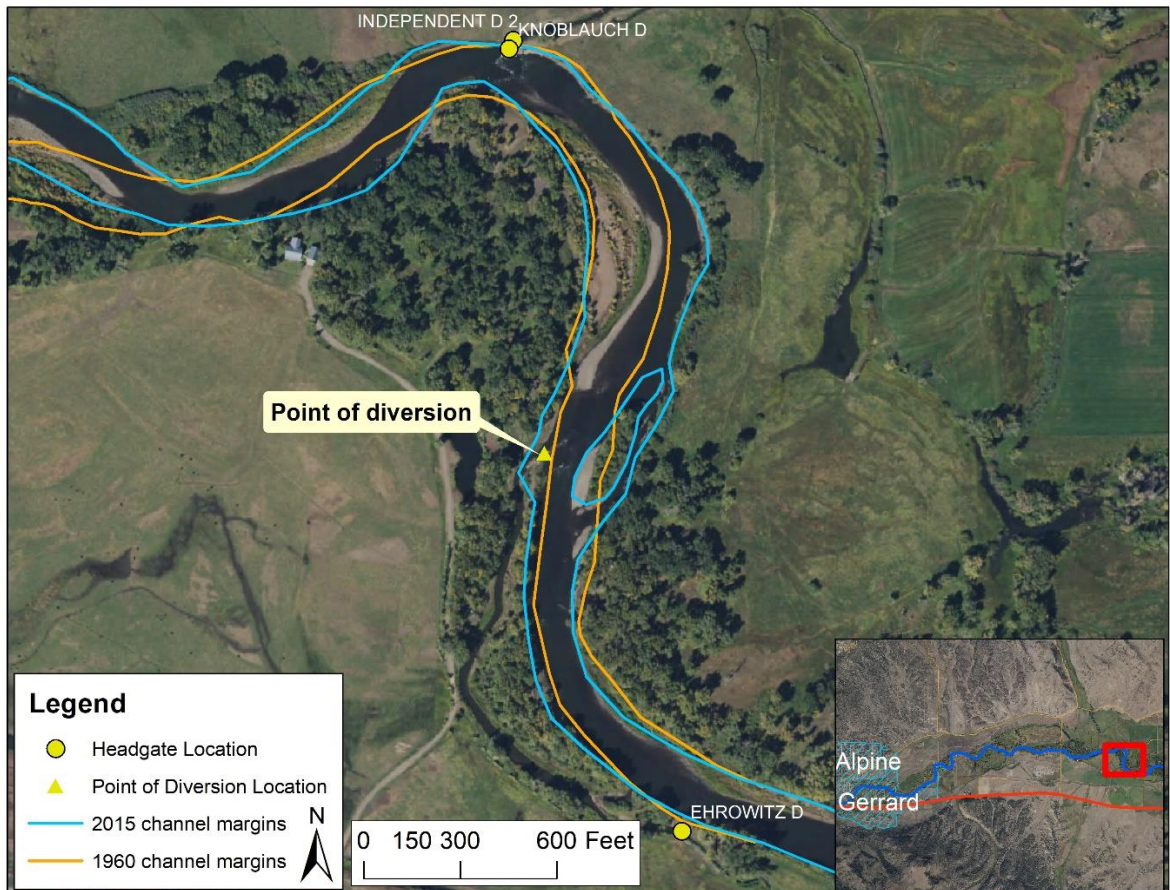
Headgate location with 1960 and 2015 channel margins overlaid

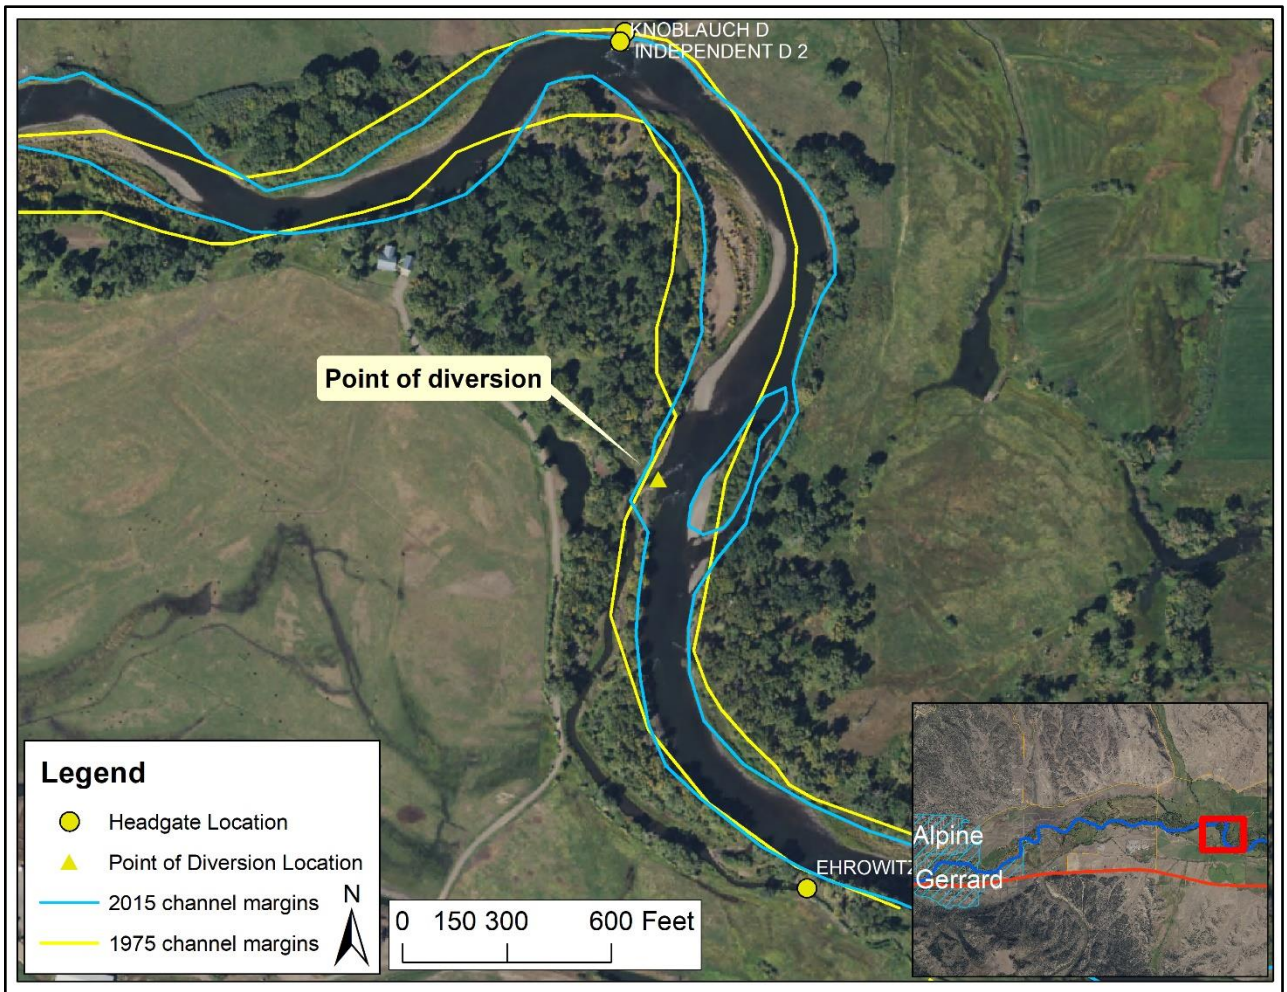
Headgate and point of diversion with 1975 and 2015 channel margins overlaid
