RIO GRANDE INSTREAM INFRASTRUCTURE INVENTORY

Structure Name: EMPIRE CANAL

Date: April 1, 2019

EMPIRE CANAL

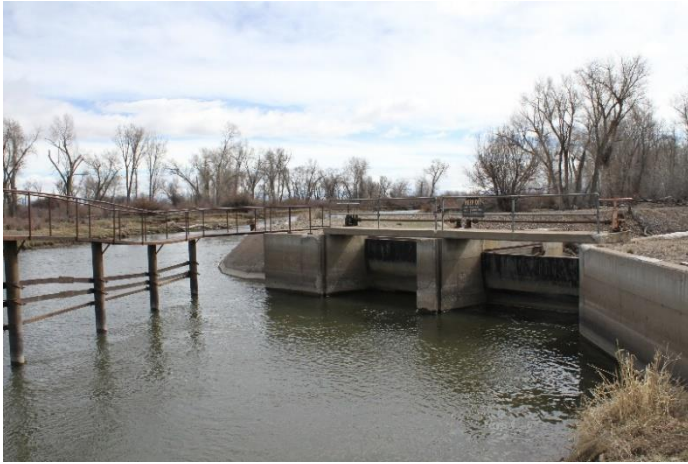
Headgate on the Rio Grande

Structure Description: The headgate sits along the south bank of the river. The concrete is spalling on the river headgate, also noted in 2006 inventory. There is no formal diversion dam, but water is diverted effectively because the headgate is located on the outside of a meander. There is a trash rack along the south bank of the river just upstream of the headgate that does not appear to be functional. There are slots in the headgate upstream of the radial gates to place stop boards. The feeder canal transports water approximately 3.3 miles from the river headgate to the main headgate. At the main headgate, a return flow structure returns any unused water to the river upstream of County Rd 3. The channel is unstable and has migrated significantly both upstream and downstream of the structure. Upstream of the river headgate, meanders are developing due to lateral migration of the river downstream. As the meanders upstream continue to develop, there is a small chance the river will intercept a historic channel, which would cut off this structure. Riprap has been placed on the north bank of the river immediately upstream of the structure. Two bank stabilization projects were installed between this structure and Hwy 285 - one in 2009 and a second in 2010. During low flows, water administration between this structure and the Billings Ditch is difficult. In addition, the flume has difficulty measuring accurately at low flows.

Repair(s) or Improvement(s) Currently Needed: The SMP Technical Advisory Tam (TAT) recommends river headgate repairs to address aging concrete, removal of riprap and installation of enhanced bank stabilization structures and riparian revegetation, channel migration monitoring, and repair or replacement of the flume. Improved bank stabilization would reduce annual maintenance and eliminate the need for heavy equipment operation in the channel and headgate and flume repairs would reduce future infrastructure risks and maintenance.

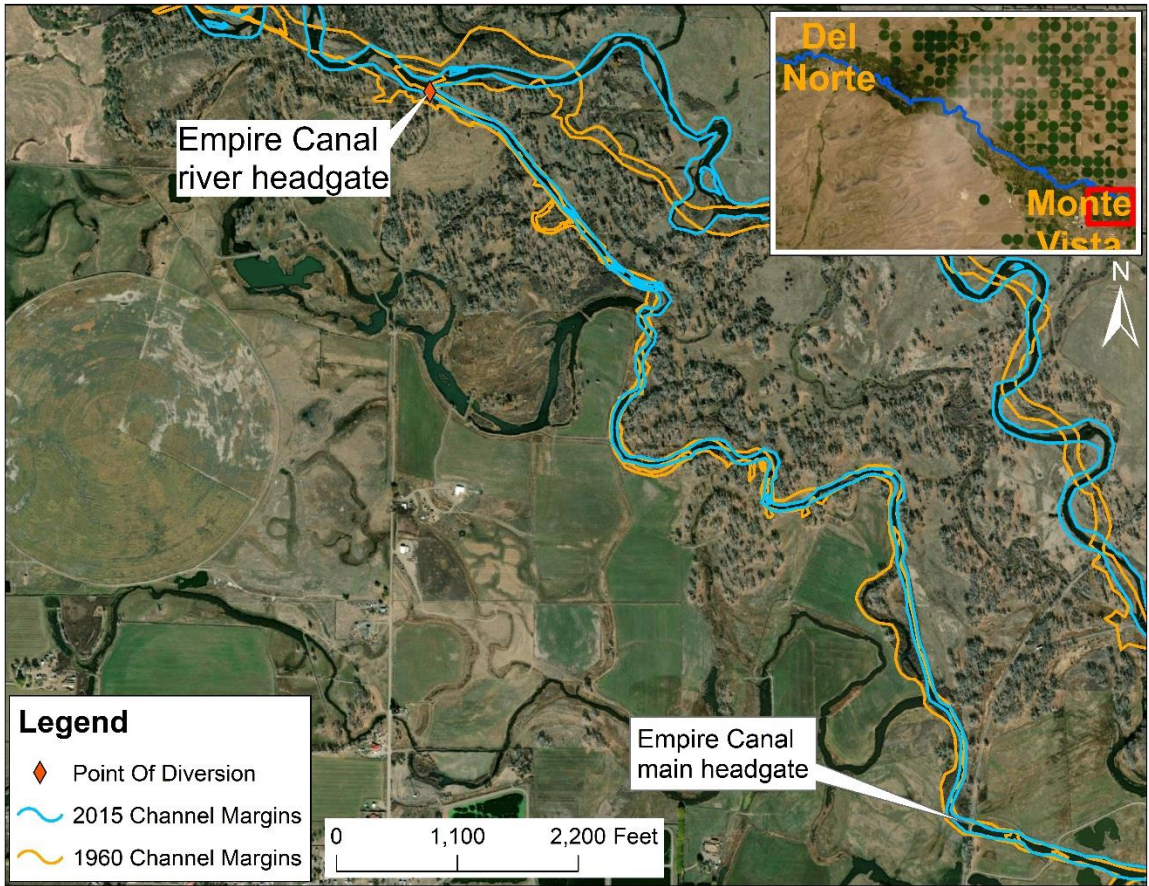
Empire Canal river headgate and main headgate with 1960 and 2015 channel margins overlaid

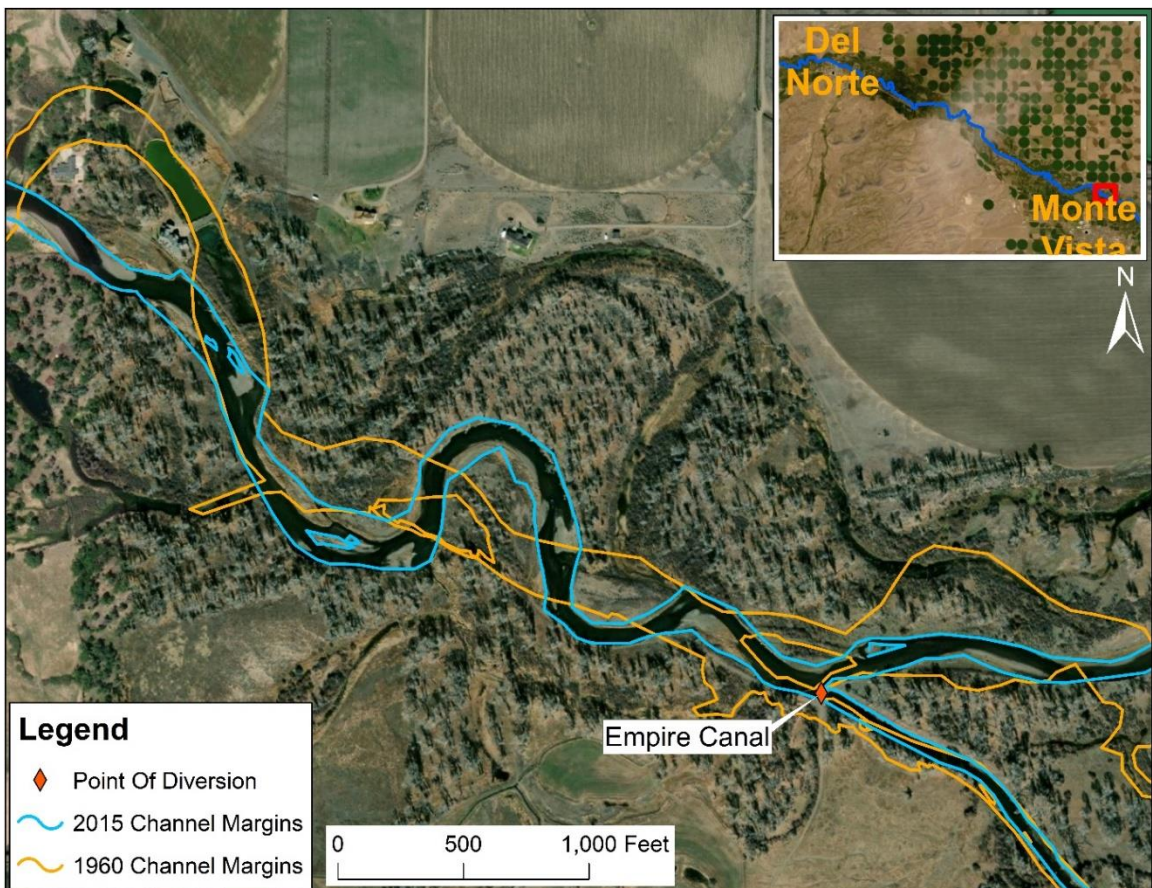
Empire Canal river headgate with 1960 and 2015 channel margins overlaid

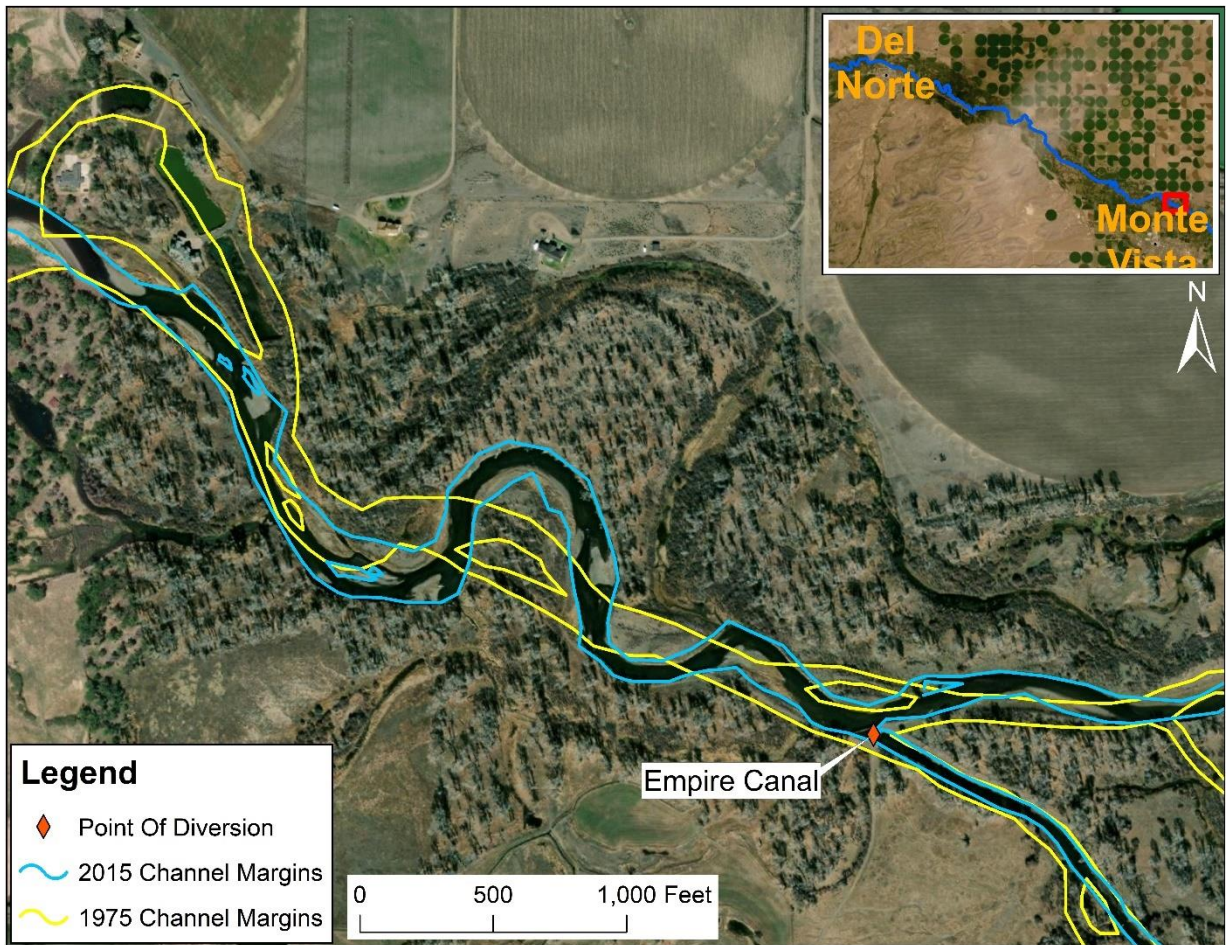
Empire Canal river headgate with 1975 and 2015 channel margins overlaid. This map illustrates the meander development upstream of the diversion and lateral migration downstream.
