RIO GRANDE DIVERSION INFRASTRUCTURE INVENTORY

Structure Name: EXCELSIOR D

Date: April 10, 2019

EXCELSIOR DITCH

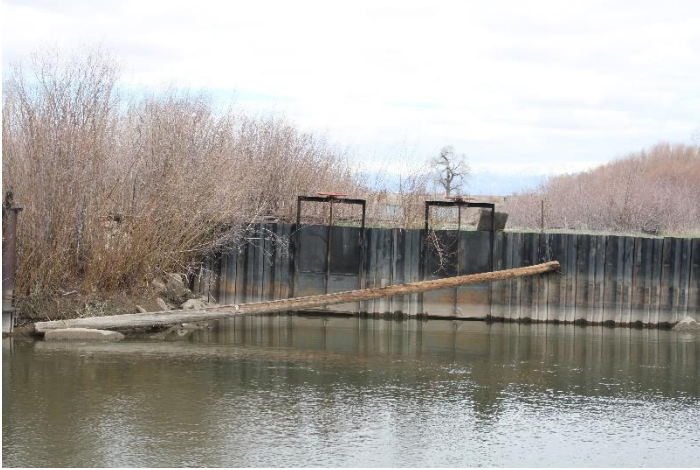
Headgate looking downstream

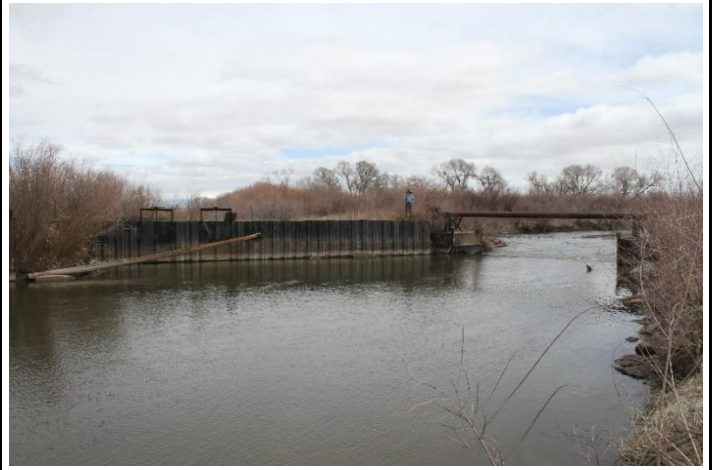
Headgate and diversion dam

Repair(s) or Improvement(s) Currently Needed: Given these issues, the Technical Advisory Team (TAT) recommends installing a new automated headgate and diversion dam at this location, improving the return flow structure, and upstream bank stabilization. CPW recommends fish passage and the TAT recommends creating safe boat passage and increasing sediment transport capacity. A new headgate, especially one with automation, would allow for increased water control, diurnal flow adjustments, and lower maintenance. A new diversion dam would improve the ability of the ditch to effectively divert its water rights at all water levels. Additionally, raising the elevation of the return flow gate and return flow ditch dredging would improve water control and reduce maintenance needs. Finally, stabilization of upstream banks (in addition to bank stabilization structures installed in 2014) would help prevent this structure from being washed out during high flow events.

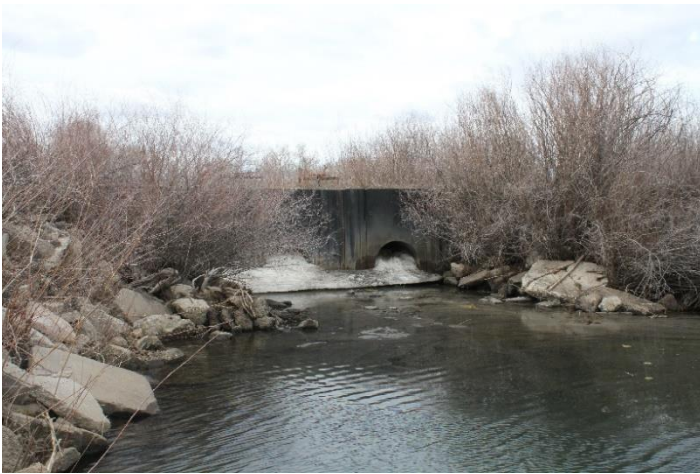
Headgate outlet

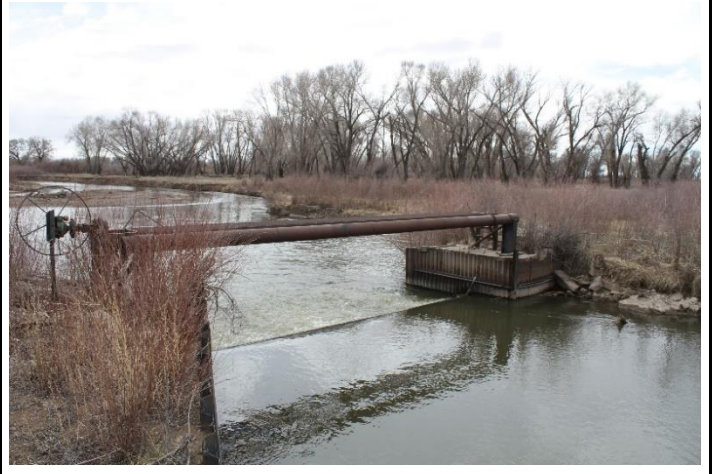
Structure Description: The diversion structure is an adjustable steel weir with hand cranks that spans the river and diverts river flow to the river headgate, located on the north bank of the river. There is a log trash boom in front of the headgate where woody debris accumulates. This structure does not function well during both high and low flow conditions. The ditch is not able to divert its full decree during low river flows and water users have difficulty adjusting diversion rates based on streamflow fluctuations. Silt has accumulated upstream of the diversion and the river is occasionally dredged. During previous high flow events, the ditch bank downstream of the headgate has washed out due to the river overtopping its banks upstream and draining toward the downstream ditch berm. Flow from the river also backs up in the downstream return flow ditch and enters the ditch through the return flow slide gate. The gradient on the return flow ditch is very low, and silt accumulates along the downstream side of the gate. Channel migration has previously and is currently occurring both upstream and downstream of the structure (see maps in below). An emergency overflow channel on the south bank is intended to mitigate damage by increasing channel capacity during high flows. Bank stabilization structures were installed upstream of the structure on the north bank or river.

Diversion dam

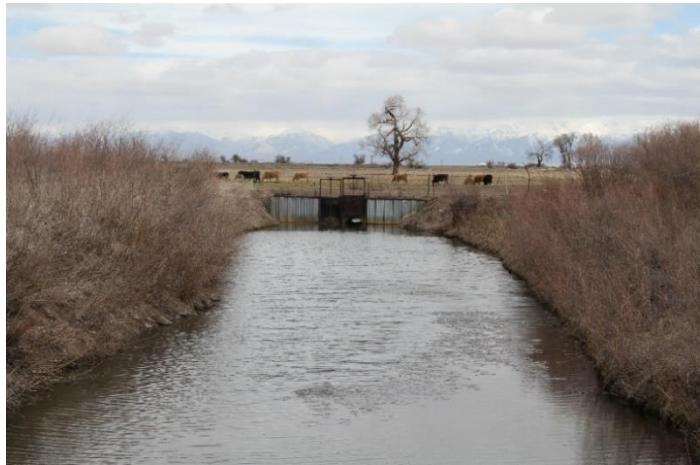
Downstream adjustment gates

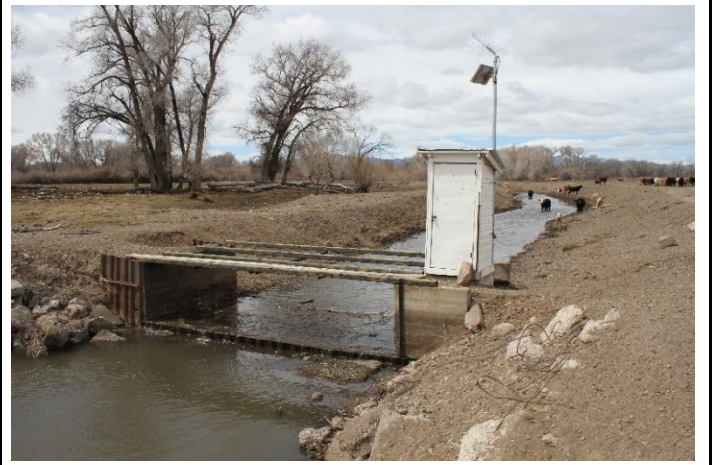
Comments: The flume functions well and is rated B. This ditch uses the Costilla Canal as a carrier ditch. This structure includes priorities 74, 163, 249, and 262.

Flume looking upstream
