RIO GRANDE DIVERSION INFRASTRUCTURE INVENTORY

Structure Name: FISH D

Date: April 1, 2019

FISH DITCH

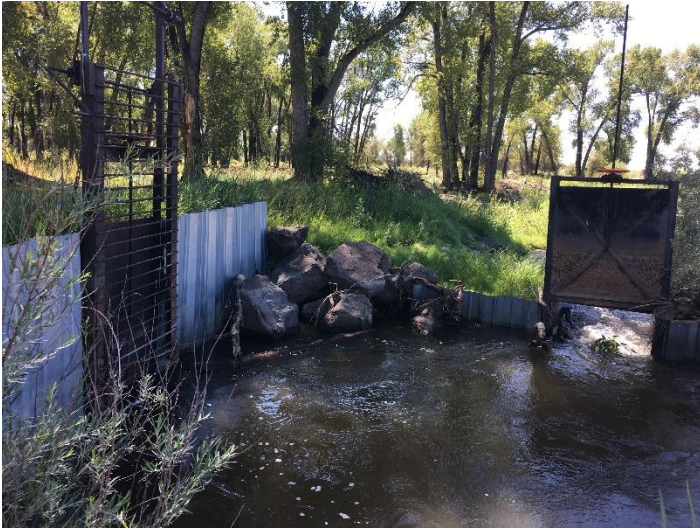
River headgate looking downstream

Repair(s) or Improvement(s) Currently Needed: The Technical Advisory Team (TAT) recommends installing an improved trash rack at the river headgate and implementing bank stabilization and riparian revegetation upstream of the diversion to prevent possible channel avulsion.

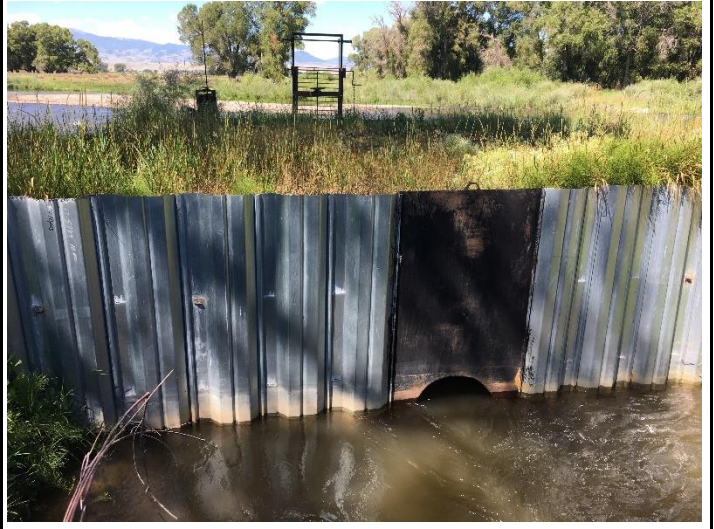
River headgate outlet

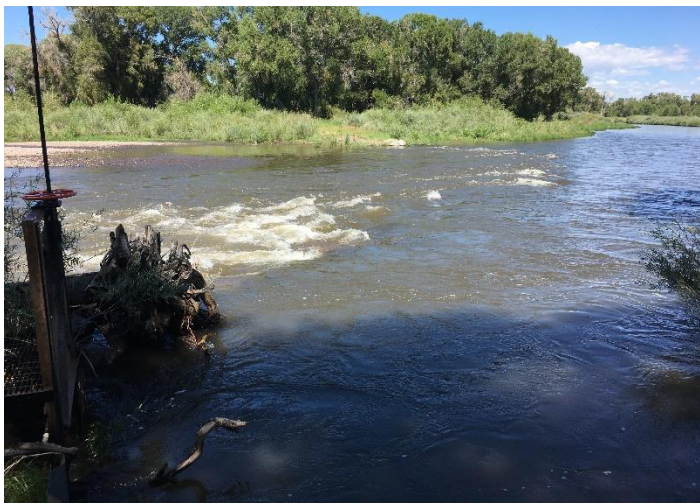
Diversion dam looking upstream

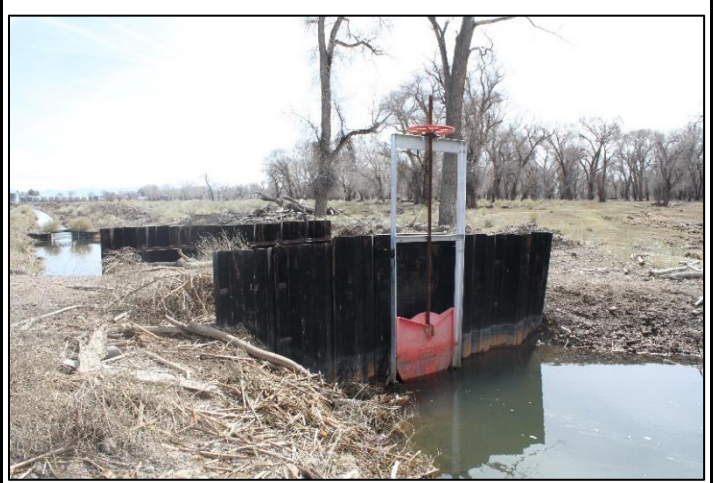
Repair(s) or Improvement(s) Completed Since 2006: The adjustment headgate was recently replaced and is functioning well.

Adjustment headgate outlet

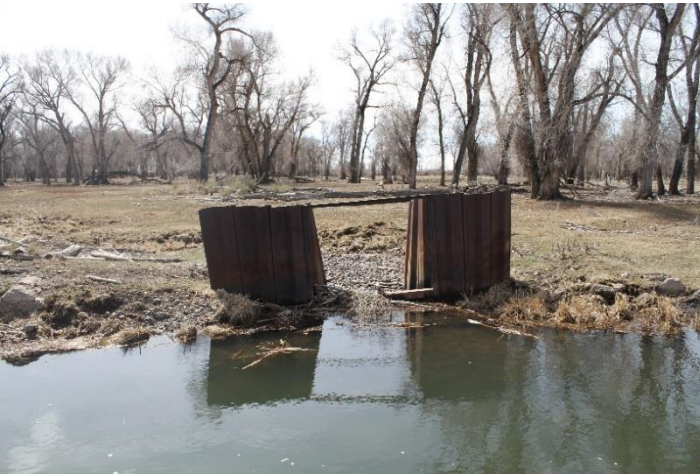
Overflow channel

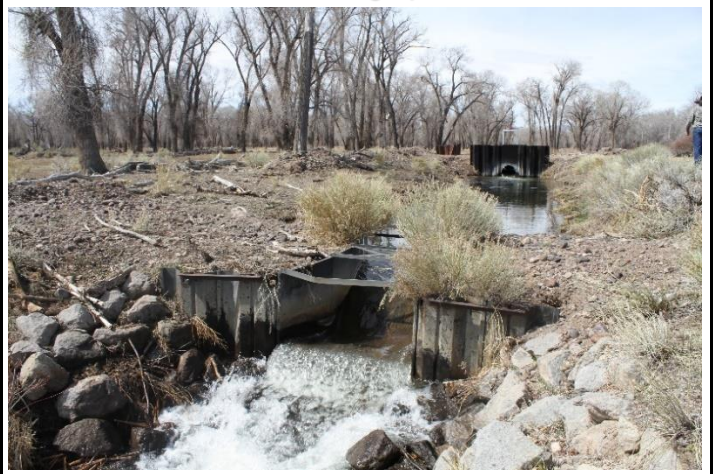
Flume looking upstream

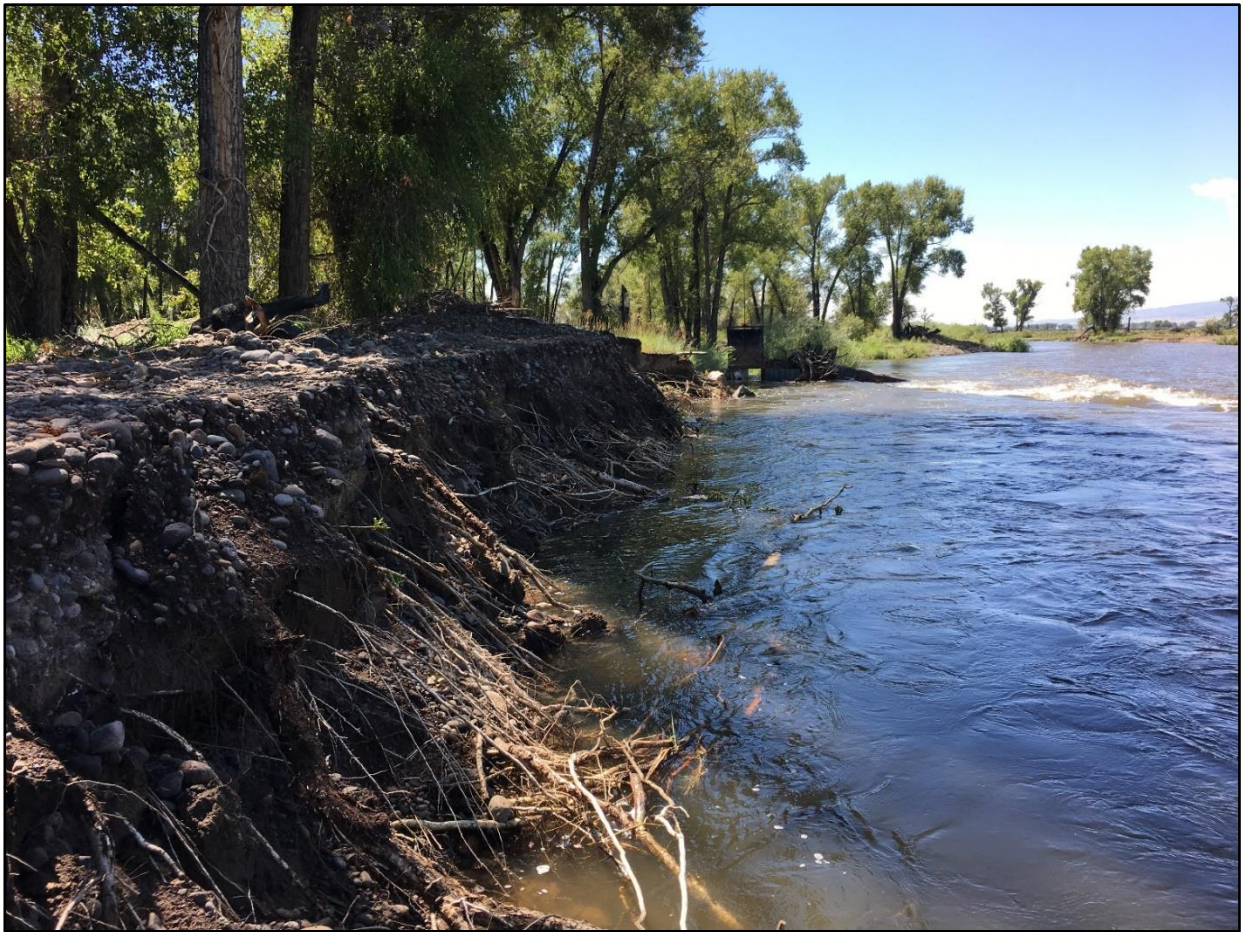
Bank erosion upstream of headgate (north bank)

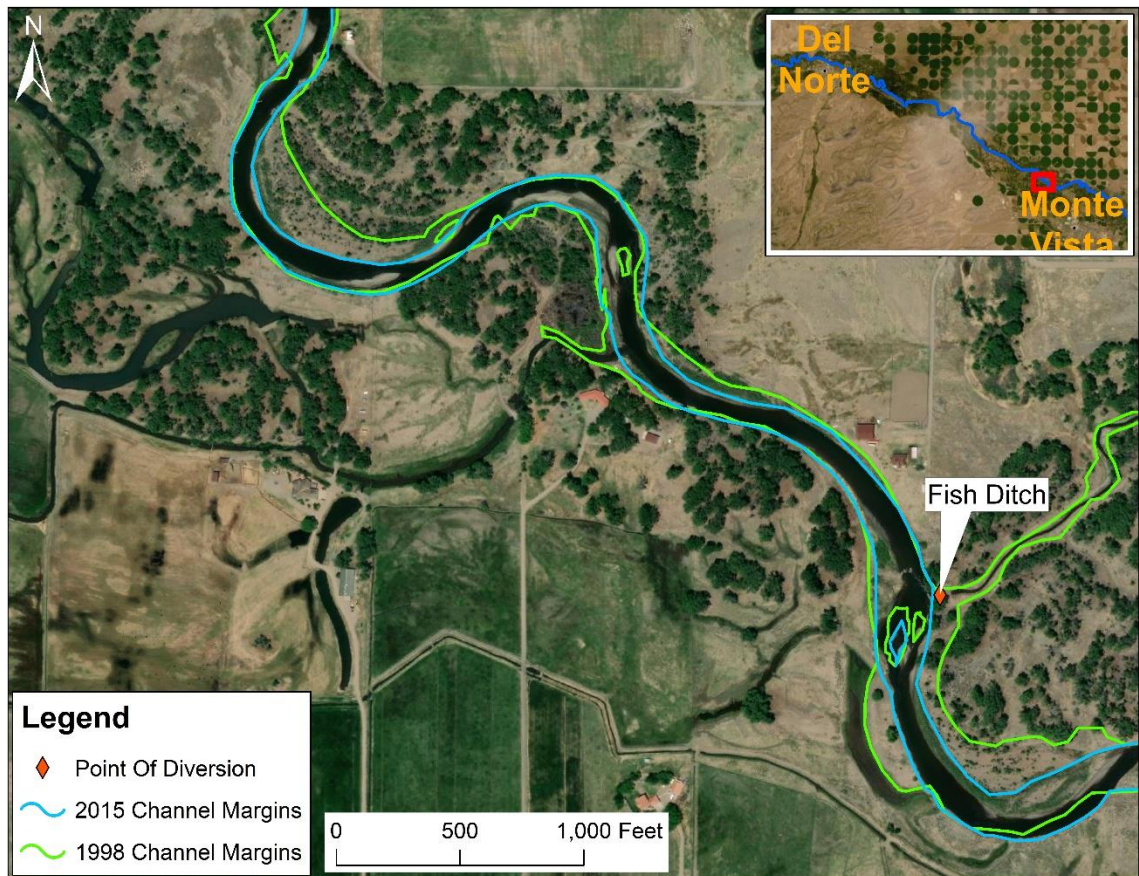
Fish Ditch diversion with 1998 and 2015 channel margins overlaid

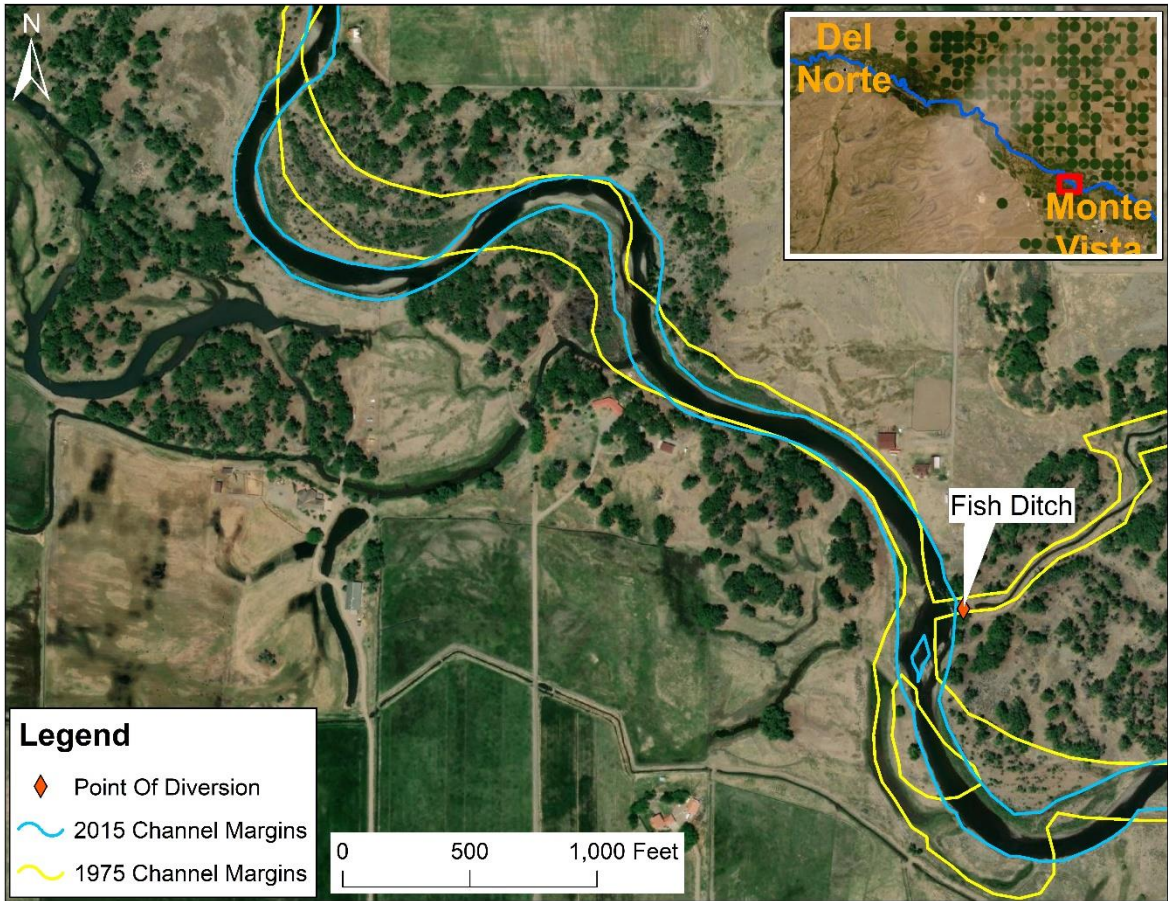
Fish Ditch diversion with 1975 and 2015 channel margins overlaid
