# RIO GRANDE DIVERSION INFRASTRUCTURE INVENTORY

**Structure Name:** HALL-VOSS D

**Date:** April 1, 2019

HALL-VOSS DITCH

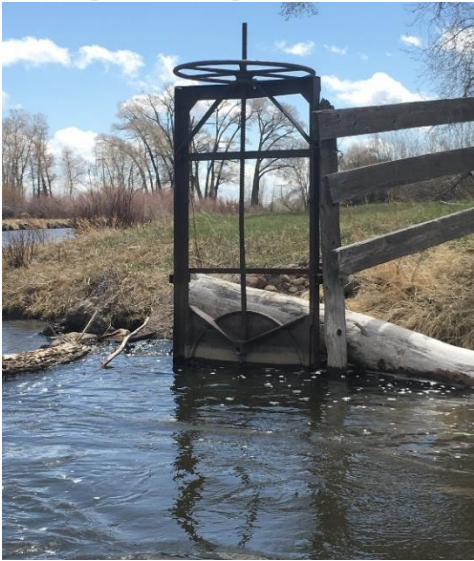
**Structure Description:** The river both upstream and downstream of this structure has remained stable in the recent past. A small stacked rock diversion dam directs water to the headgate, which is located on the south bank of the river. The diversion dam functions moderately well, but the ditch has difficulty conveying high flows. The headgate is wired to a fence post for support. The headgate lacks a supporting headwall and it leaks and is difficult to operate.

Headgate looking downstream

**Repair(s) or Improvement(s) Currently Needed:** The Technical Advisory Team (TAT) recommends headgate replacement, installation of a headgate support structure, and ditch enlargement and/or cleaning to increase conveyance capacity.

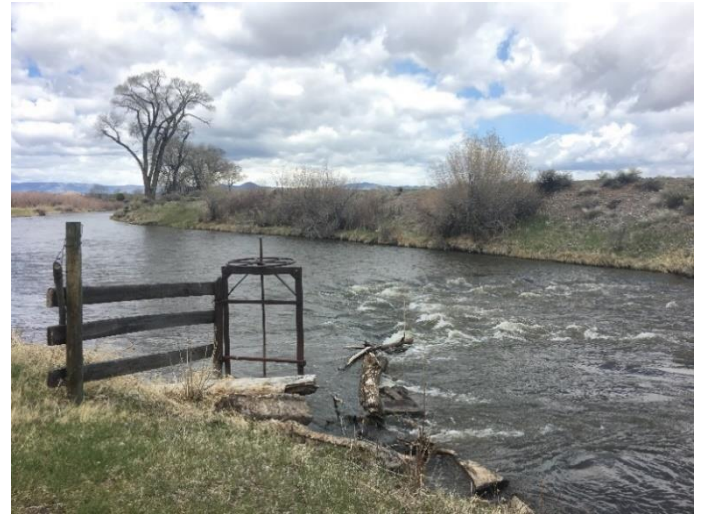
Headgate and diversion dam

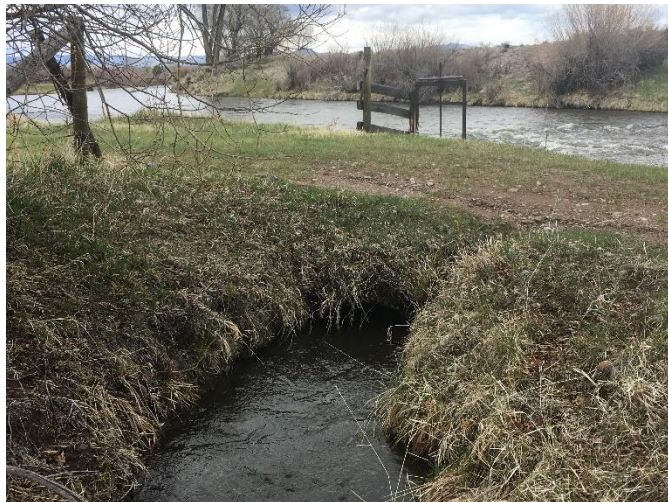
Headgate outlet

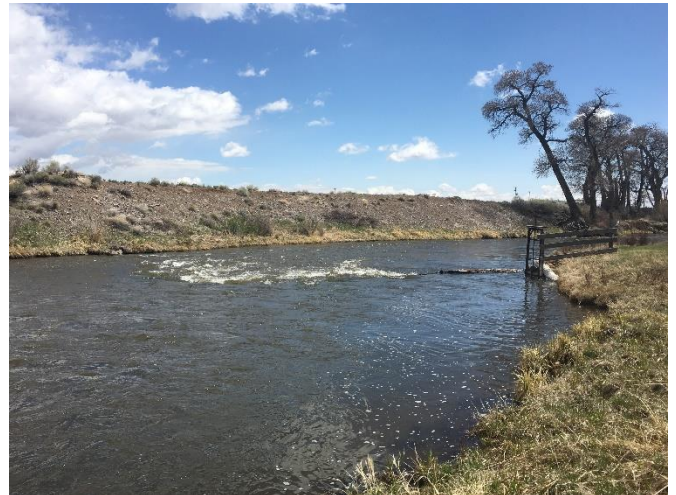
Diversion dam

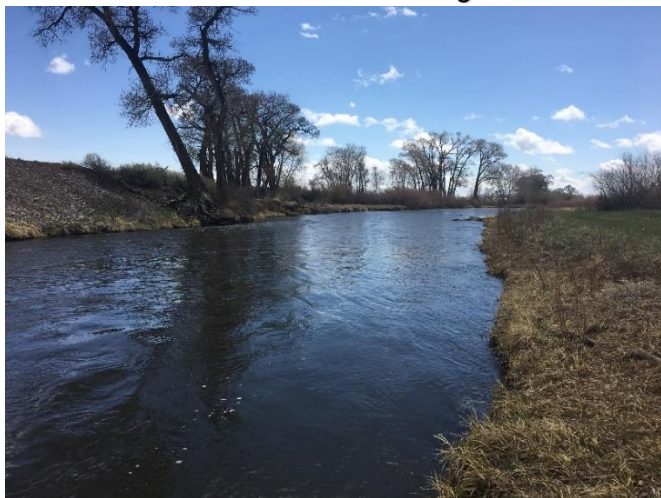
North channel Rio Grande looking downstream

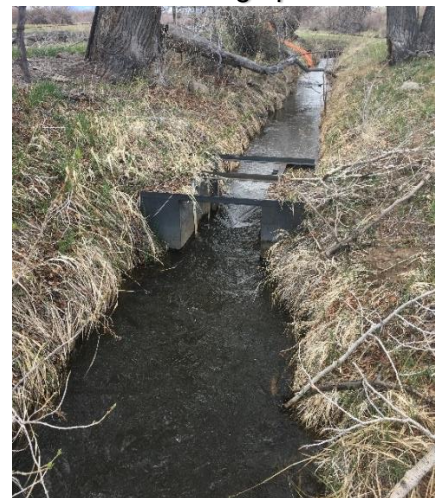
Flume looking upstream

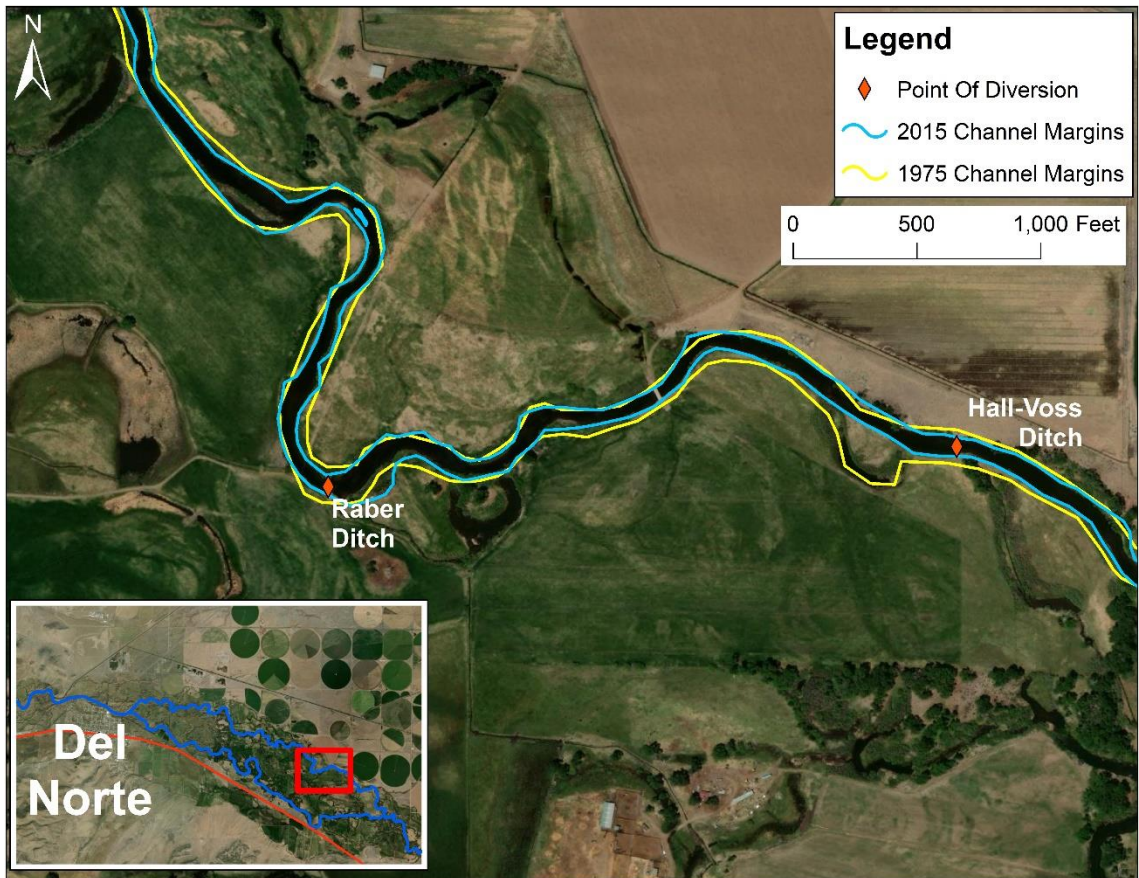
Map of headgate with 1975 and 2015 channel margins overlaid
