# RIO GRANDE DIVERSION INFRASTRUCTURE INVENTORY

**Structure Name:** HORNER YDREN D

**Date:** April 1, 2019

HORNER YDREN DITCH

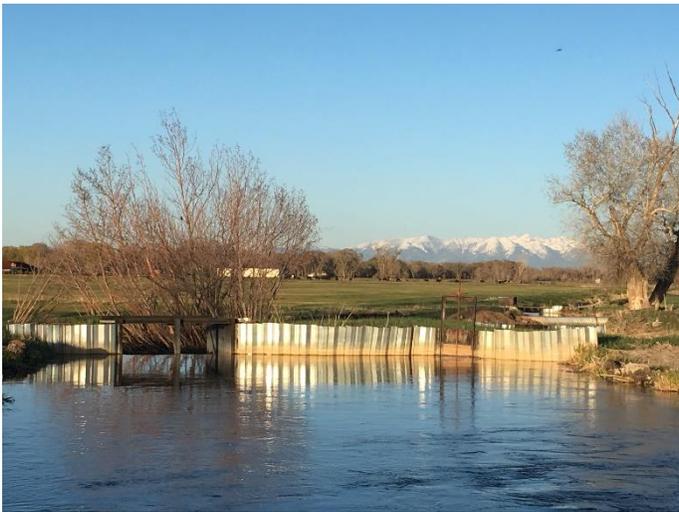
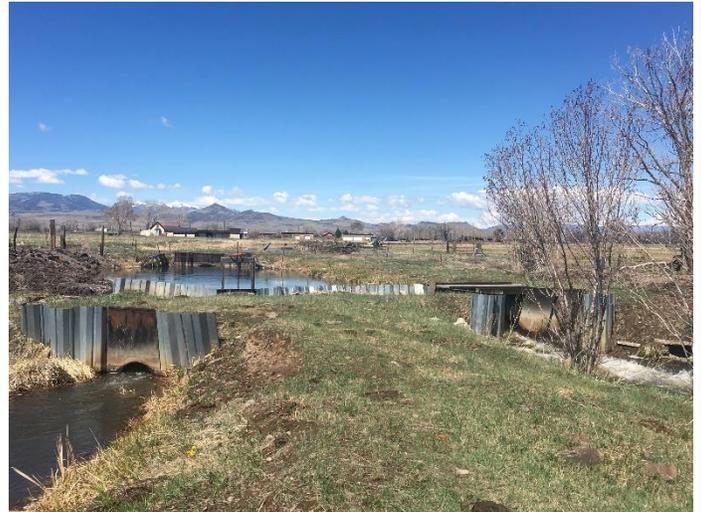
Headgate and return structure

**Repair(s) or Improvement(s) Completed Since 2006:** The headgate, wing walls, and overflow structure were recently replaced.
