RIO GRANDE DIVERSION INFRASTRUCTURE INVENTORY

Structure Name: HUBBARD D

Date: April 1, 2019

HUBBARD DITCH

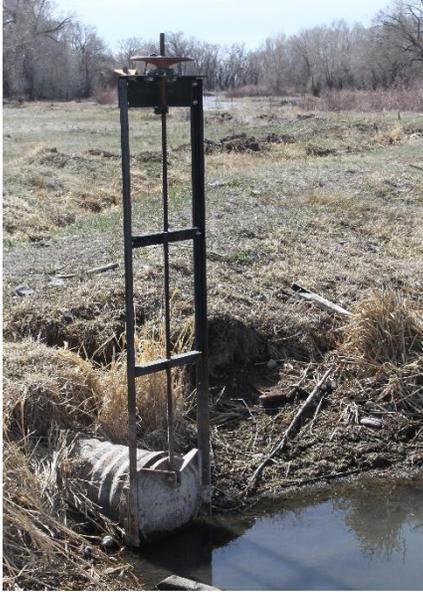
Headgate looking downstream

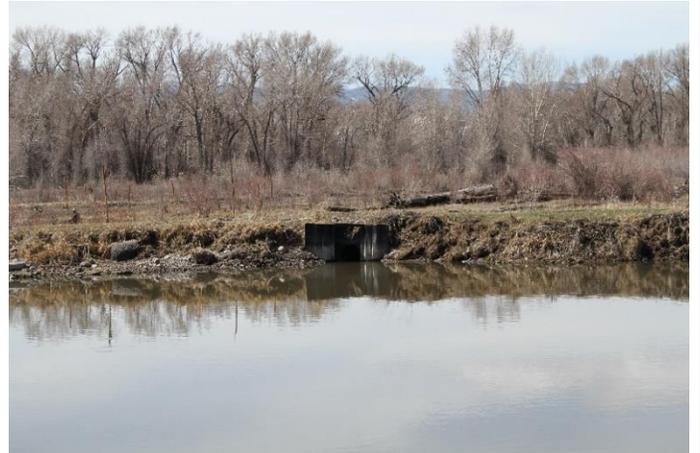
Return flow structure/diversion dam

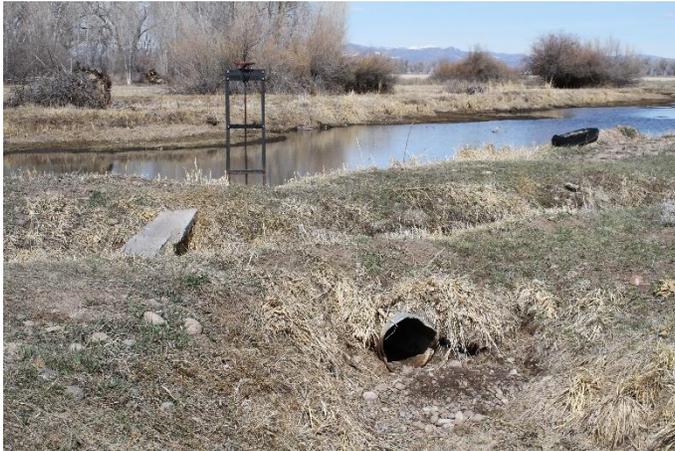
Headgate outlet

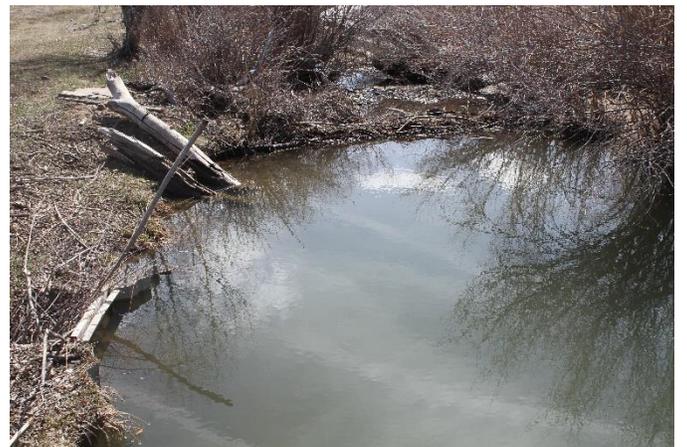
Return channel upstream of headgate

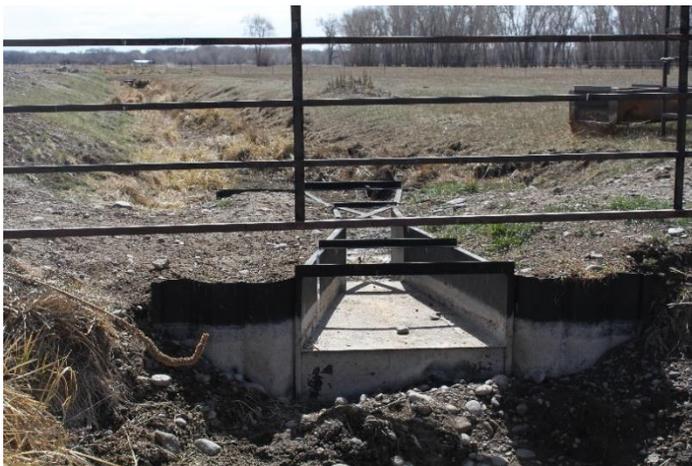
Repair(s) or Improvement(s) Completed Since 2006: The flume was replaced in 2018.

Flume looking downstream

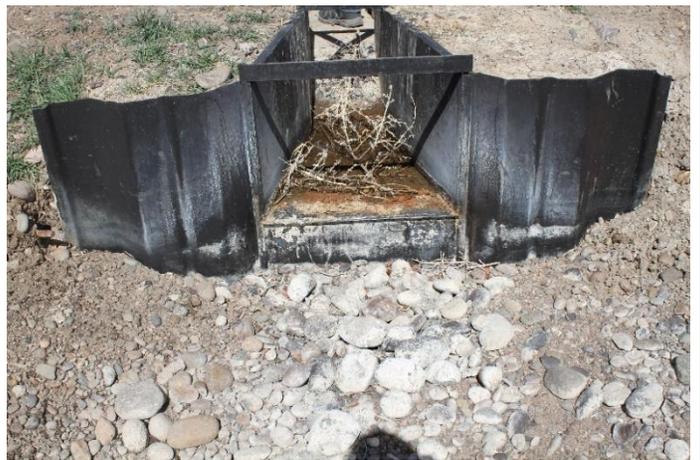
Flume looking upstream

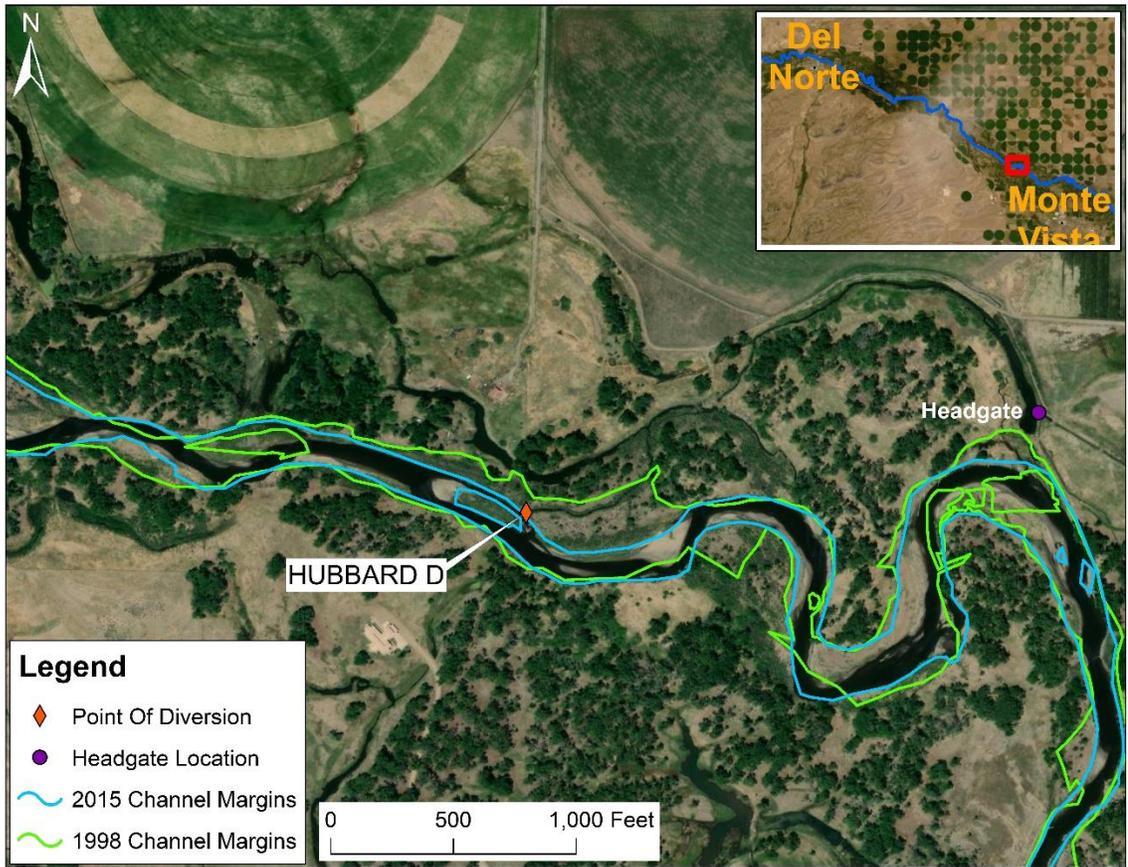
Structure Description: The channel in this area has shown signs of past avulsion. For example, a meander was cut off between 1975 and 1998. The existing feeder channel follows this historic channel (see map below). A small stacked rock diversion dam on the Rio Grande directs water to a long feeder channel. Approximately 0.25 miles down the feeder channel is a primary headgate and return flow structure. An additional 0.45 miles downstream (a total of approximately 0.7 miles from the diversion dam) is the main headgate. A culvert return flow structure with check boards also serves as a diversion dam for the main headgate.

Map of 2015 and 1998 channel margins. A meander was cut off at some point during this time period. The existing feeder ditch follows the historic channel.

Repair(s) or Improvement(s) Currently Needed: Sediment and debris accumulation in the feeder channel and headgate are major issues for this ditch. Because a trash rack is not likely to ameliorate this issue, the Technical Advisory Team (TAT) recommends regular debris clearing in the feeder channel and culvert upstream of the headgate. Alternatively, the point of diversion could be relocated downstream to reduce maintenance needs in the feeder channel.
