RIO GRANDE DIVERSION INFRASTRUCTURE INVENTORY

Structure Name: INDEPENDENT D 2

Date: May 7, 2019

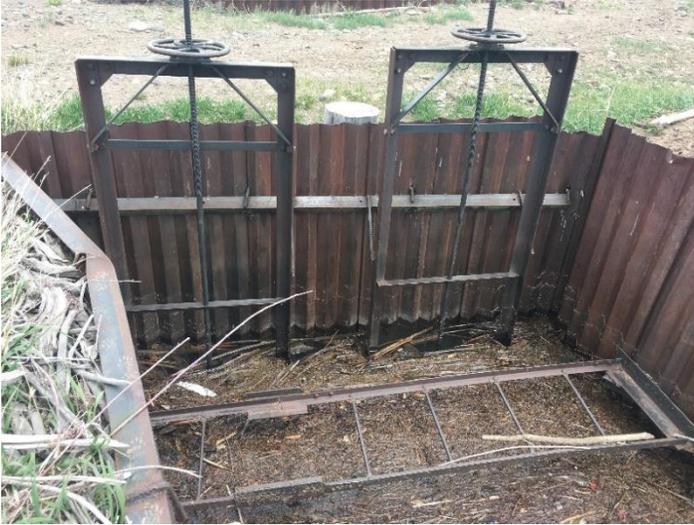
Headgate looking downstream

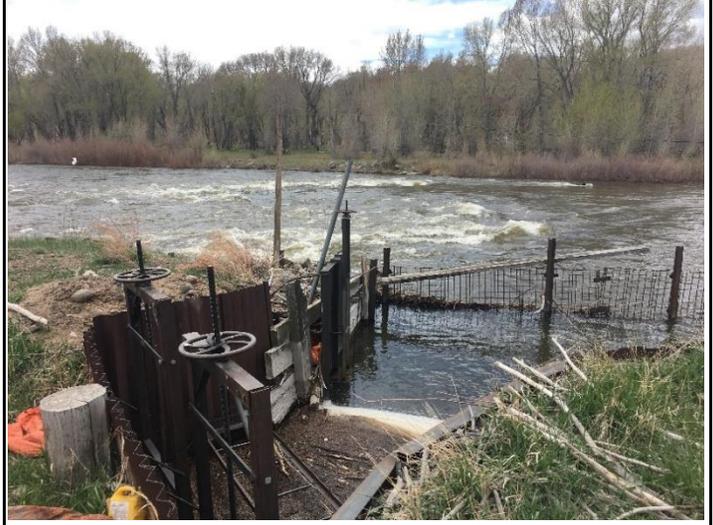
Structure Description: A W-shaped diversion dam made of boulders directs water to the headgate, which is on the north bank of the river. Recent high flow events have shifted some of the boulders which make up the diversion, resulting in a boating hazard and making water diversion at low flows very challenging. A trash rack made of 4 ft galvanized metal fence sits in front of the headgate, which does not seal properly. There are various materials stabilizing the banks upstream of the structure and around the headwall. However, the banks that are not reinforced are largely unstable and subject to erosion. This structure is located on the outside of a bend just upstream of the apex. According to the 2001 Rio Grande Headwaters Restoration Project, this meander bend is tightening and there is potential for the entire meander to be cut off during a high flow event, making this structure unusable.

Headgate and diversion dam

Repair(s) or Improvement(s) Currently Needed: Given these issues, the SMP Technical Advisory Team (TAT) recommends improving the diversion dam, repairing or replacing the headgate, and revegetating and stabilizing the adjacent streambanks. An improved diversion could be designed to be easily passable by boats while also effectively diverting water at all flows. Streambank stabilization and riparian revegetation would mitigate erosion and reduce the risk of bank failure and future impacts to the structure.

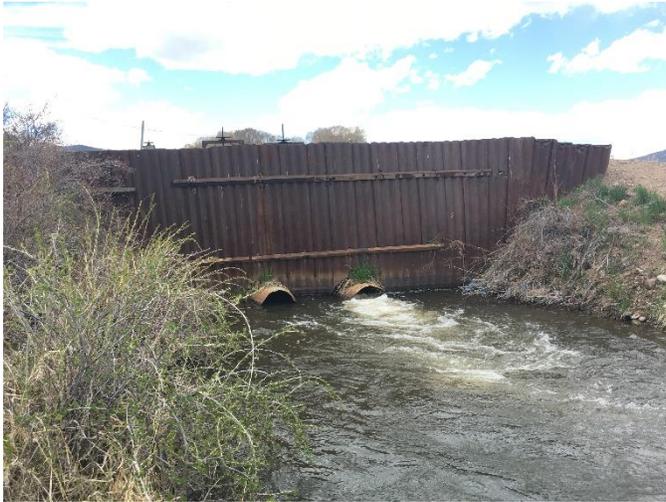
Headgate outlet

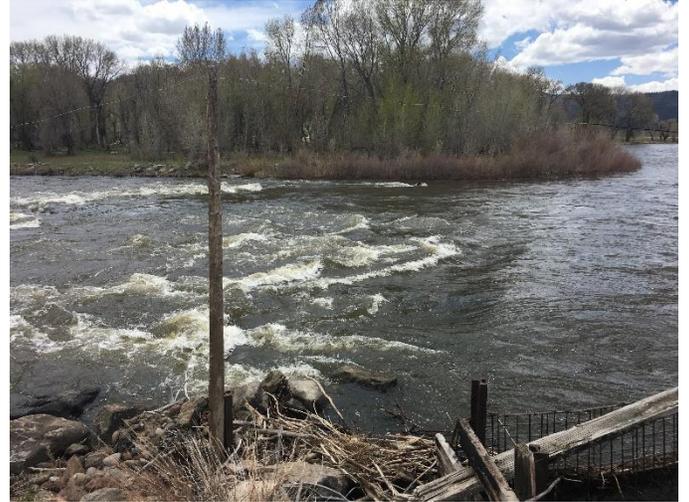
Diversion dam

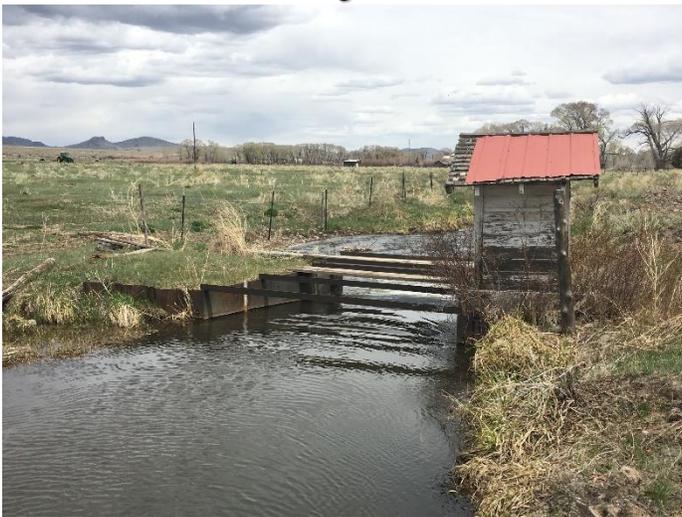
Flume looking downstream

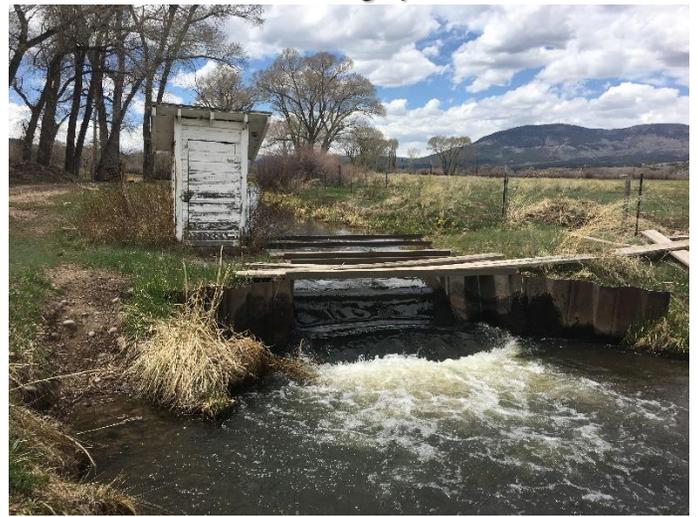
Flume looking upstream

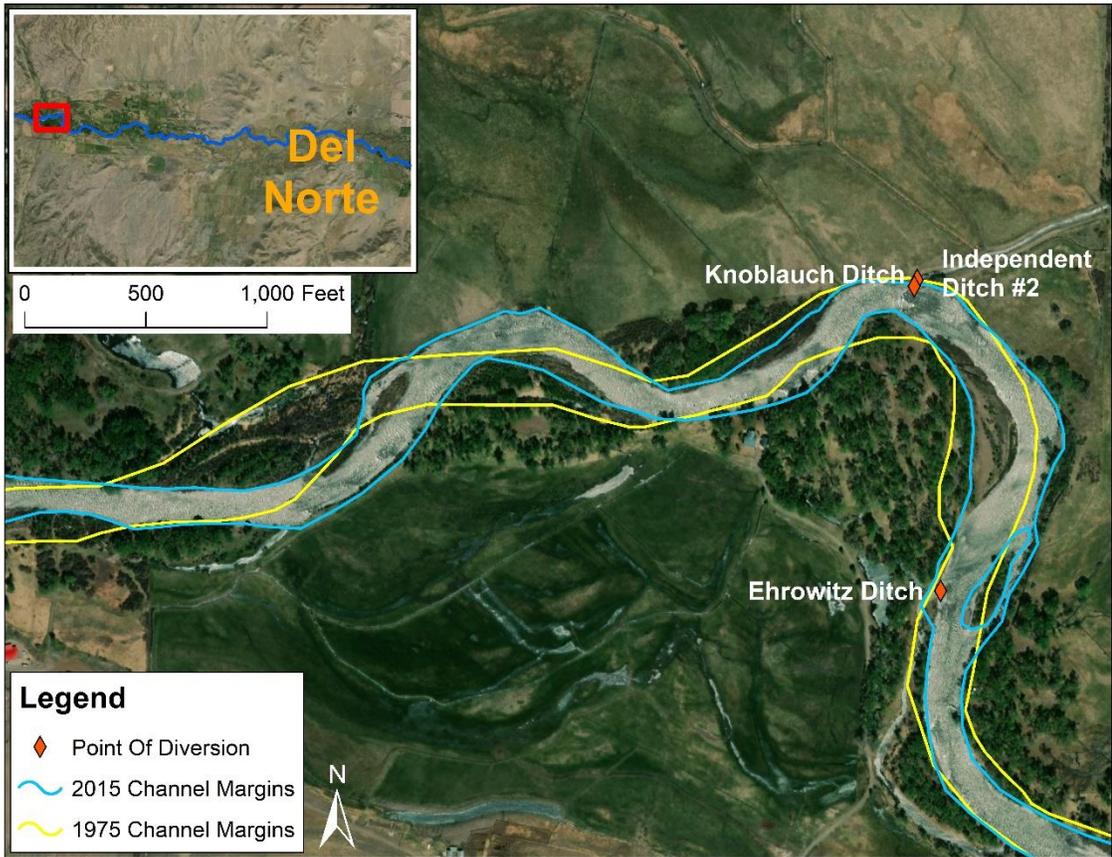
Diversion and headgate location with 1975 and 2015 channel margins overlaid. This highlights the tightening of the bend on which this structure is located.

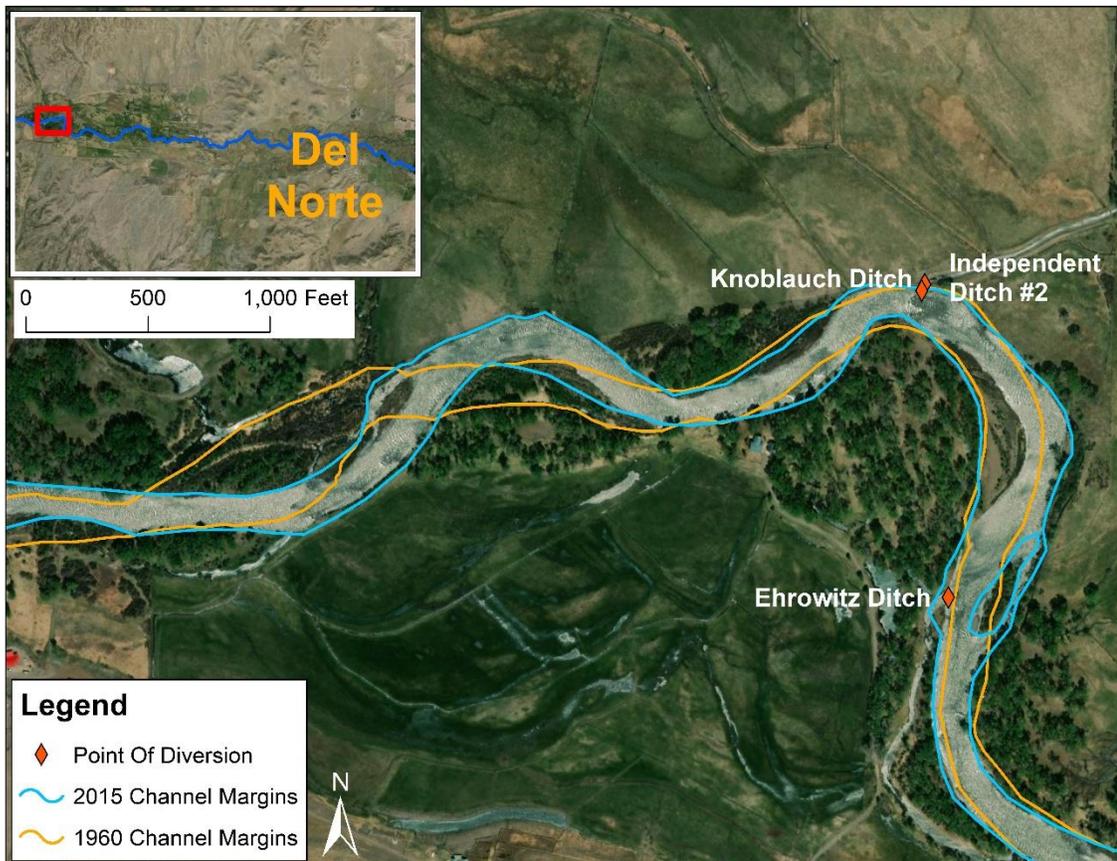
Diversion and headgate location with 1960 and 2015 channel margins from overlaid
