RIO GRANDE DIVERSION INFRASTRUCTURE INVENTORY

Structure Name: JESSUP D 1

Date: May 7, 2019

Rio Grande Stream Management Plan

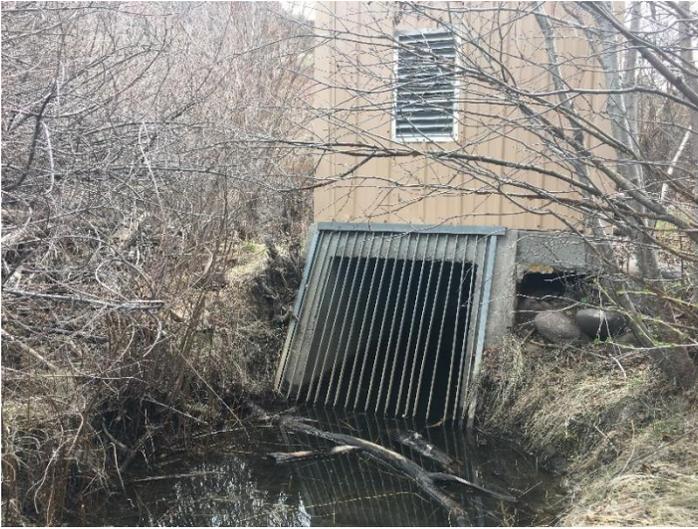
Pump house and trash rack

Repair(s) or Improvement(s) Currently Needed: Given the challenge of using a portable pump to irrigate, the SMP Technical Advisory Team (TAT) recommends repair or replacement of the pump house.

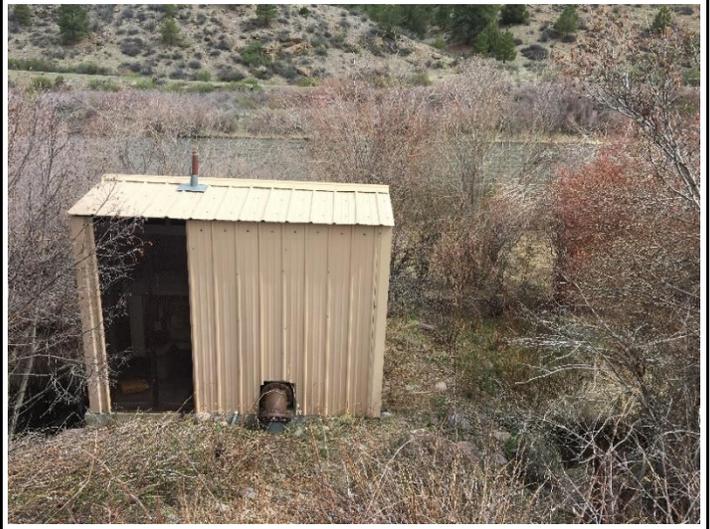
Headgate and pump house

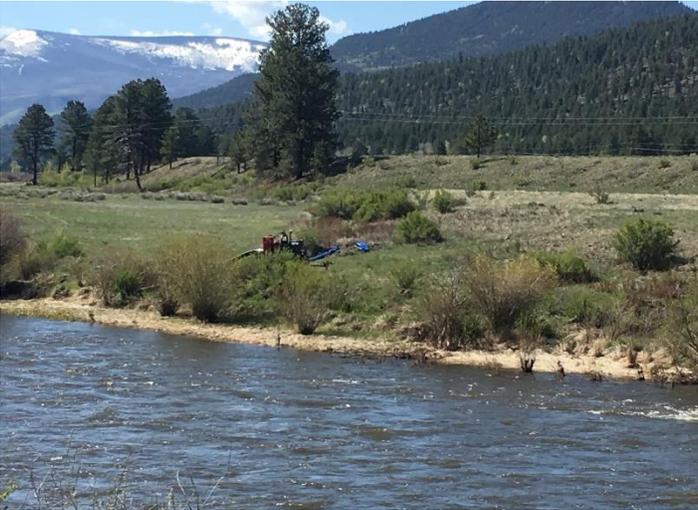
Mobile pump downstream of headgate

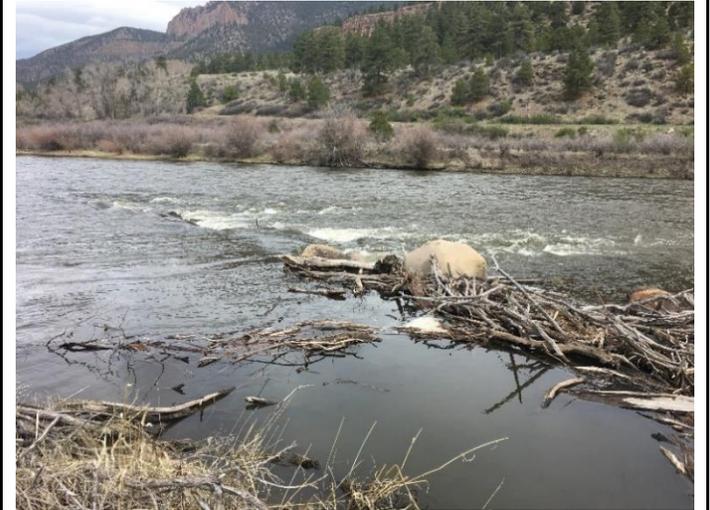
Diversion dam

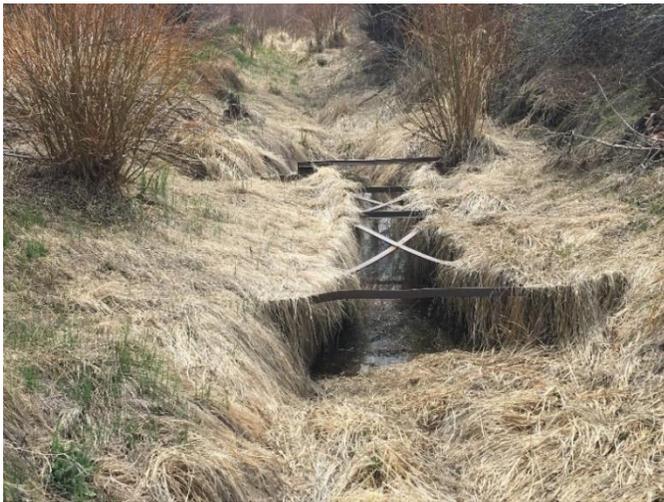
Flume looking downstream

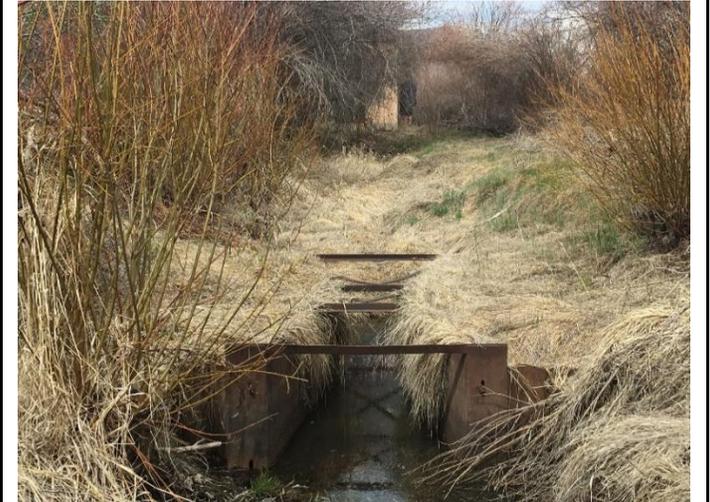
Flume looking upstream
