RIO GRANDE DIVERSION INFRASTRUCTURE INVENTORY

Structure Name: JOHN ANDERSON D

Date: April 1, 2019

PHOTO LOG

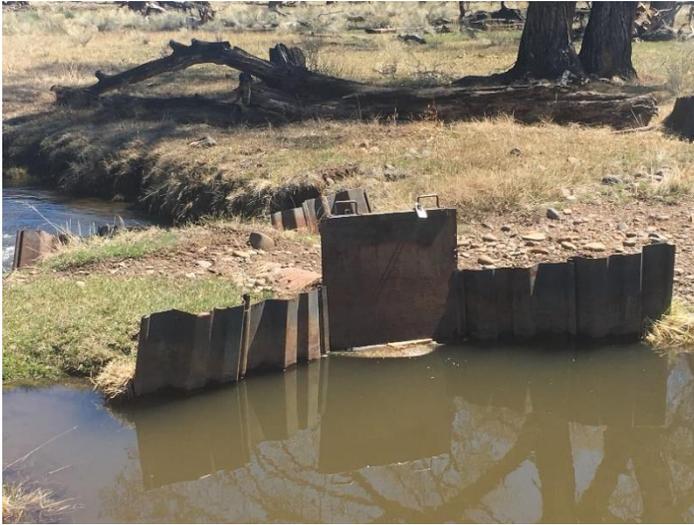
Structure Description: This structure is located approximately 1.8 miles downstream of the Consolidated Ditch diversion. A short feeder channel just downstream of County Rd 3W branches off of the Consolidated Slough, which directs water to the headgate, which is aging and difficult to operate. The downstream adjustment and return flow structure are approximately 0.5 mile downstream. The flume could not be located at the time of inspection but the water commissioners confirmed that it measures accurately.

Headgate looking downstream

Repair(s) or Improvement(s) Currently Needed: The SMP Technical Advisory Team (TAT) recommends headgate replacement for ease of use and efficient water delivery.

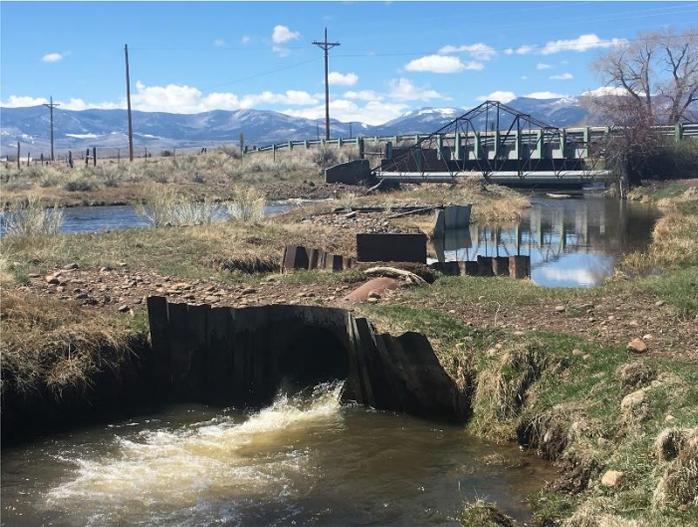
Headgate outlet

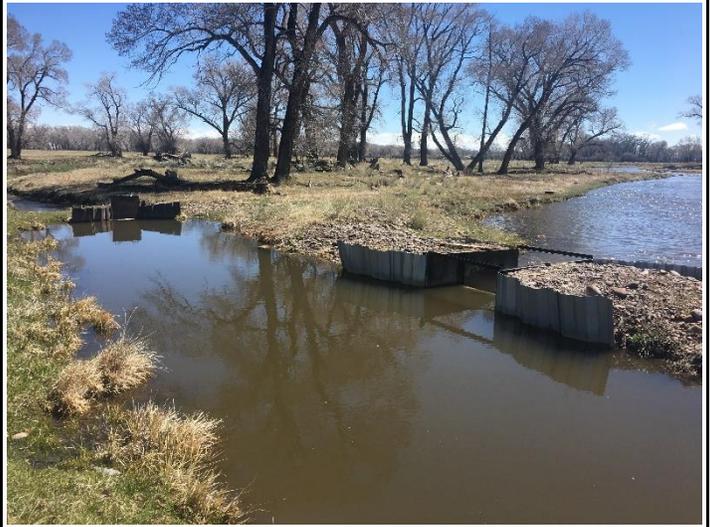
Diversion dam

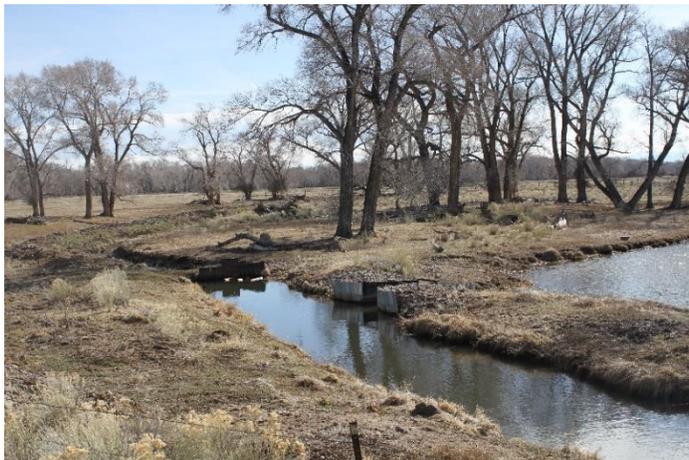
Flume looking downstream

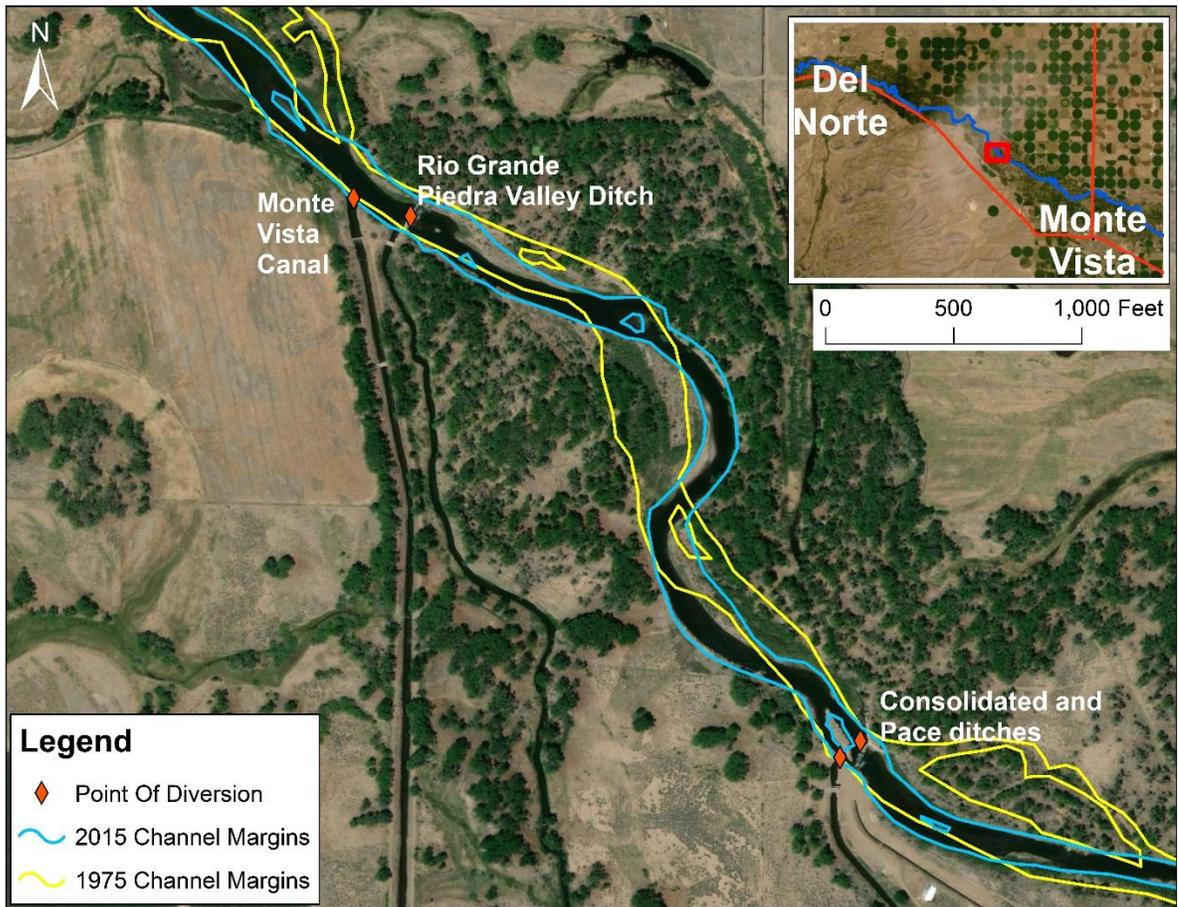
Consolidated Ditch diversion dam with 1975 and 2015 channel margins overlaid. This map also shows the gravel bar upstream of the diversion (outlined in blue).

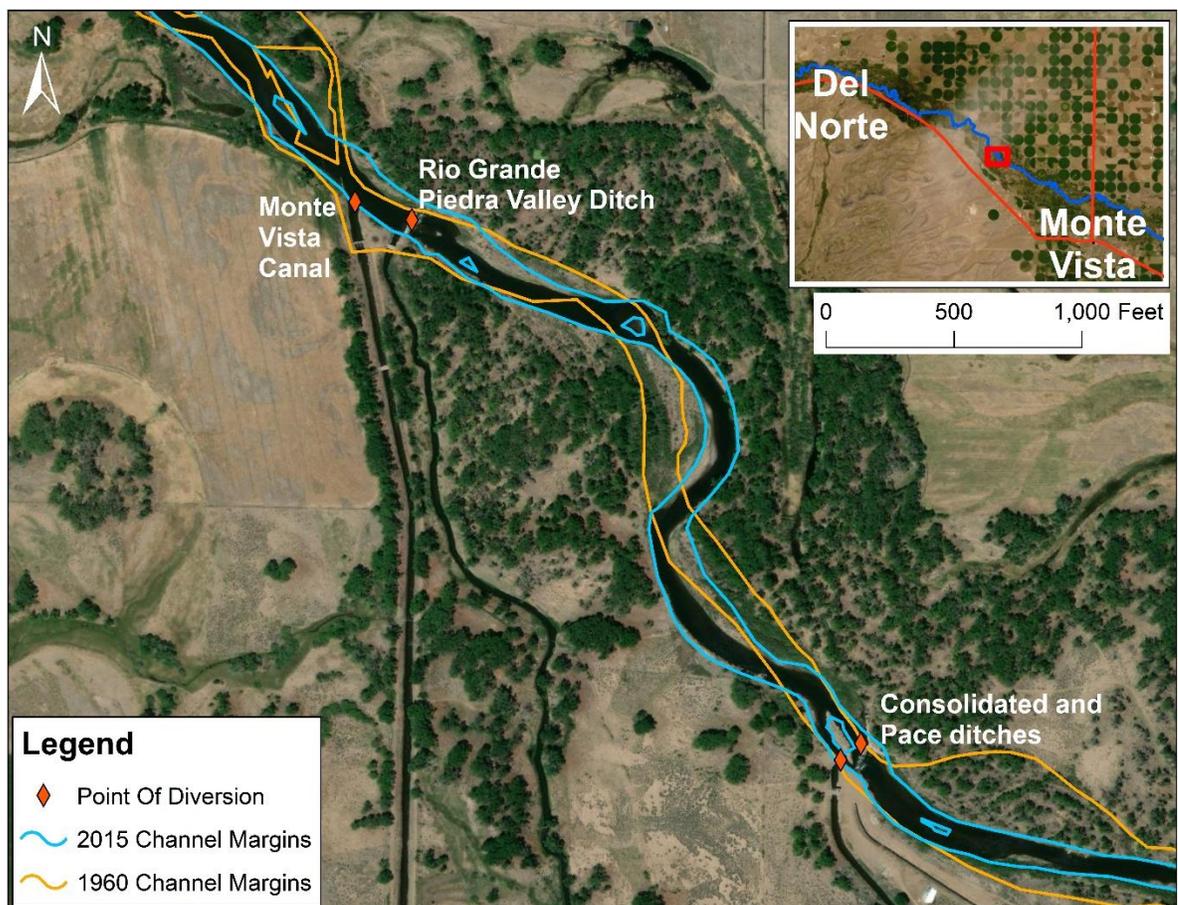
Consolidated Ditch diversion dam with 1960 and 2015 channel margins overlaid
